C.T. MALE ASSOCIATES

September 22, 2017

RE: *Visual Structural Evaluation of Existing Building*
962 Madison Avenue
Albany, NY
C.T. Male Project No. 17.7563

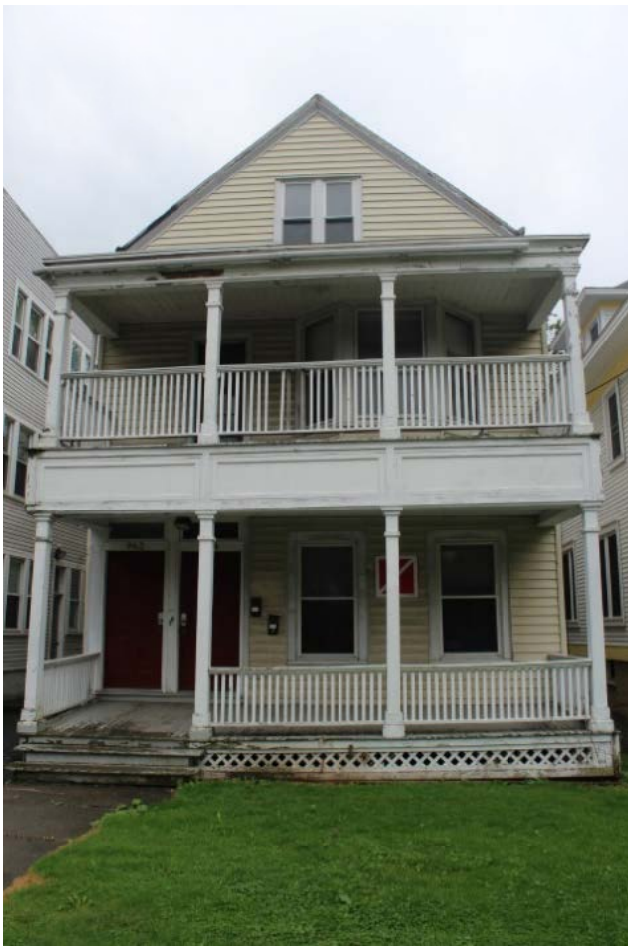
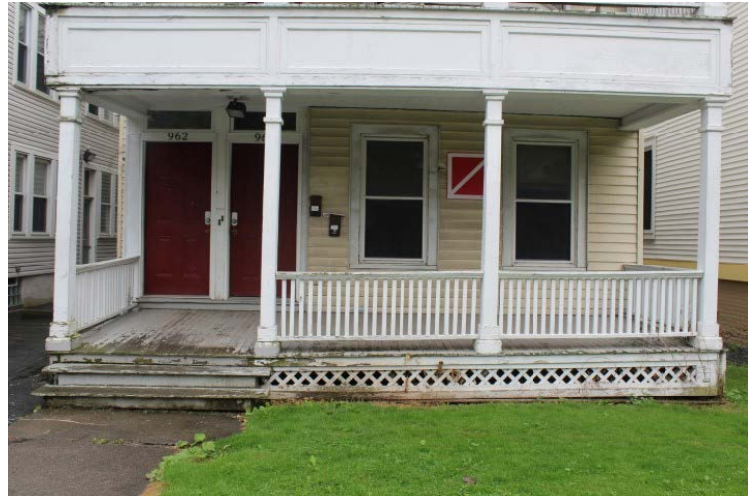
- Walls generally appear to be in structurally acceptable condition. See photos 01-04.

- The front porch has experienced excessive and differential settling at the front of the porch. See photos 01-02. **Recommendation: The four porch footings should be removed and reconstructed to provide an adequate footing size and frost depth (4' deep).**

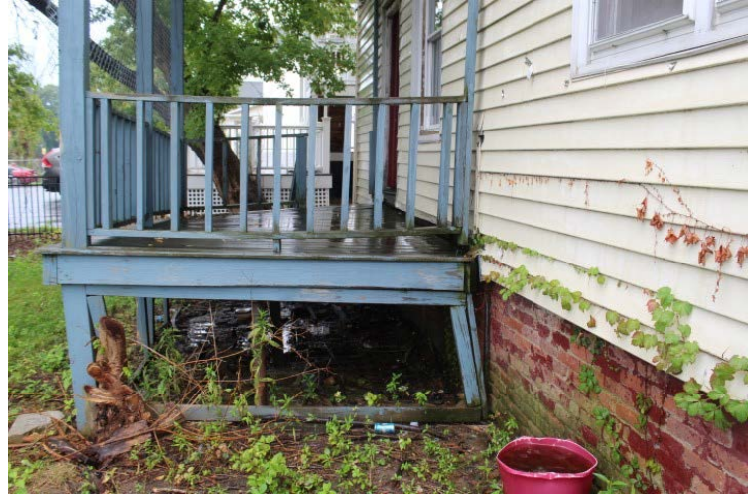
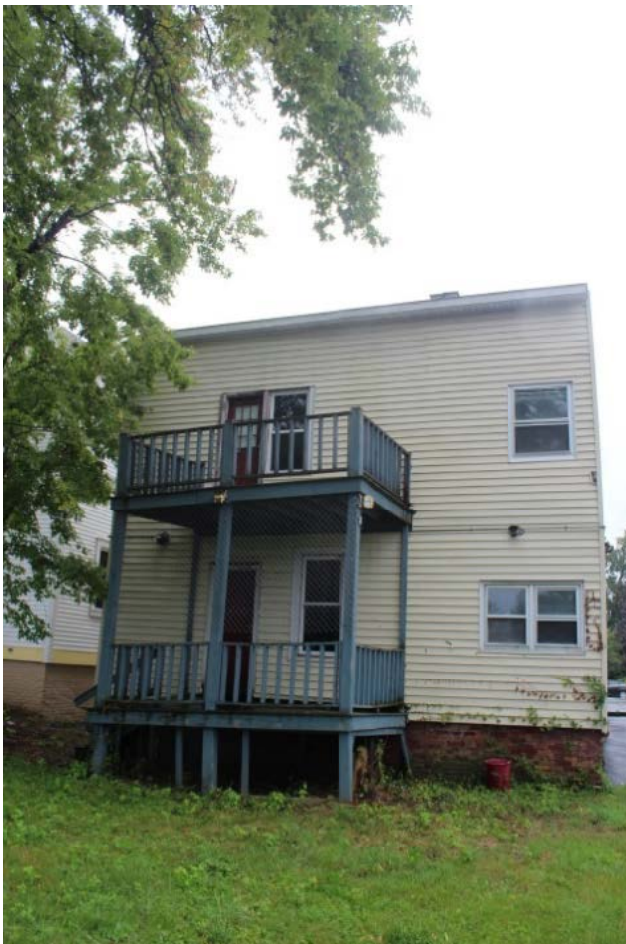
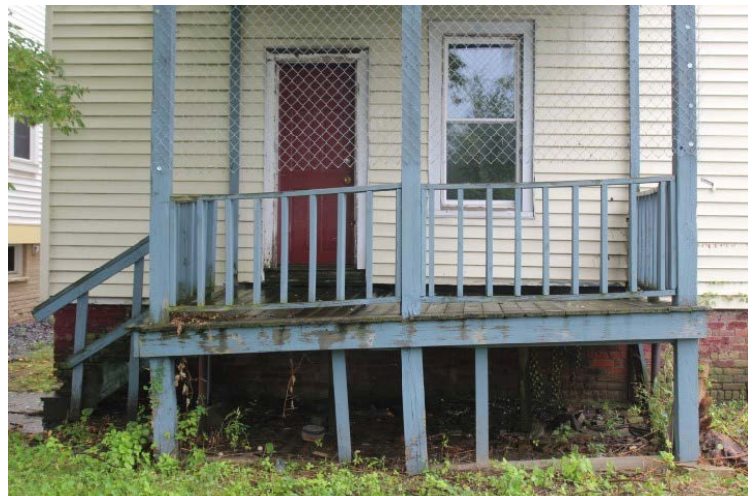
- The rear porch is pulling away from the building. Additionally, the east side of the porch has settled more than the west side. See photos 06-08. **Recommendation: The rear porch should be demolished. A new deck or stairs should be constructed or the existing doors could be removed and the openings could be framed in.**

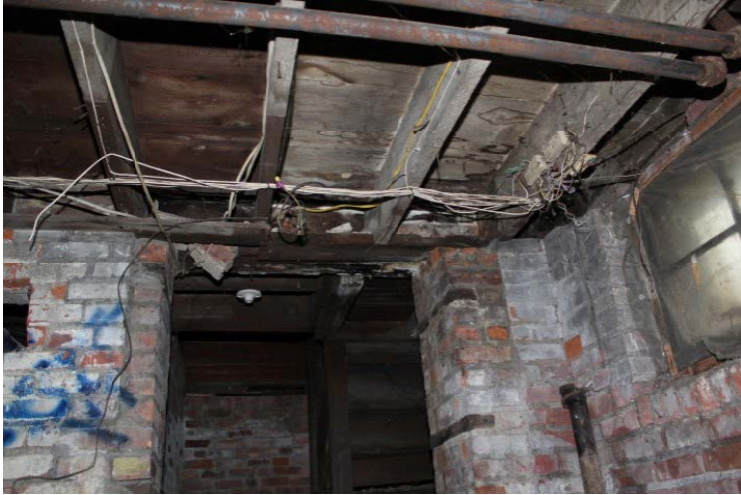
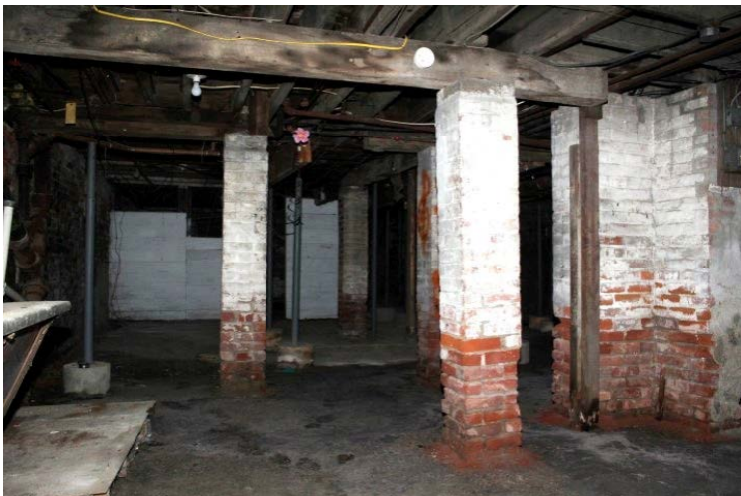
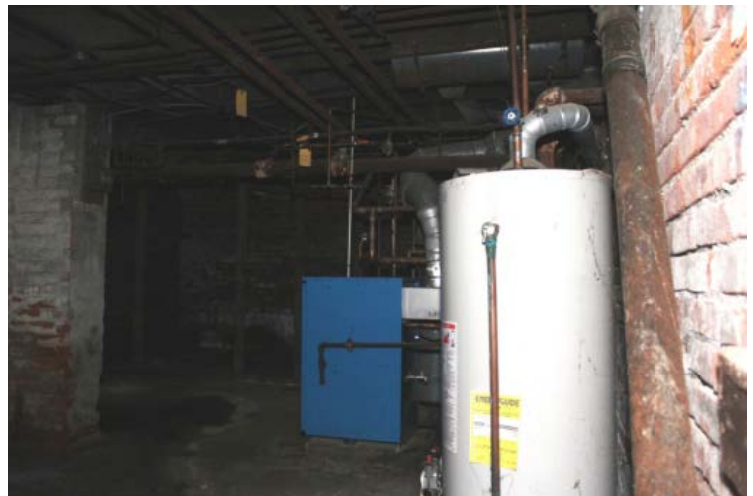
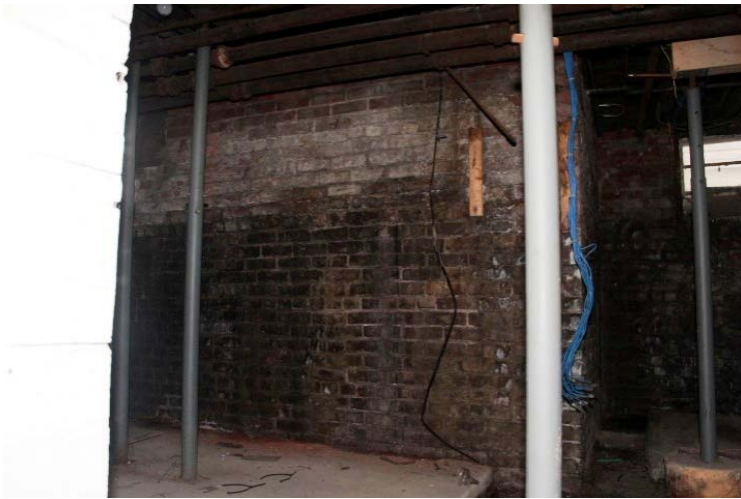
Basement/Foundation Walls: Foundation walls are brick and the basement floor is poured concrete. Below the kitchen area at the back of the building, the basement area is a crawl space. At the full height portion of the basement, many supplemental steel posts on cylindrical concrete footings supporting new wood beams have been added between the original floor beams. See photos 13-19.

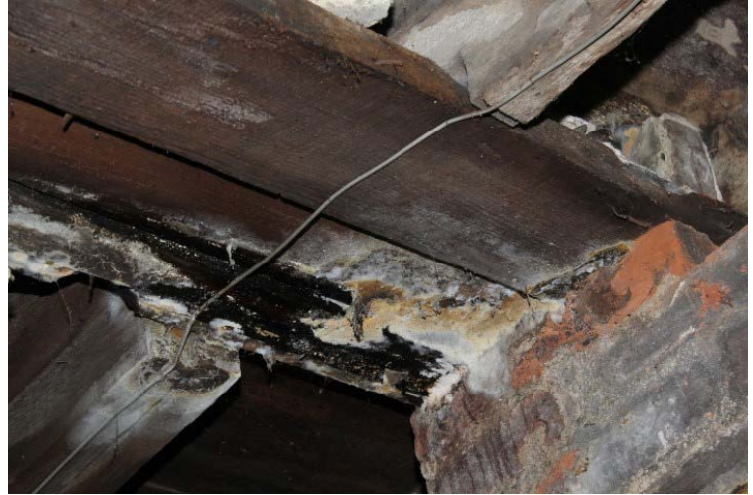
962 Madison Ave 14.JPG

- Water was visibly leaking through the door to the basement located below the kitchen/dining room walls above. (See photo 14) **Recommendation: Address all roof leaks. Repair deteriorated framing.**

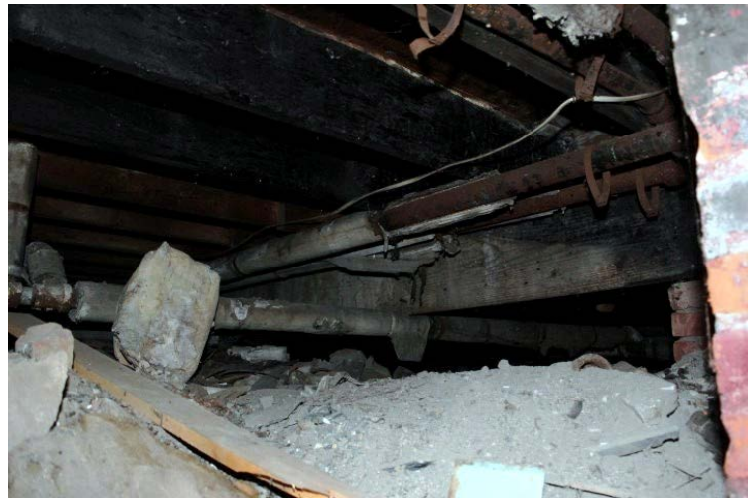
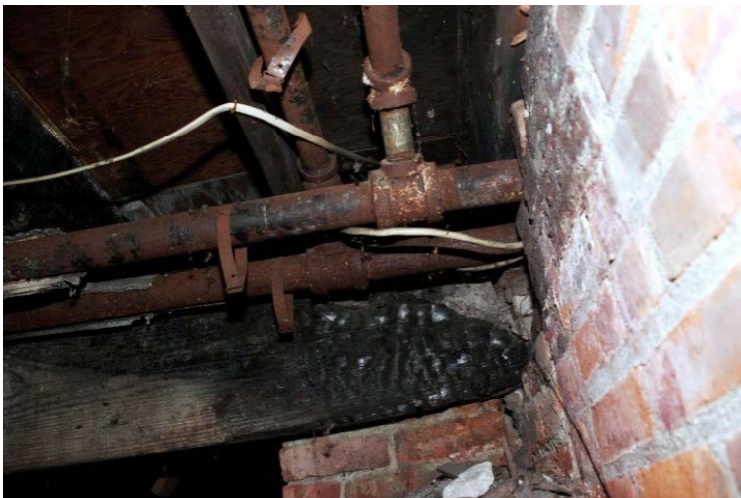
- At the crawl space portion of the basement, there was fire damage to one of the floor beams. The beam does not currently appear to be supported at one end. See photos 18-19. **Recommendation: Add a structural support for the unsupported beam.**

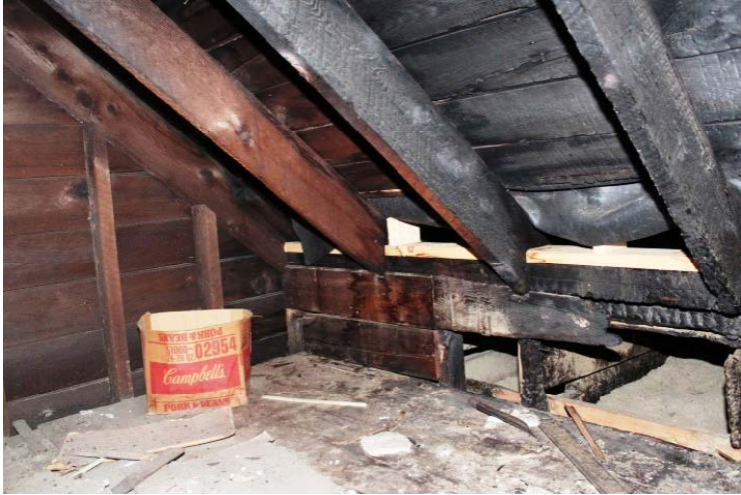
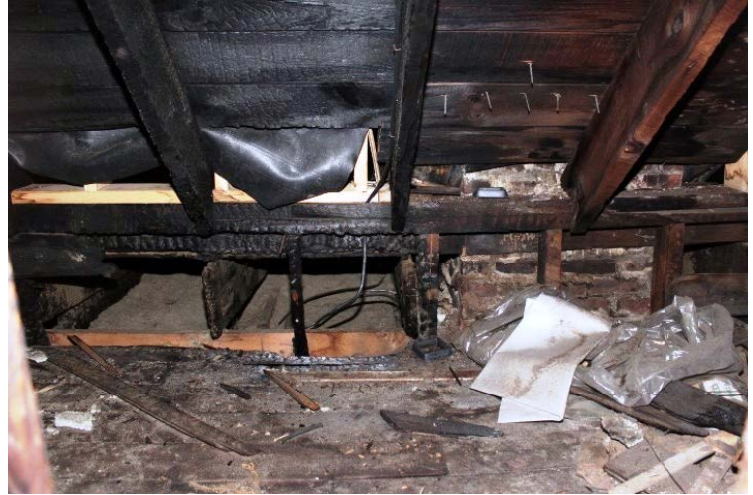
- Some water damage is visible at several active roof leak locations. The largest leak is above the back hallway/dining room wall (photo 24, 32). There is a leak at the finished room above the front stairway (photo 23). There are a few small leaks at the west eave side of the building (photos 25 - 27). This may have caused deterioration at some wall and floor framing, especially at the back hallway/dining room wall. **Recommendation: Address all roof leaks, either by repairing the existing roof, or by providing a new roof. Repair deteriorated framing.**
- Roof framing has fire damage near the back of the building. See photos 21 and 22. **No action required.**

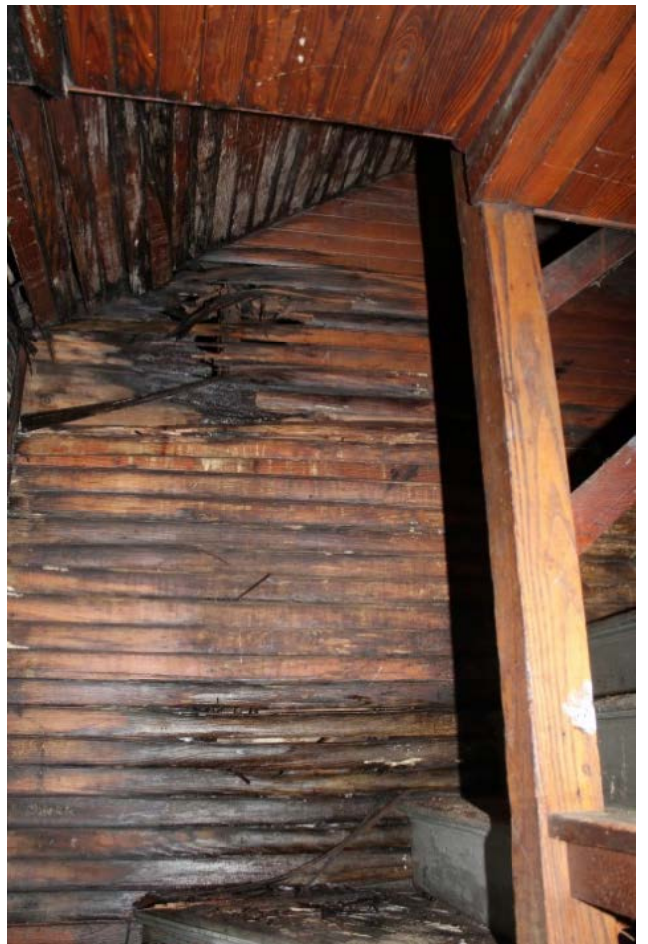
962 Madison Ave 32.JPG

- The structure is wood framed, 2-stories high plus a partially finished attic.
- The structure has wood framed porches at both the front and back of the building.
- The exterior appears to have originally been wood siding, but is now clad with vinyl siding.
- The interior has plaster on wood lath, gypsum board, or wood bead-board finishes.
- The building has experienced roof leaks and may have structural deterioration that is concealed behind wall finishes. In general, as damaged wall finishes are replaced, the framing behind these finishes should be evaluated. If deteriorated framing is discovered, it should be repaired or replaced. Photos 32 and 34 show two areas of damaged wall finishes.

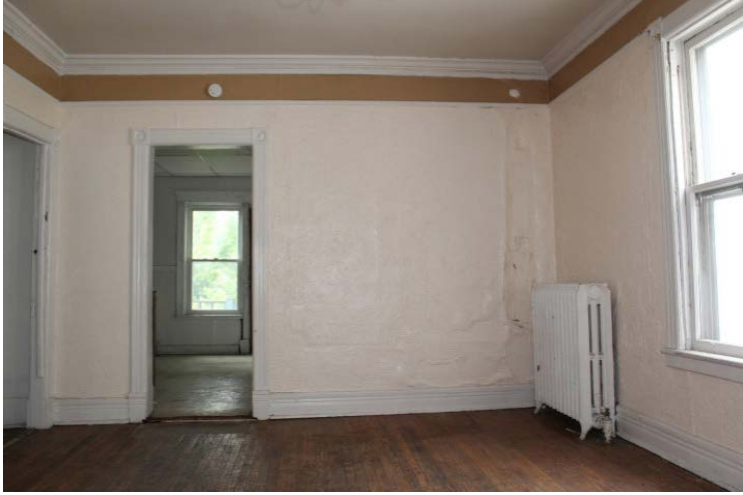
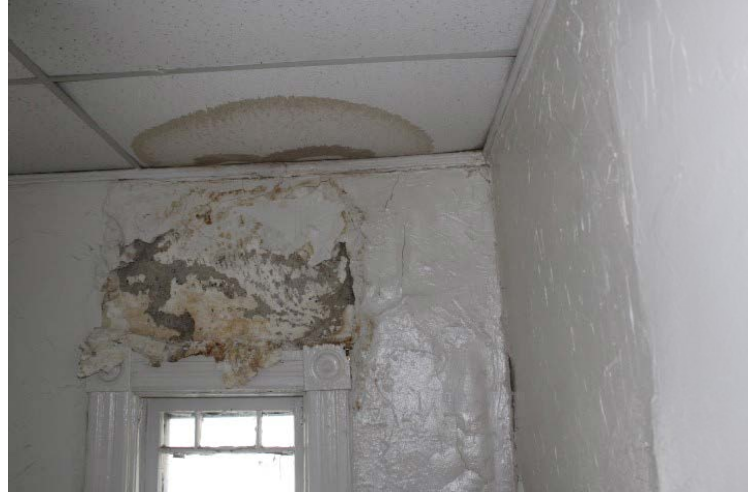
- Some water damage is visible corresponding to water leaks at the roof (see the attic/roof section). This may have caused deterioration at some wall and floor framing, especially at the back hallway/dining room wall. See photos 33-34. **Recommendation: Address all roof leaks. Repair deteriorated framing.**
- The bay window at the front of the building slopes significantly. The floor slopes and the side window frames are racked, preventing the window sashes from closing completely at the top or bottoms of the opening. See photo 35. **Recommendation: Provide a structural support for the front of the bay window.**
