C.T. MALE ASSOCIATES

RE: *Visual Structural Evaluation of Existing Building*
192 Partridge Street
Albany, NY
C.T. Male Project No. 17.7563

Visual Structural Evaluation of Existing Buildings
192 Partridge Street - Albany, NY
September 22, 2017
Page 2

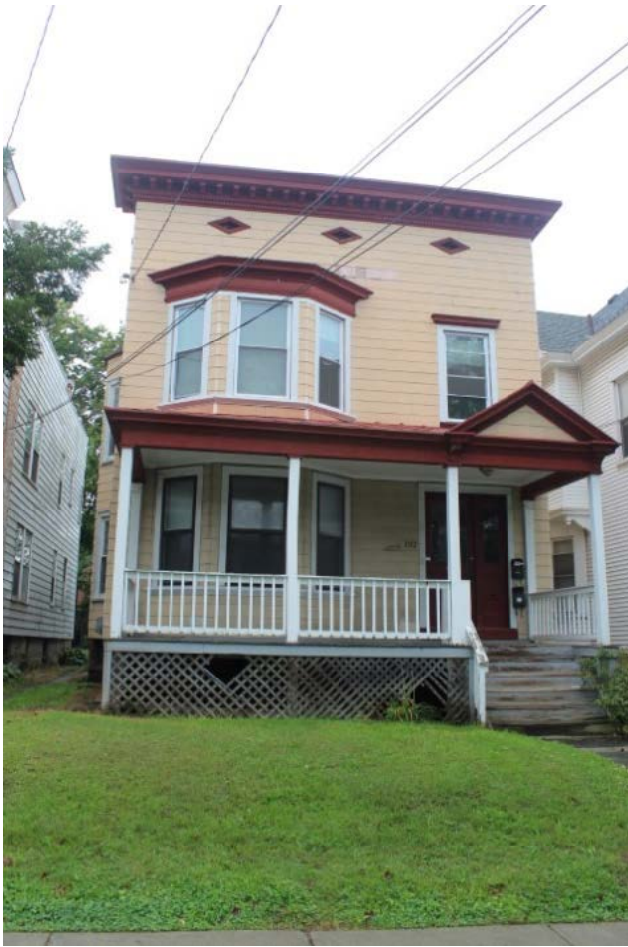
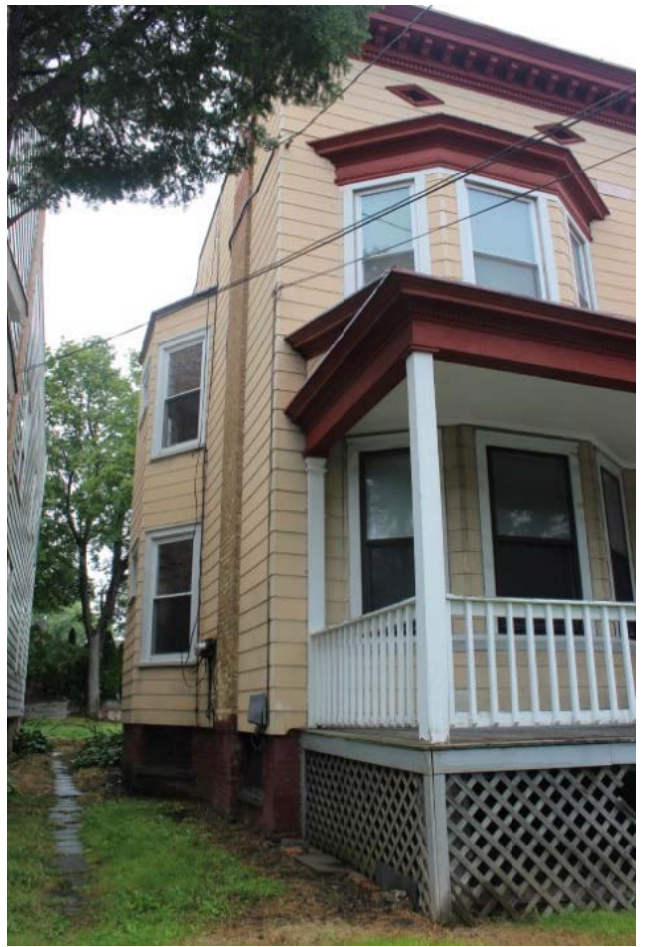
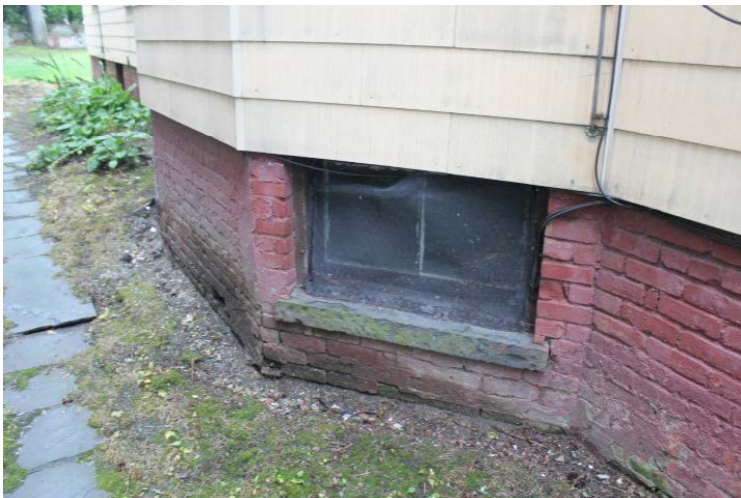
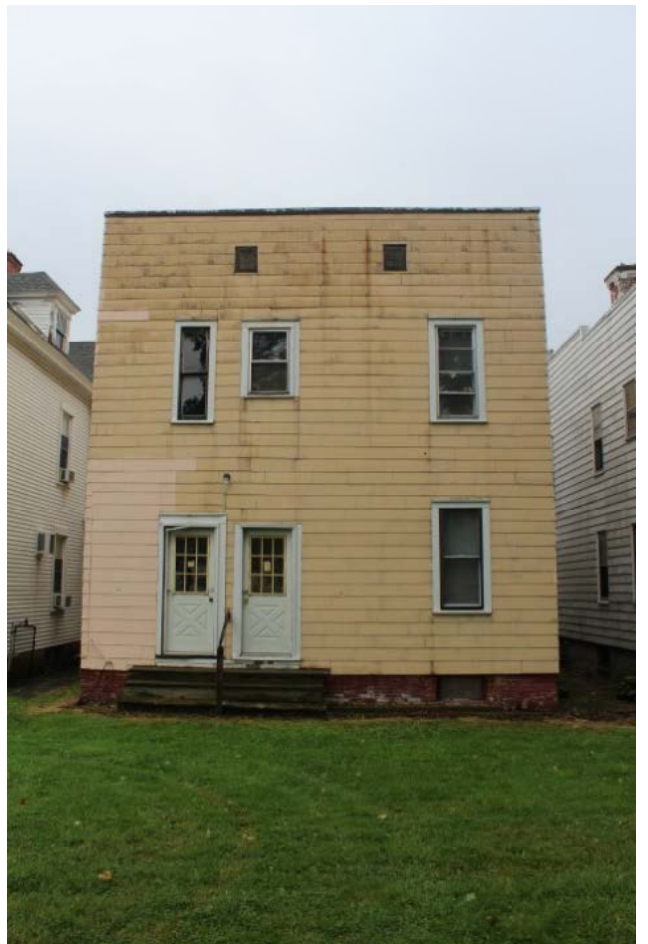
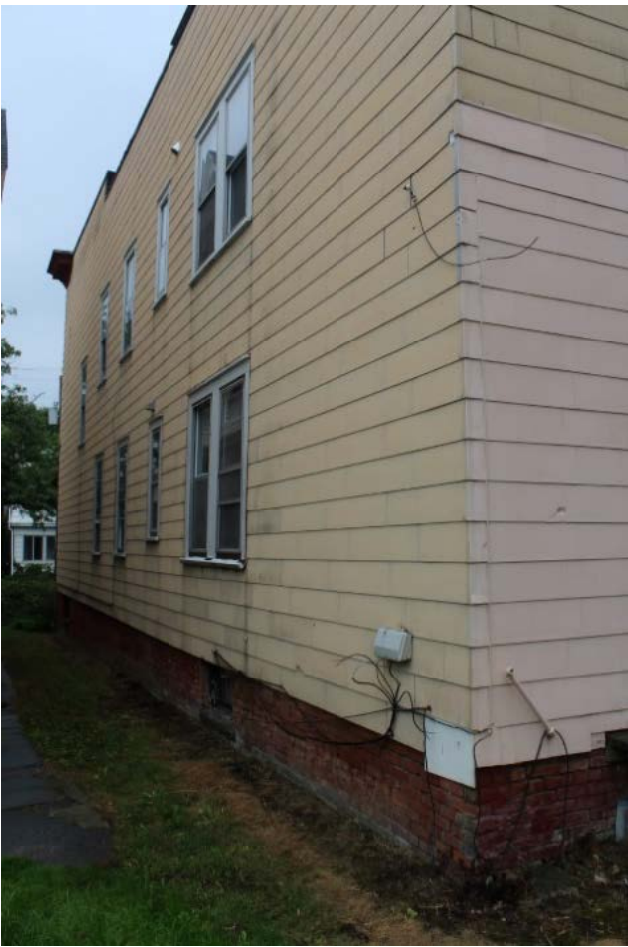
- Walls generally appear to be in structurally acceptable condition. There is some non-structural damage to siding. See photos 01-05. **No action required.**

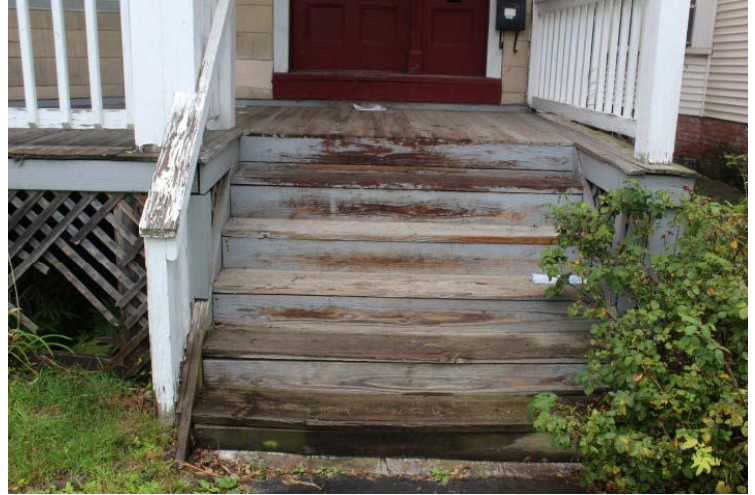
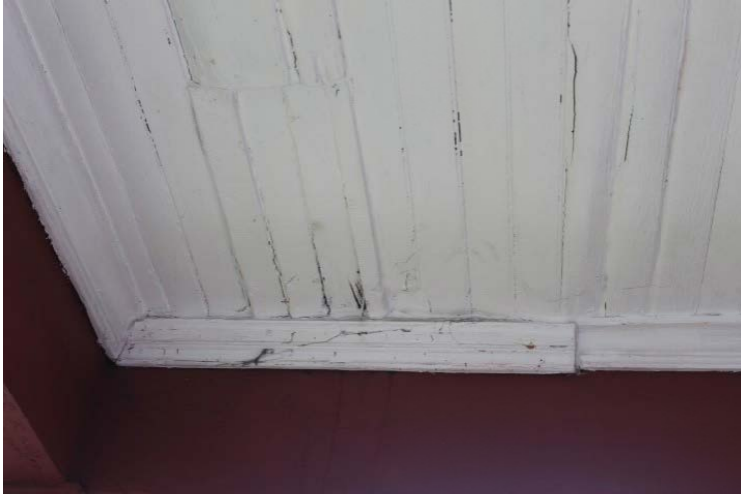
Front porch: See photos 01 and 06 through 09.

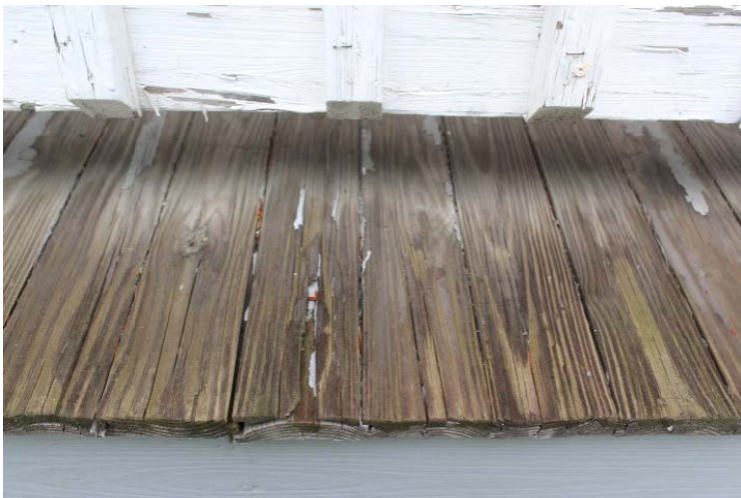
192 Partridge 07.JPG

- The front porch deck surface is significantly worn and checked/split. See photo 07. **Recommendation: The porch deck surface should be replaced.**
- Front steps to the porch are deteriorated. See photo 08. **Recommendation: Rebuild the stairs.**
- The pathway to the front steps is out of level. The middle stone has settled more than 1" relative to the adjacent stair and sidewalk stone. See photo 08. **Recommendation: Install a uniformly sloping walk from the site stairs to the building stairs. Either reset the existing stone or install a concrete or paver walkway.**

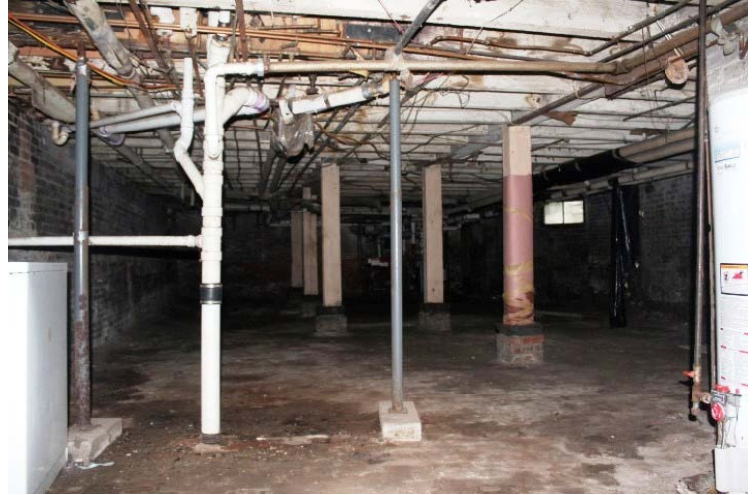
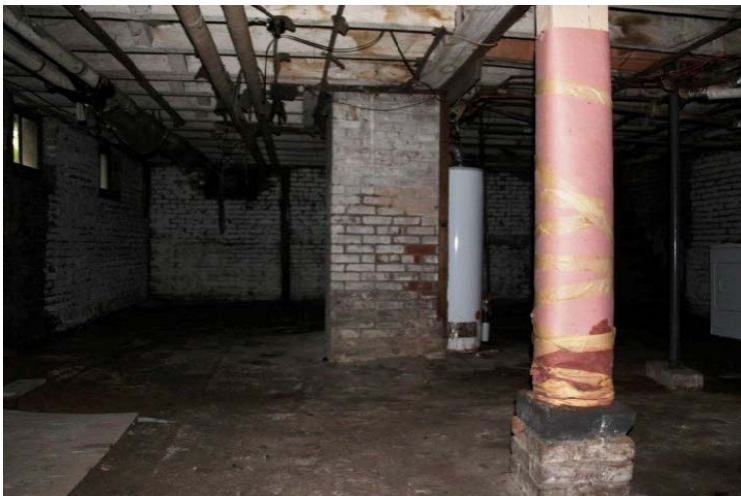
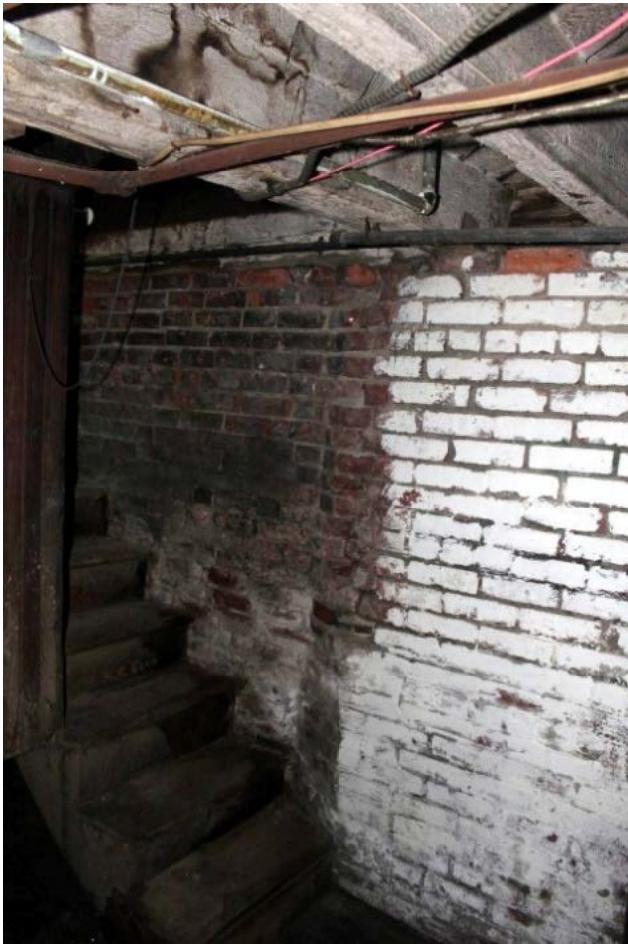
Basement/Foundation Walls: Foundation walls are brick and the basement floor is poured concrete or brick with a concrete parging over it. Basement walls retain approximately 4' of soil. See photos 10-13.

- At the exterior of the brick foundation walls, some mortar is loose and some bricks are loose, especially at the ground line. **Recommendation: Re-set any loose bricks. Re-point mortar at any exterior brick locations with loose mortar.**

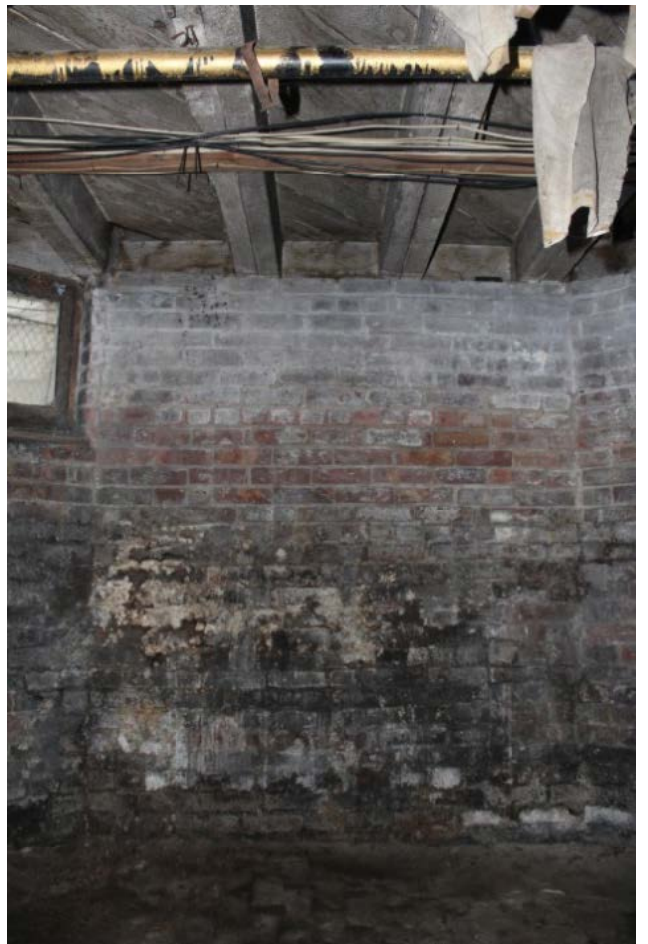
192 Partridge 12.JPG

- The basement is damp, although there was no standing water. Evidence of water infiltration can be seen on the walls. See photo 12. **No action required. This would need to be addressed if any occupancy were planned that would require a low-humidity basement.**

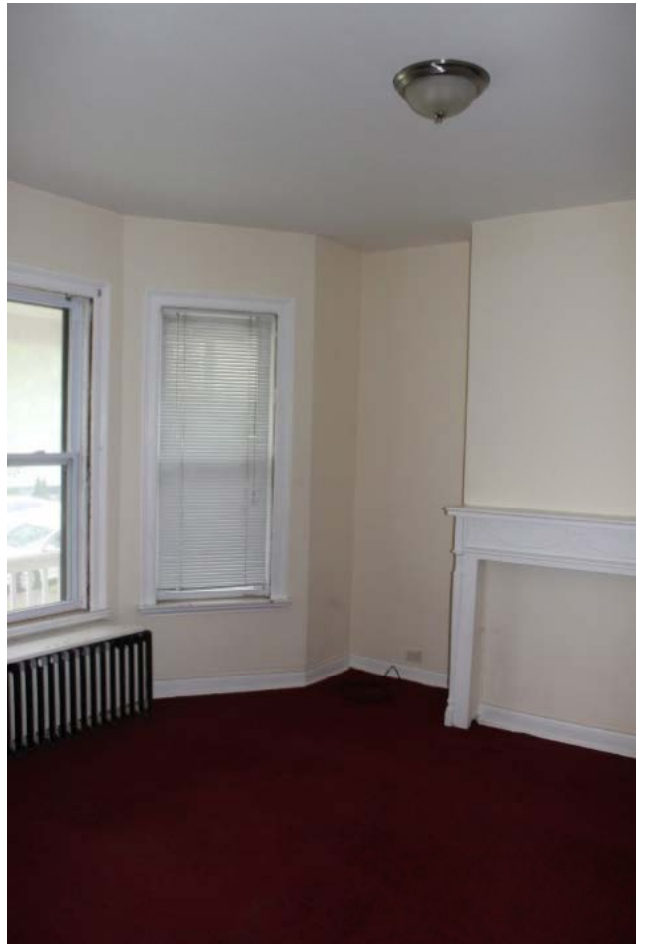
192 Partridge 14.JPG

First Floor: No structural damage or water infiltration was observed at the first floor. See photo 14.

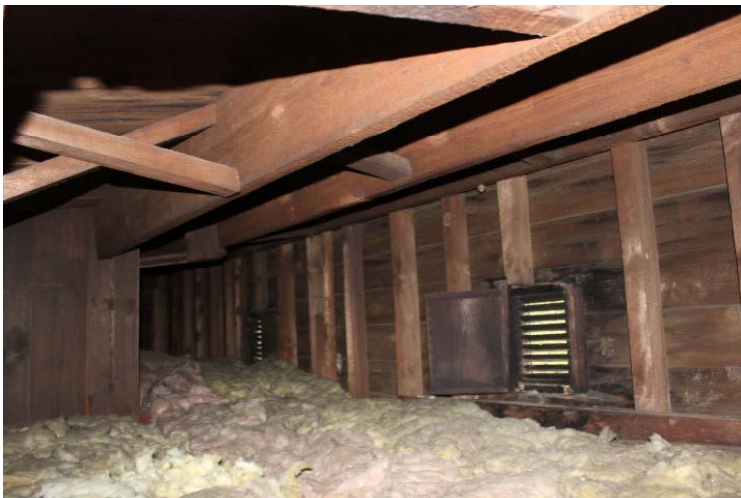
192 Partridge 15.JPG

Attic/Roof: The roof was not inspected as part of this structural visual observation. The attic space has no flooring and very limited headroom, so it could only be inspected from the hatch at the back stairwell. See photo 15.

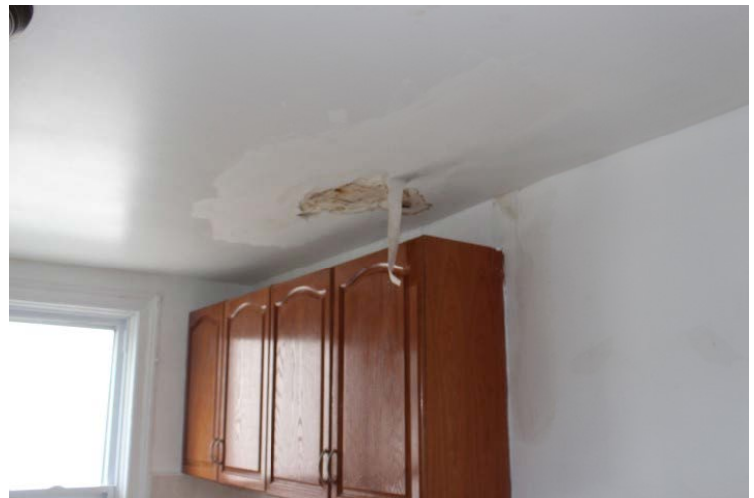
192 Partridge 16.JPG

- Some water damage is visible corresponding to water leaks at the roof above the second floor kitchen. See photo 16. **Recommendation: Address all roof leaks. Repair deteriorated framing if encountered.**

- The roof is leaking in the one location noted at the second floor. **Recommendation: Address all roof leaks. Repair deteriorated framing if encountered.**
