# C.T. MALE ASSOCIATES

RE: *Visual Structural Evaluation of Existing Building*  
*194 Partridge Street*  
*Albany, NY*  
*C.T. Male Project No. 17.7563*

*Visual Structural Evaluation of Existing Buildings  
194 Partridge Street - Albany, NY  
September 22, 2017  
Page 2*

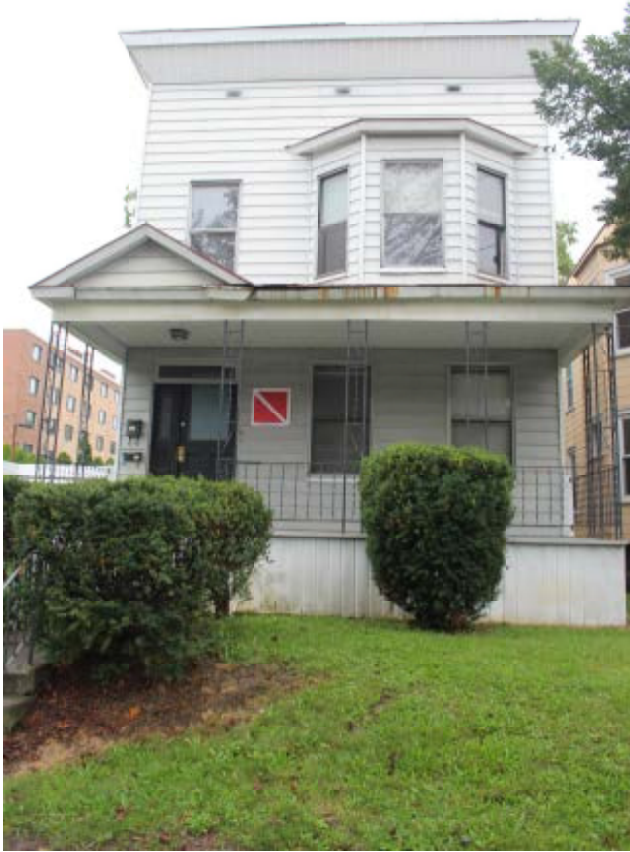
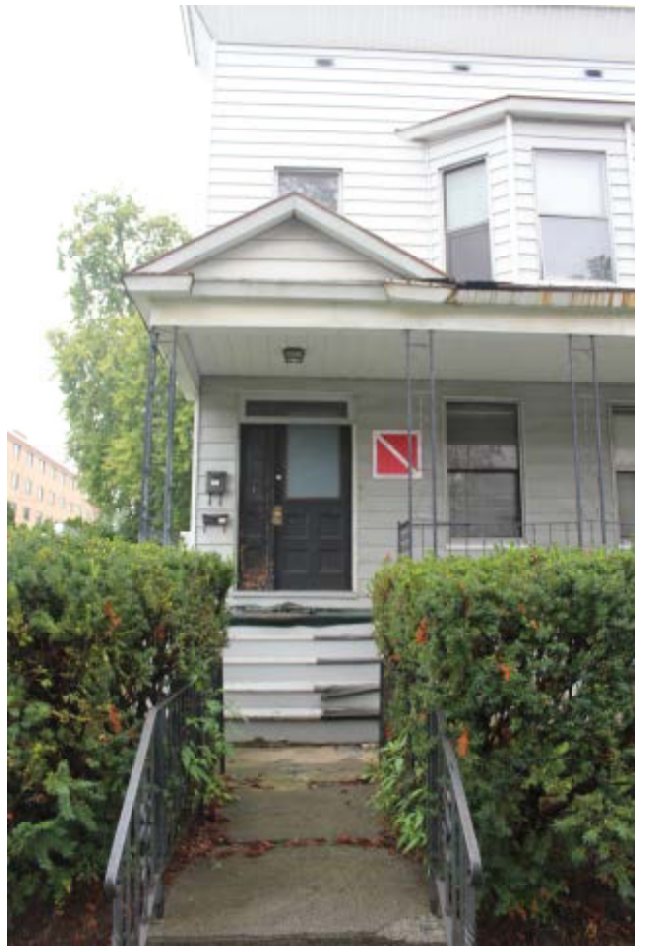
- Walls generally appear to be in structurally acceptable condition. There is some non-structural damage to siding. See photos 01-05. **No action required.**

**Front porch:** See photos 01, 02, 06 and 07.

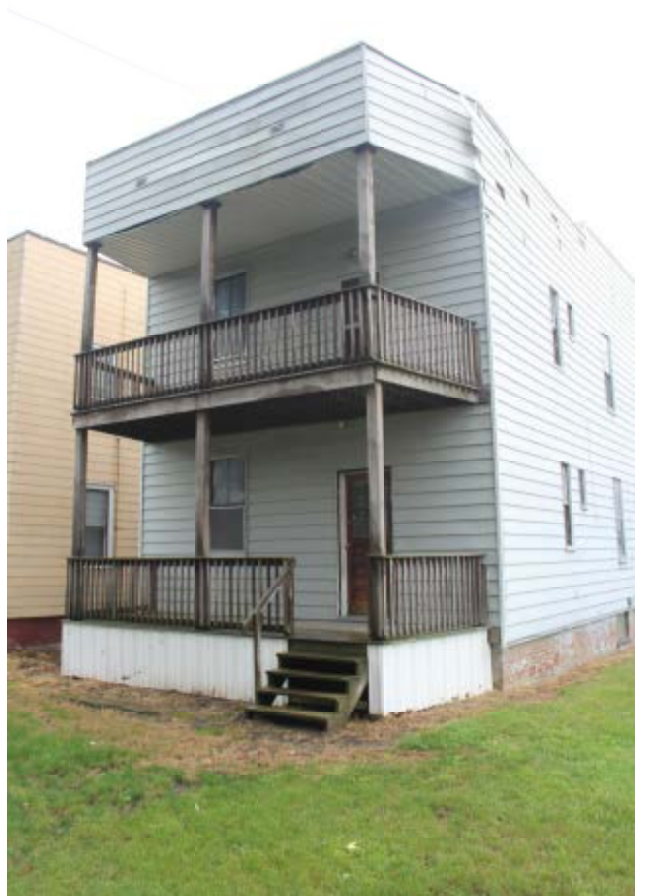
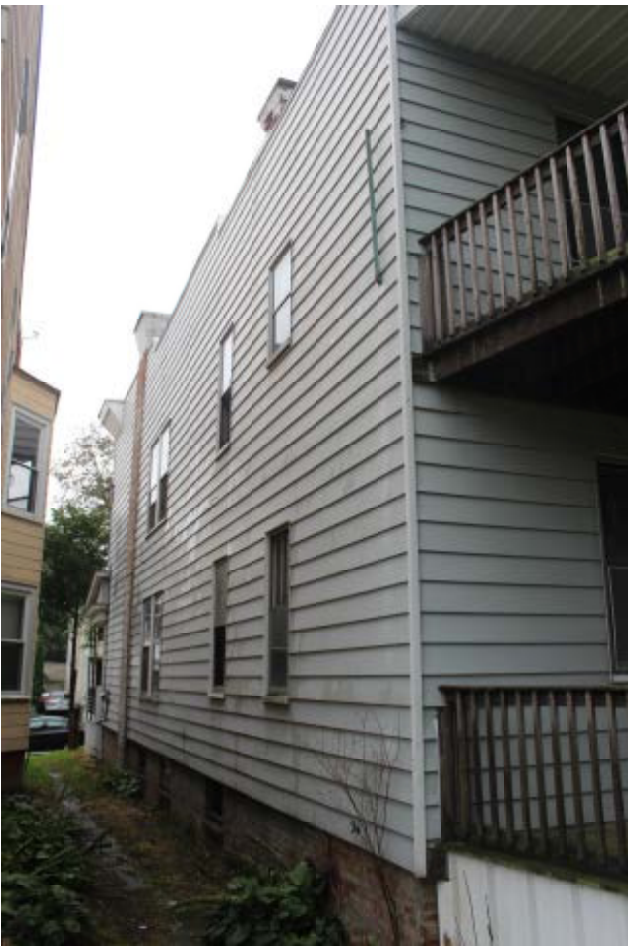
**Back porch:** See photos 04-05

- The handrail is missing from one side of the stairs. **Recommendation: Construct a matching, code compliant railing for both sides of the porch stairs.**

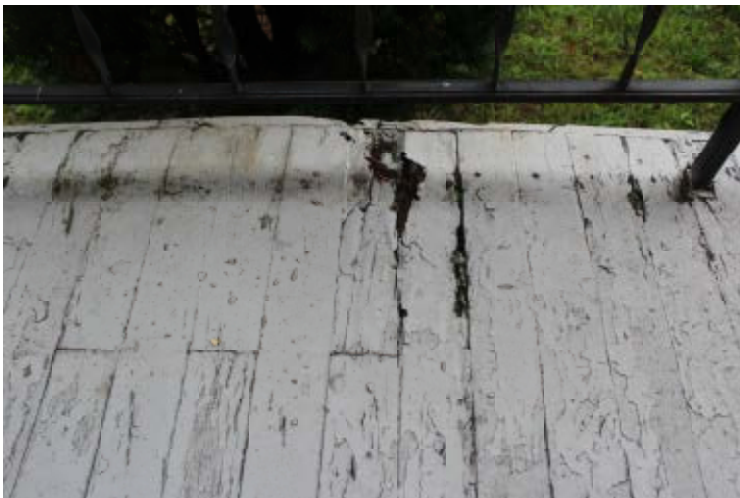
194 Partridge St 07.JPG

- The front porch deck surface has significant deterioration. See photo 07. **Recommendation: The porch deck surface should be replaced.**

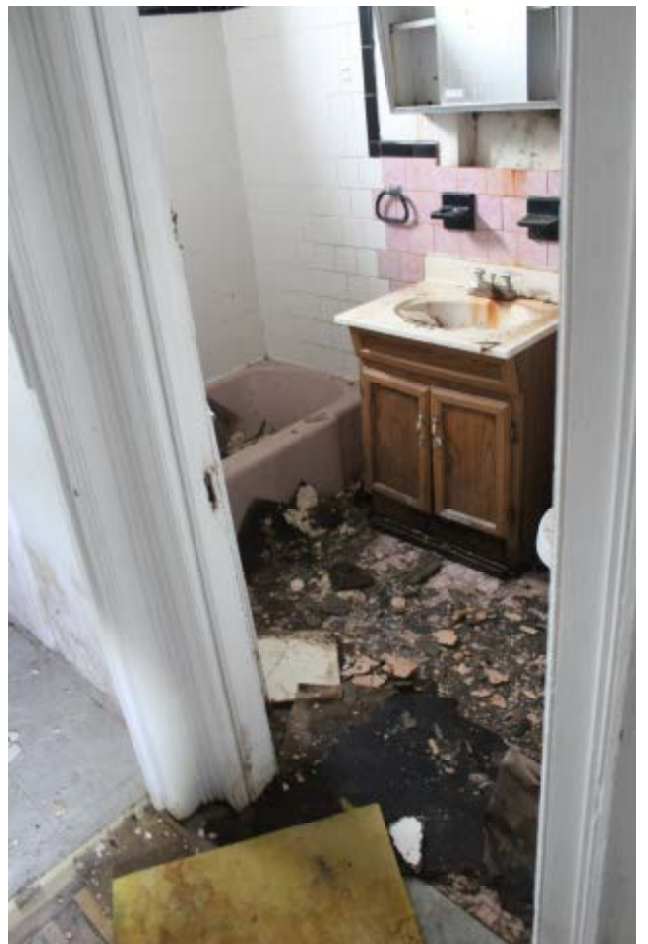
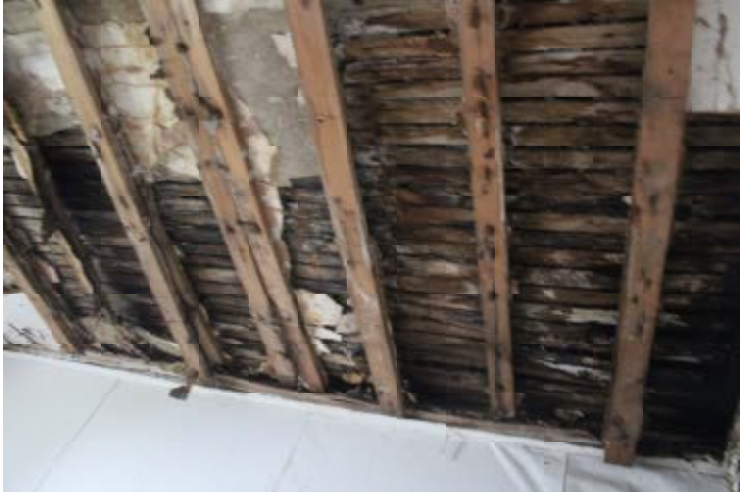
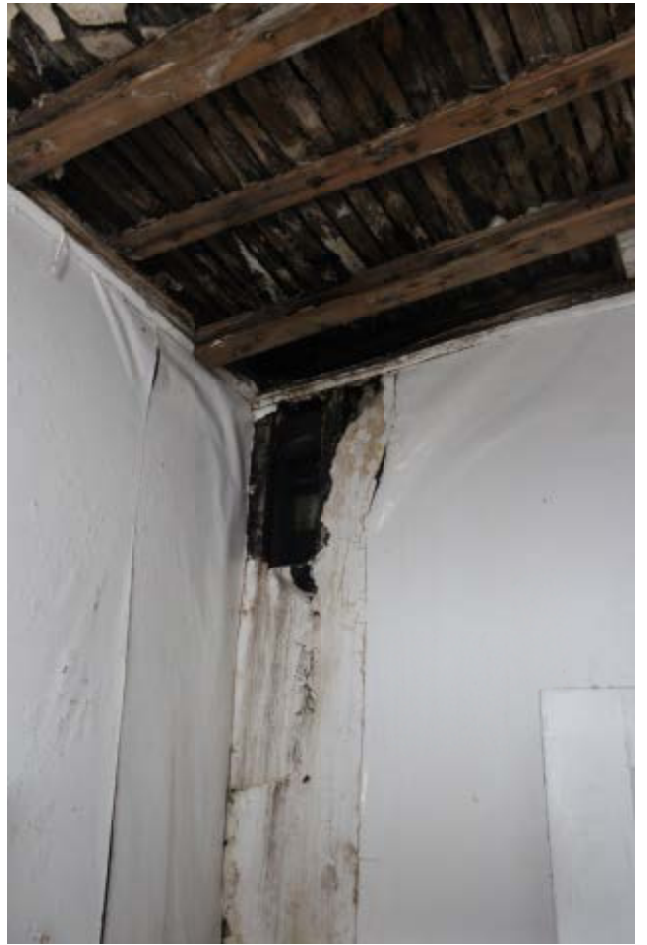
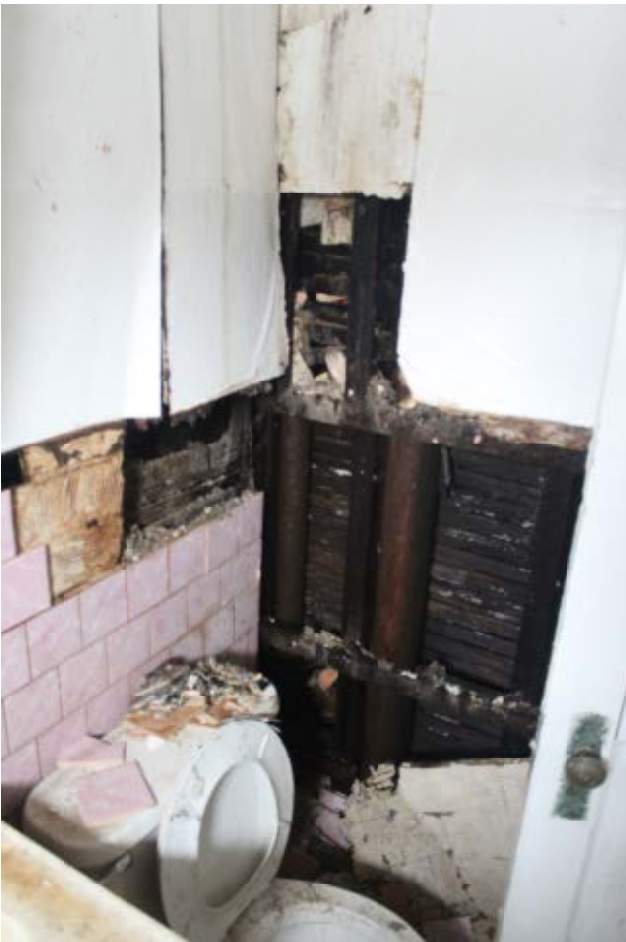
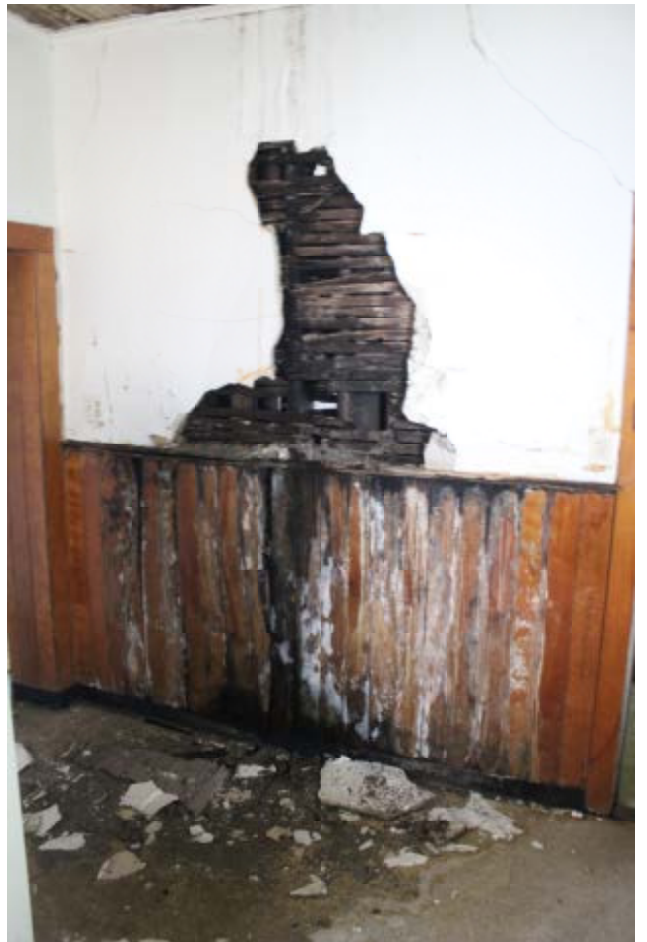
- Extensive damage to finishes is visible at the back kitchen/bathroom area. Wood behind finishes is wet and in some areas is starting to deteriorate and become soft. See photos 08-16. **Recommendation: Correct roof leaks. Remove all water damaged wall finishes. Repair or replace water damaged wall framing.**
- Floor sheathing felt soft at the back kitchen area. **Recommendation: All deteriorated sheathing should be replaced with new floor sheathing. Floor joists should be inspected as a part of this work and all deteriorated members should be repaired or replaced.**

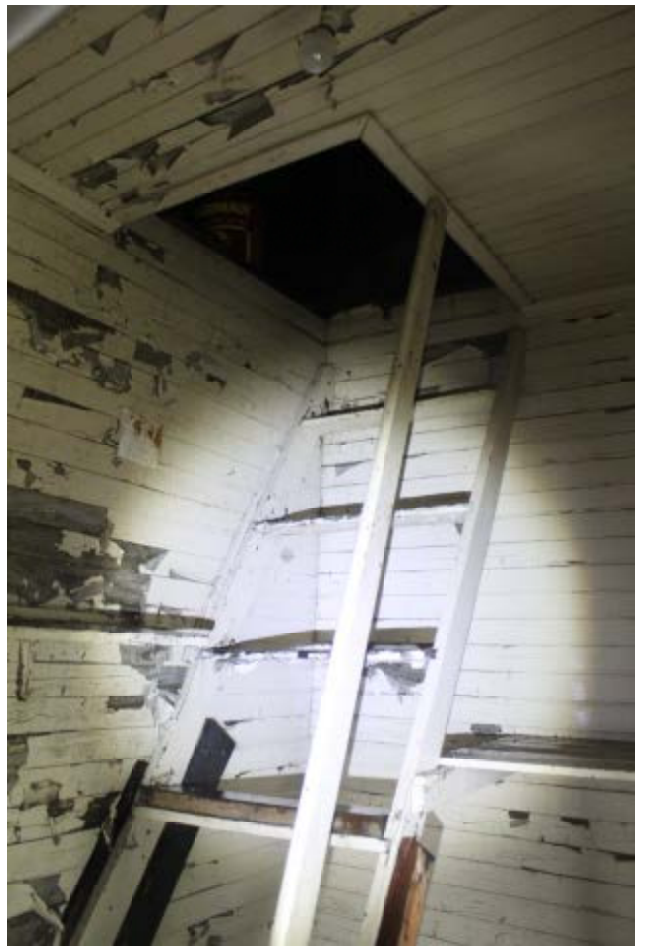
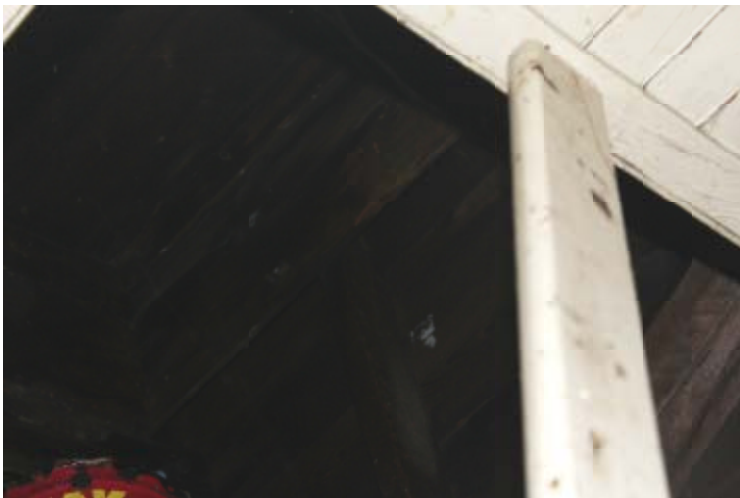
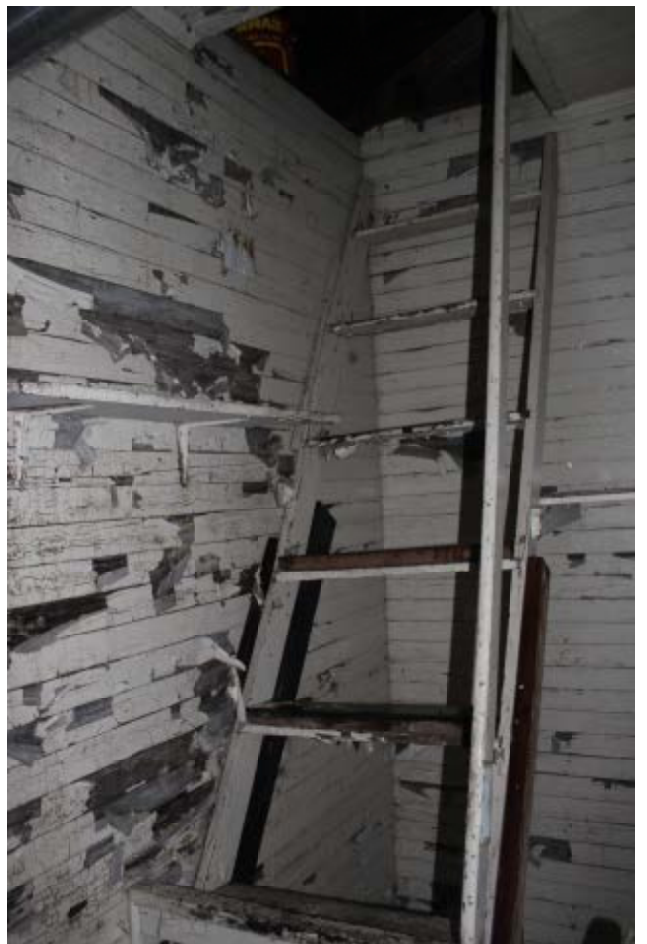
**Attic/Roof:** The roof was not inspected as part of this structural visual observation. The attic stairs/ladder has experienced some water damage, so the attic could not be inspected. See photos 14-16.

- The roof is leaking extensively at the rear half of the building. **Recommendation: A new roof should be installed on the entire building. Remove all existing roofing. Remove all deteriorated roof sheathing. Reinforce or replace any deteriorated roof rafters. Reinstall a new roofing system.**

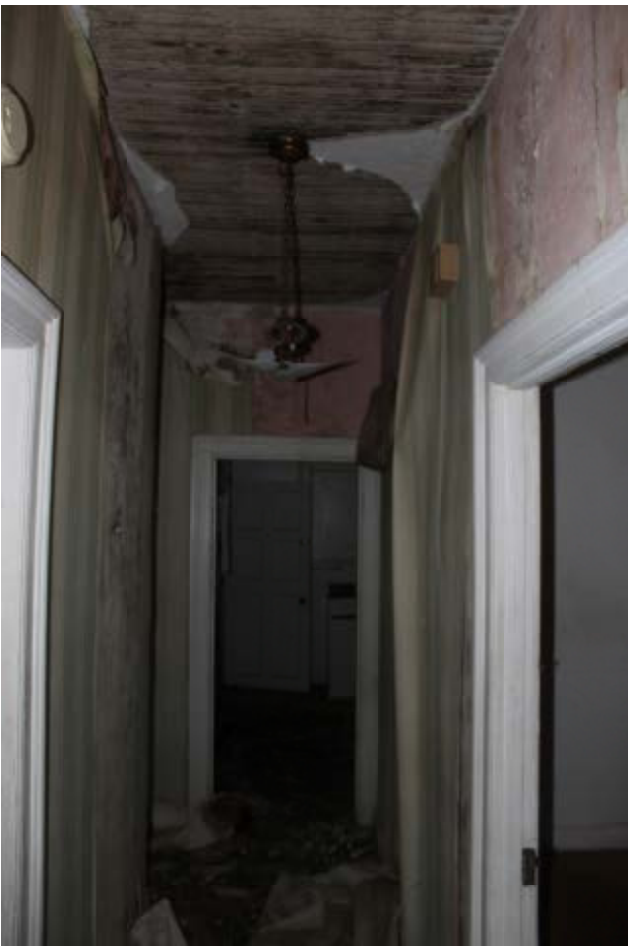
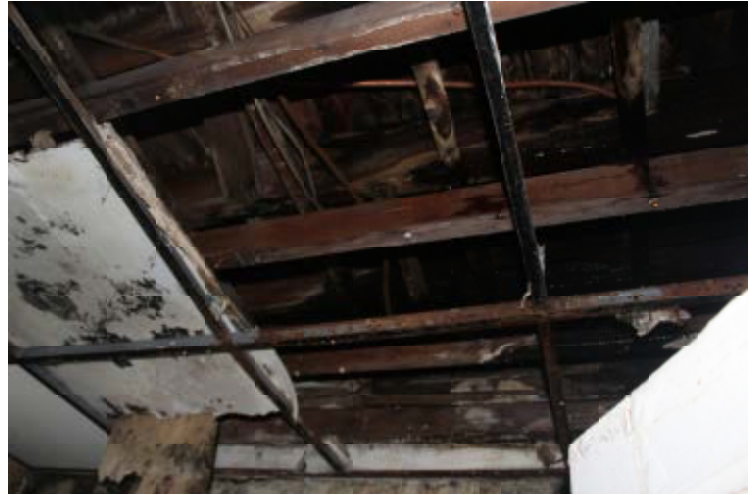
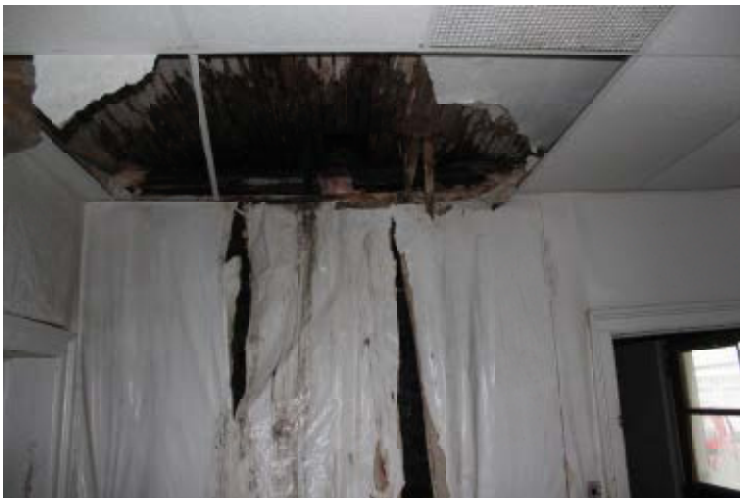
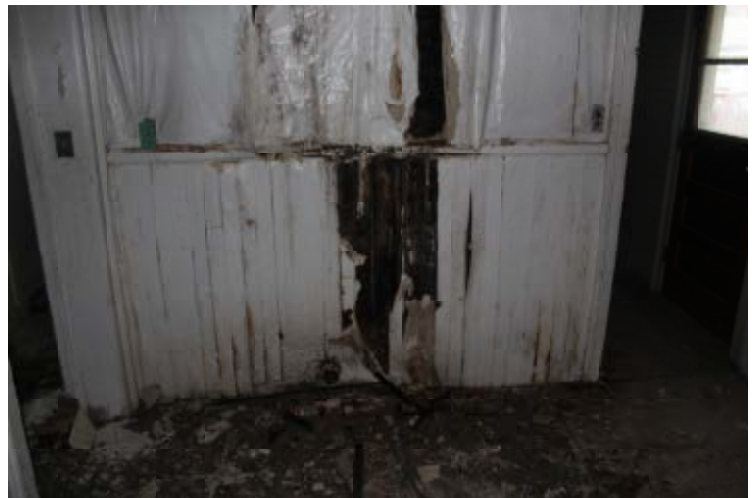
- Extensive damage to finishes is visible at the back kitchen/bathroom area. Wood behind finishes is wet and in some areas is starting to deteriorate and become soft. See photos 17-20. **Recommendation: Correct roof leaks. Remove all water damaged wall finishes. Repair or replace water damaged wall framing.**
- Floor sheathing felt soft at the back kitchen area. **Recommendation: All deteriorated sheathing should be replaced with new floor sheathing.**

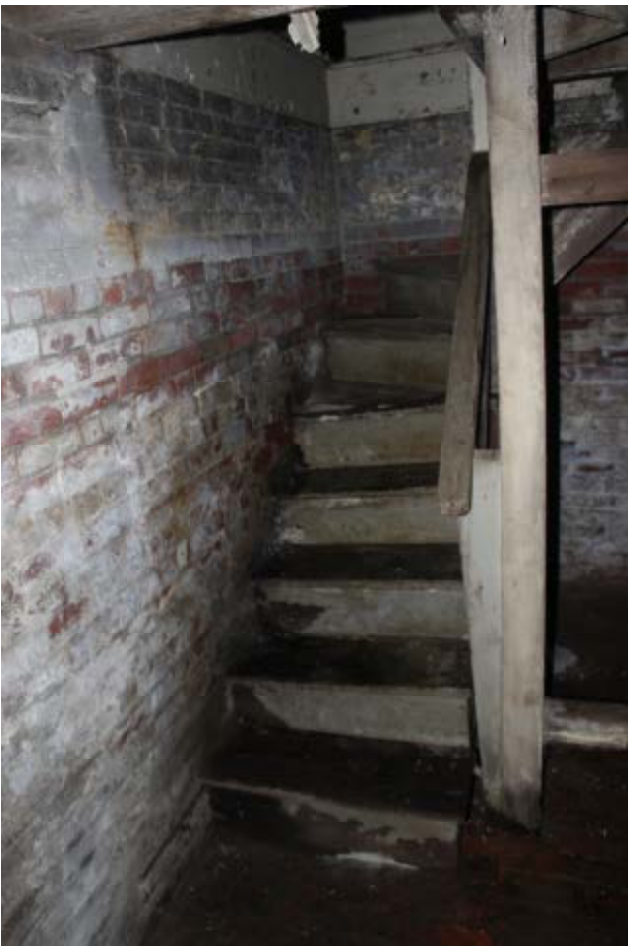
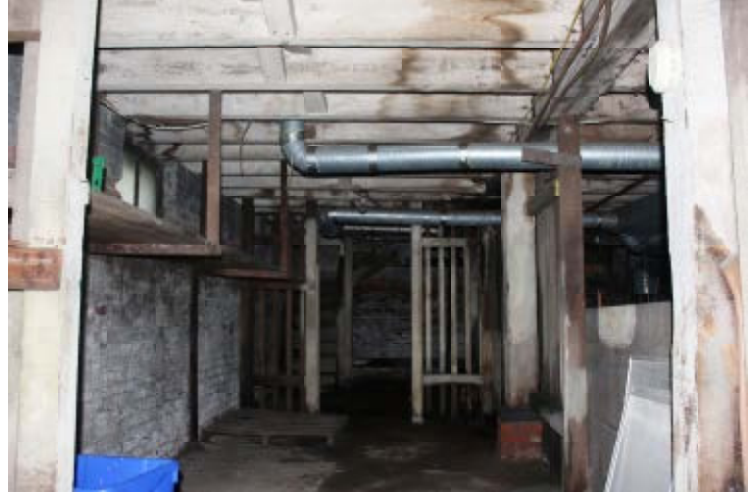
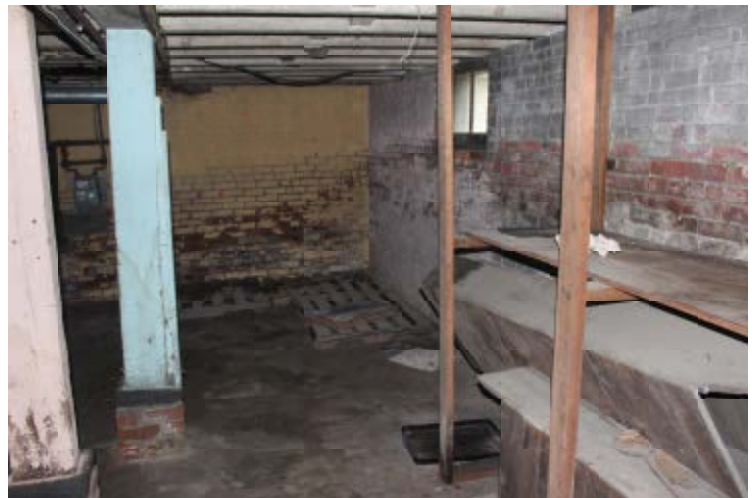
**Basement/Foundation Walls:** Foundation walls are brick and the basement floor is brick with a concrete parging over it. Basement walls retain approximately 4' of soil. See photos 21-26.

- At the exterior of the brick foundation walls, some mortar is loose and some bricks are loose, especially at the ground line. **Recommendation: Re-set any loose bricks. Re-point mortar at any exterior brick locations with loose mortar.**
- The basement is wet from water leaking through the building., although there was no standing water. Evidence of water infiltration can be seen on the walls. See photo 23. **No**

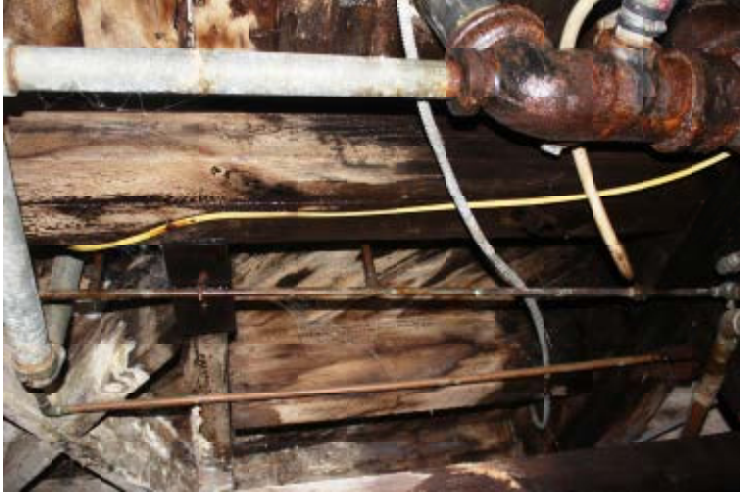
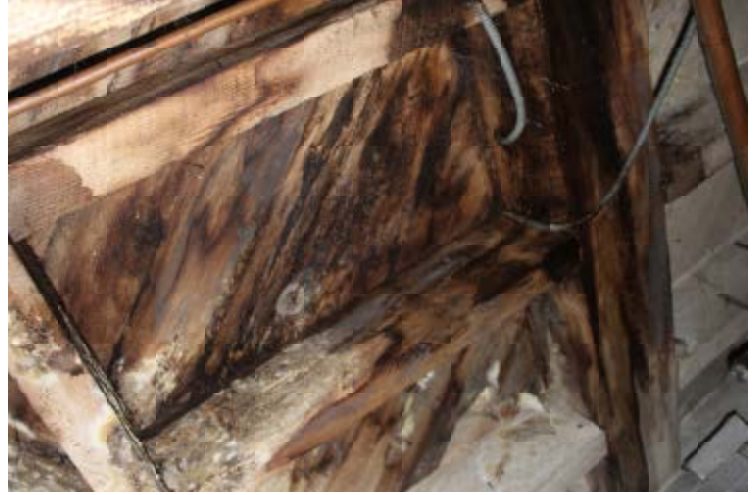
- Wood framing in the basement area below the water leaks has been damaged by long-term exposure to water. The wood is soft in some areas and there is organic growth on the wood in some areas. See photos 25-26. **Recommendation: Organic growth should be evaluated and remediated. Deteriorated structural members should be reinforced or replaced.**
