Re: *Visual Structural Evaluation*  
*136 Livingston Avenue*  
*Albany, NY 12210*  
*C.T. Male Associates Project No. 15.5188*

As requested, C.T. Male Associates Engineering, Surveying, Architecture & Landscape Architecture, D.P.C. (C.T. Male Associates) conducted a visual structural evaluation of the above-referenced building on January 19, 2017. The purpose of this evaluation was to visually observe the condition of the building and to provide an opinion on its structural integrity. Based on our visual observations during this site visit, it is our opinion that a pre-demolition asbestos survey can be performed.

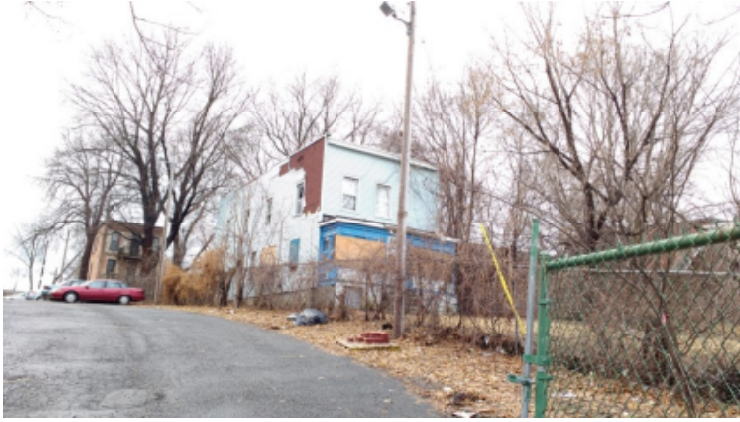
136 Livingston Ave 01.jpg

- Walls have experienced significant water damage in some locations. See photos 01-05.
- The northwest wall (right side) is significantly out of plumb.

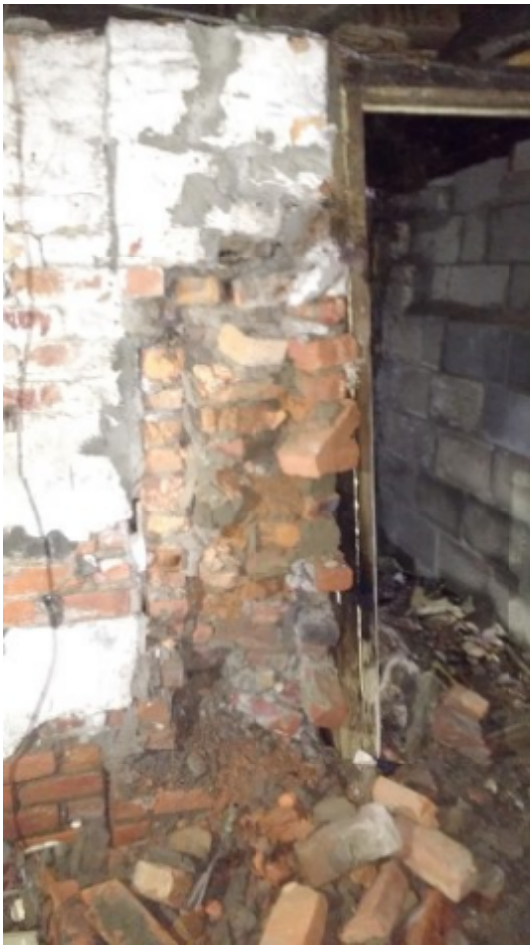
136 Livingston Ave 09.jpg

- The basement walls have pushed inward at several locations so that walls are up to about 2" out of plumb. Some of these locations would need to be addressed structurally if the building is going to be occupied. See photos 09-11.
- There is isolated damage to brick portions of the foundation walls. See photo 10.

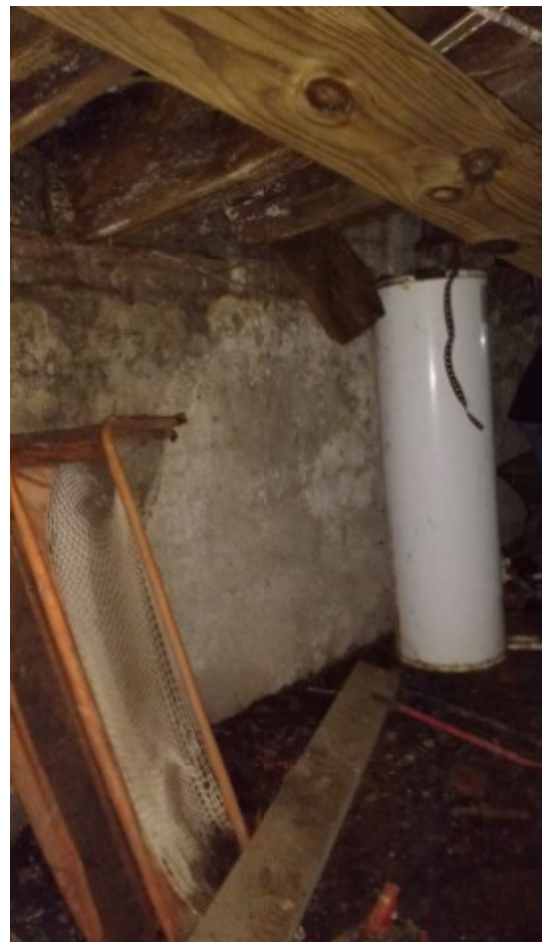
136 Livingston Ave 12.jpg

- Floors and walls have significant water damage. See photos 12 and 13.

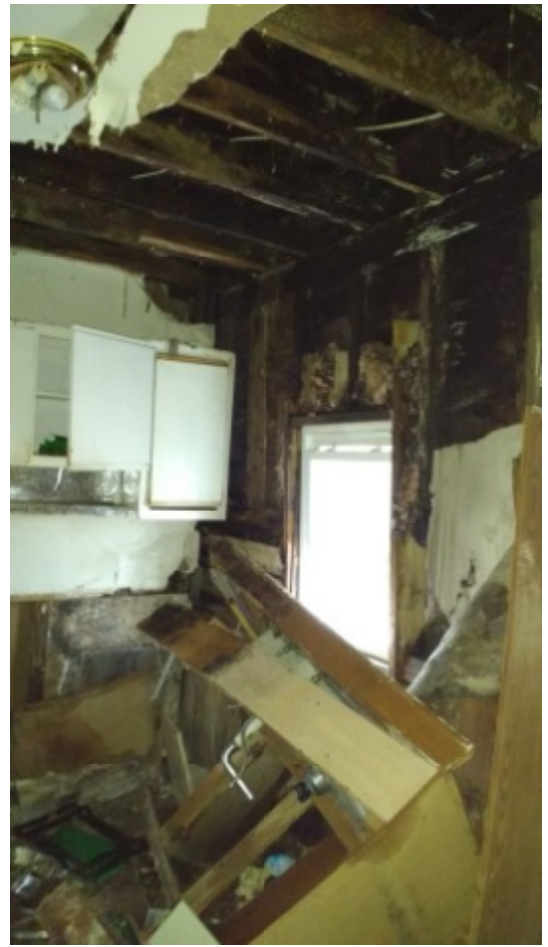
136 Livingston Ave 14.jpg

- Roof sheathing and rafters have significant water damage. See photo 14.
