Re: *Visual Structural Evaluation*
127 Clinton Street
Albany, NY 12206
C.T. Male Associates Project No. 15.5188

Visual Structural Evaluation
127 Clinton St. – Albany, NY
January 31, 2018
Page 2

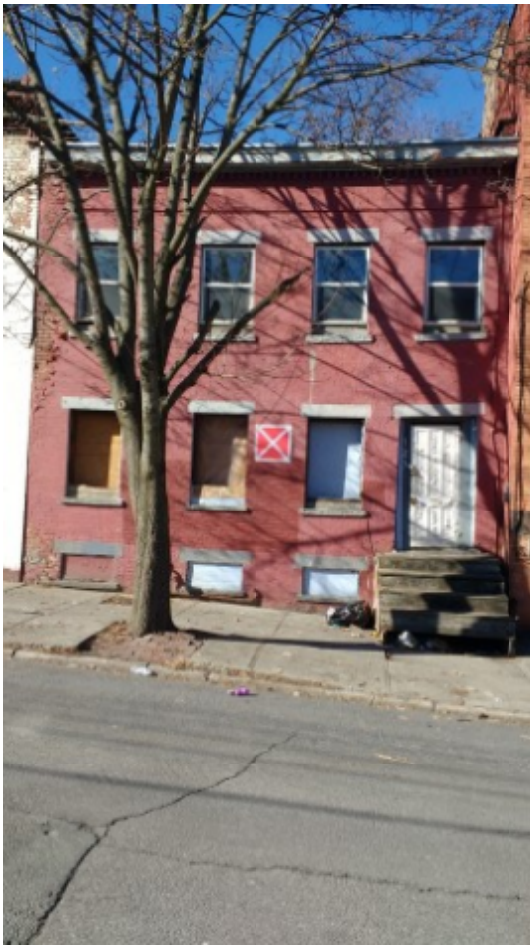
127 Clinton St 01.jpg

- The front brick wall is generally plumb and in structurally acceptable condition. See photos 01-03.
- Perimeter walls at the sides and back of the building have some damage, but are generally intact. The back wall was not accessible at the time of the site visit.
- The wood front steps are deteriorated and handrails are missing. See photos 01-02.

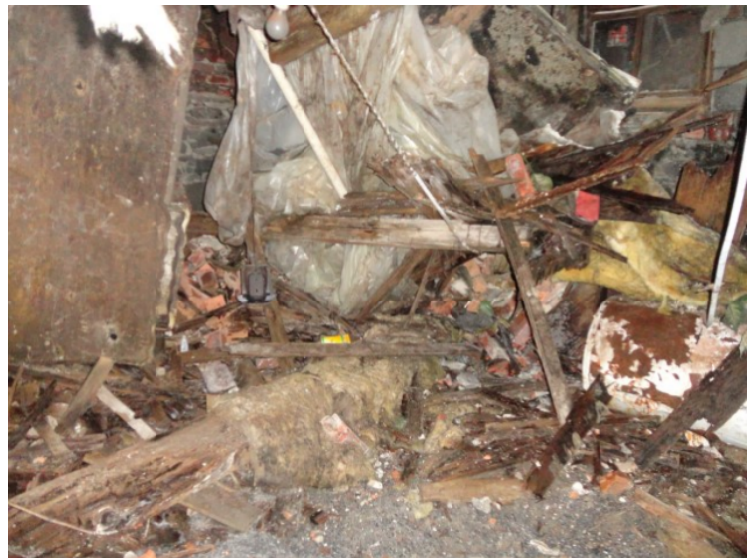
127 Clinton St 04.JPG

- Wood posts and first floor beams and joists are significantly deteriorated. First floor framing is collapsing into the basement near the middle of the building. See photo 04.
- Basement walls are typically brick. Most basement walls could not be observed due to collapsing framing from above.
- Basement stairs have partially collapsed.

- Floor framing and sheathing is collapsing into the basement near the middle of the house. The back portion of the house was not safely accessible. See photos 04-09.

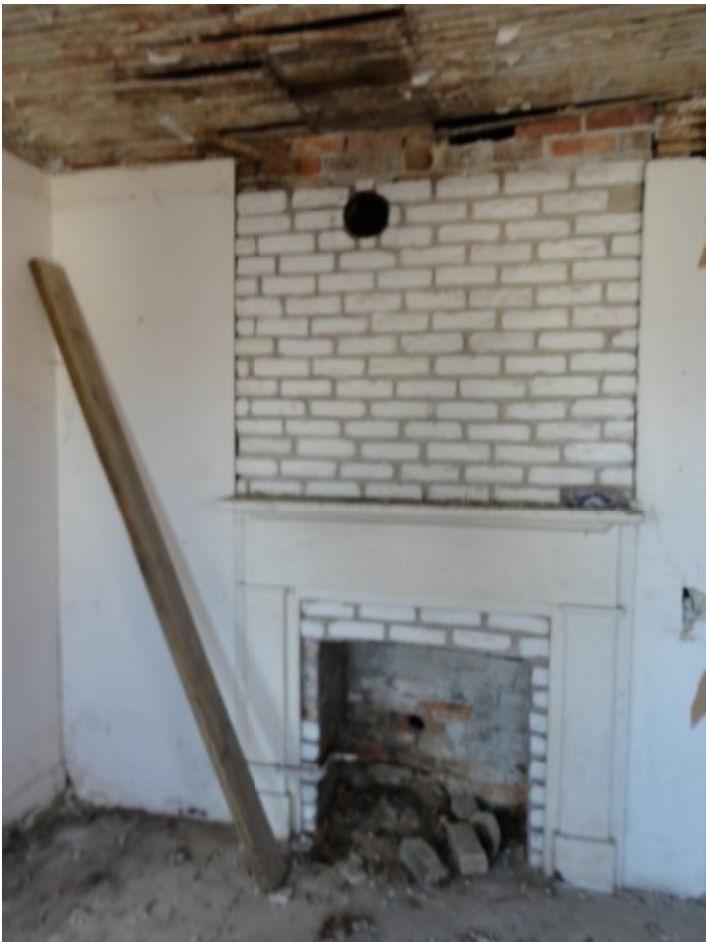
127 Clinton St 11.JPG

- Floor framing and sheathing is collapsing into the first floor near the middle of the house. The rear portion of the second floor was not safely accessible at the time of the site visit. See photos 11-15.

- Roof leaks are active and roof framing is significantly deteriorated. See photos 11-15.
