# C.T. MALE ASSOCIATES

February 6, 2017

Re: *Visual Structural Evaluation*  
*410 Clinton Ave.*  
*Albany, NY 12206*  
*C.T. Male Associates Project No. 15.5188*

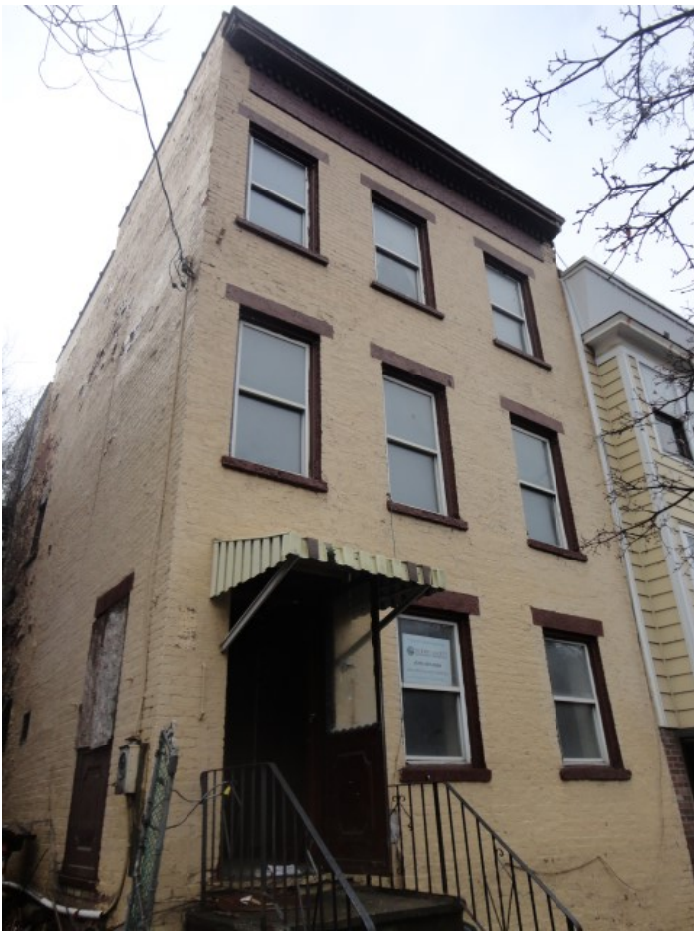
410 Clinton Ave 01.JPG

- Wall is in structurally acceptable condition. See photos 01, 02 and 06.

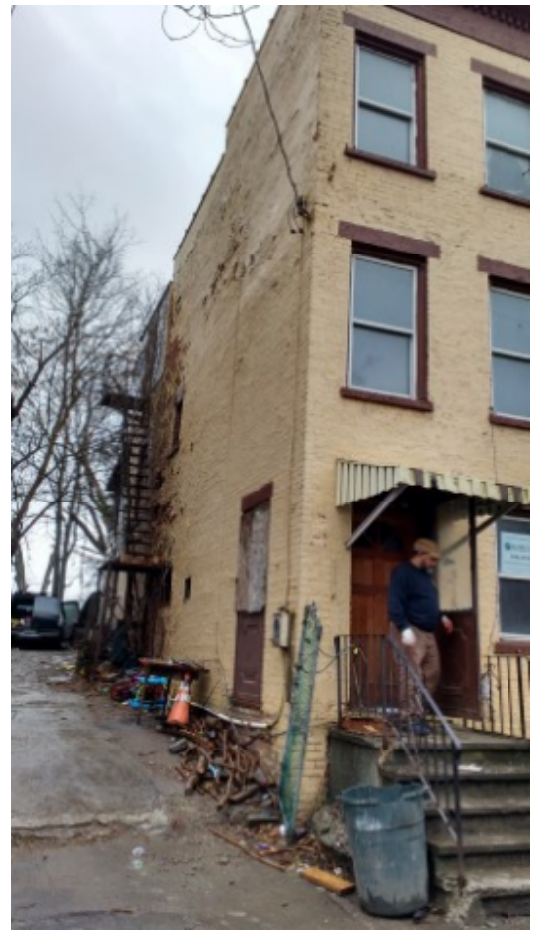
410 Clinton Ave 02.jpg

- Brick is severely deteriorated in several locations. See photos 02, 03 and 10.

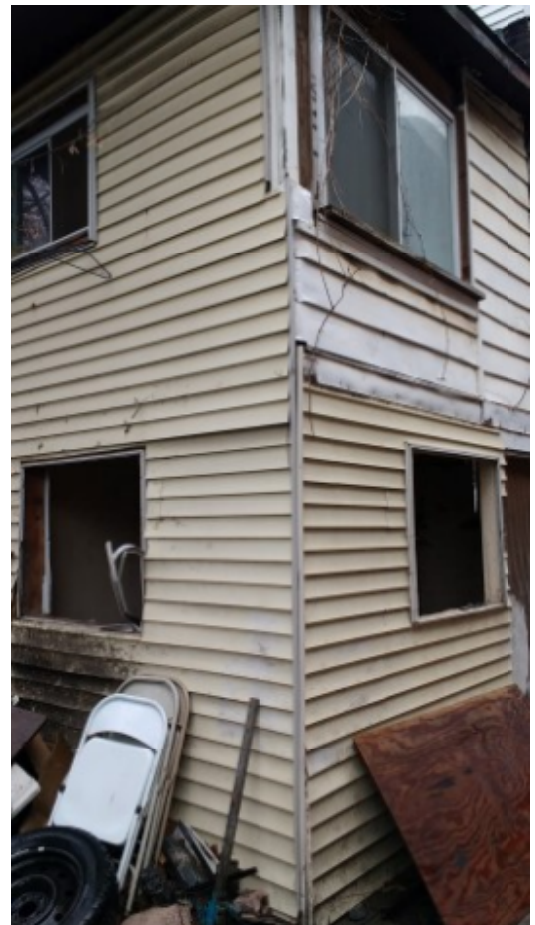
410 Clinton Ave 04.jpg

- 2-Story Wood addition has experienced serious water damage. See photos 04, 05, 07, 13, 14 and 15.

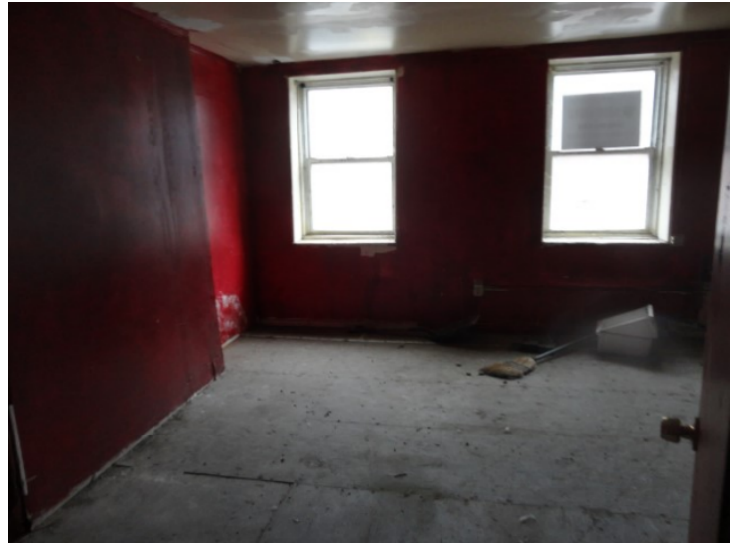
410 Clinton Ave 06.JPG

- Floor in the middle room is starting to cave in. See photo 08.
- Floors have extensive water damage. See photos 06-10.

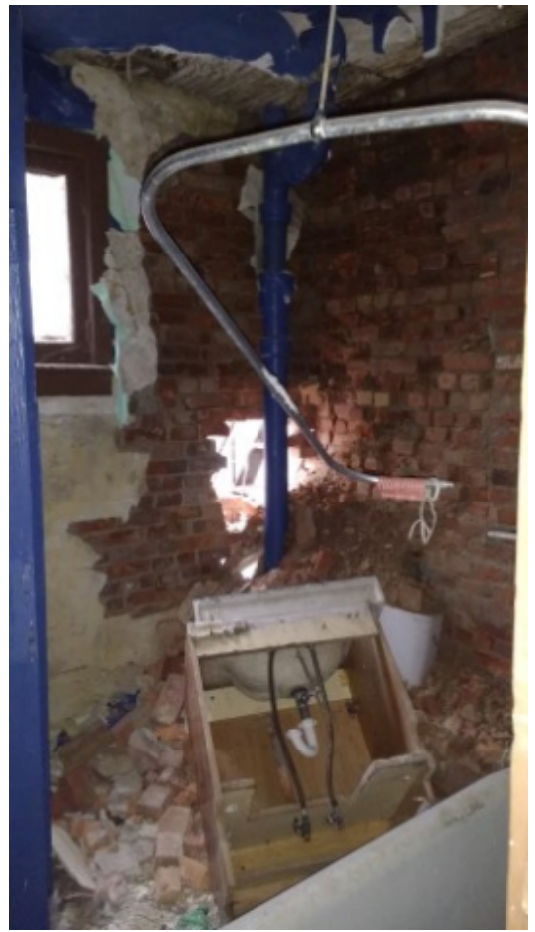
410 Clinton Ave 10.jpg

- The middle room floor had trapped several inches of water. See photo 11.
- Brick walls around the roof drain are falling apart. See photo 10.
- Floors have extensive water damage.

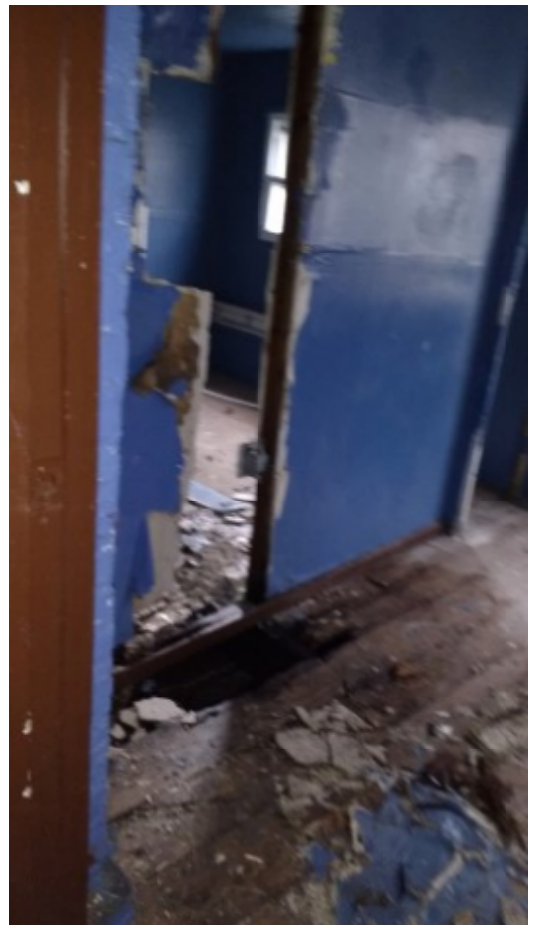
410 Clinton Ave 12.jpg

- Floor in the front room is starting to cave in. See photo 12 and 15.
- Floors have extensive water damage. See photos 12-15.

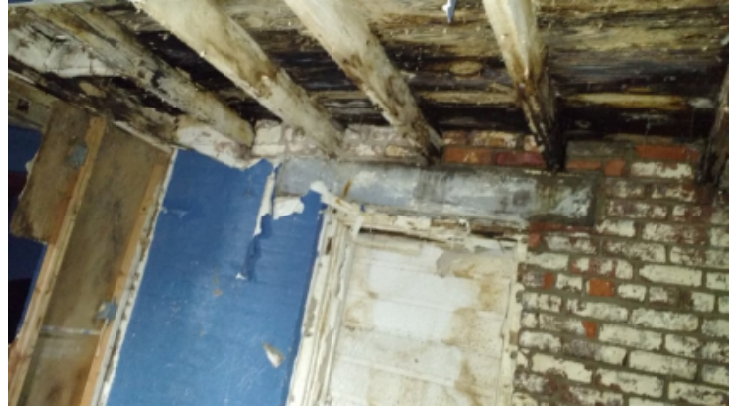
410 Clinton Ave 14.jpg

- Roof framing has extensive water damage, especially at the back of the building. See photos 14 and 15.
