C.T. MALE ASSOCIATES

December 7, 2017

Re: *Visual Structural Evaluation*
522 First Street
Albany, NY 12206
C.T. Male Associates Project No. 15.5188

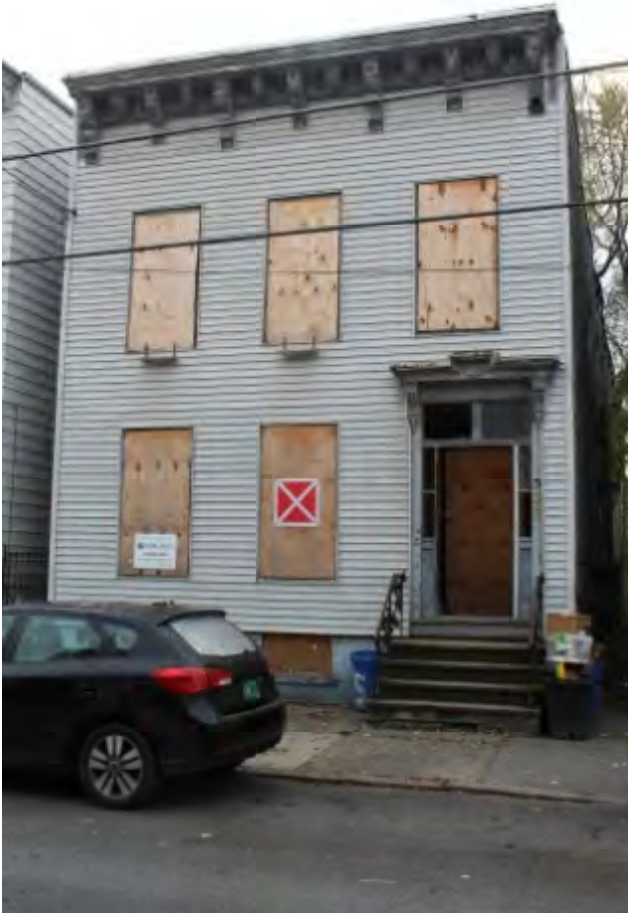
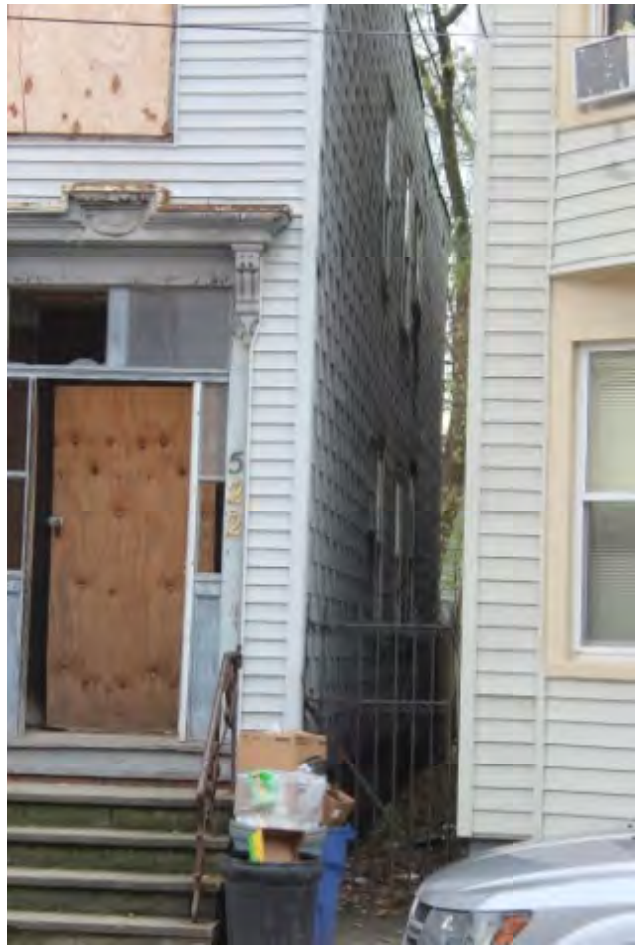
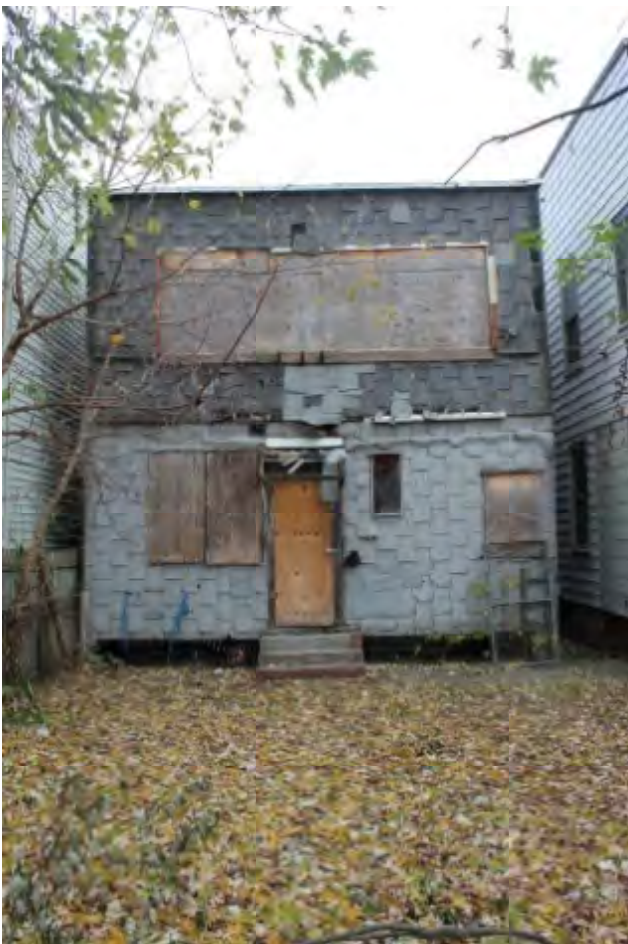
Exterior – See photos 01-04

- Overall, walls are generally plumb
- Exterior walls are deteriorated at areas of roof leaks.

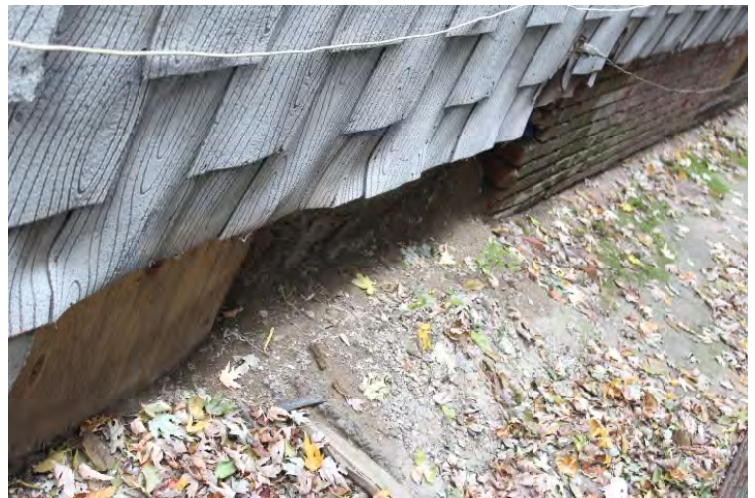
522 First St 04.JPG

- Wood posts and first floor beams and joists are significantly deteriorated over the back 2/3 of the main building. See photos 18-22.
- Basement walls are typically brick but are concrete block or parged in localized areas. See photos 18-22
- The back stairwell addition is supported on posts some of which are deteriorated due to contact with the soil. See photos 03, 23 and 24.
- A portion of the foundation wall is missing at the exterior face of the wall. See photo 04

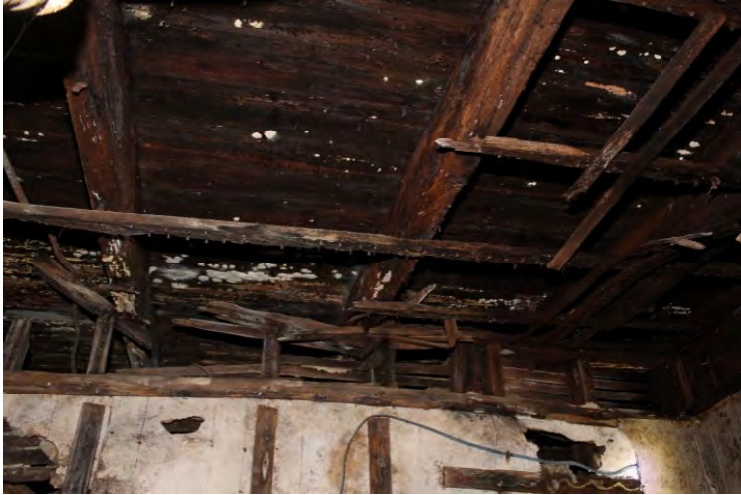
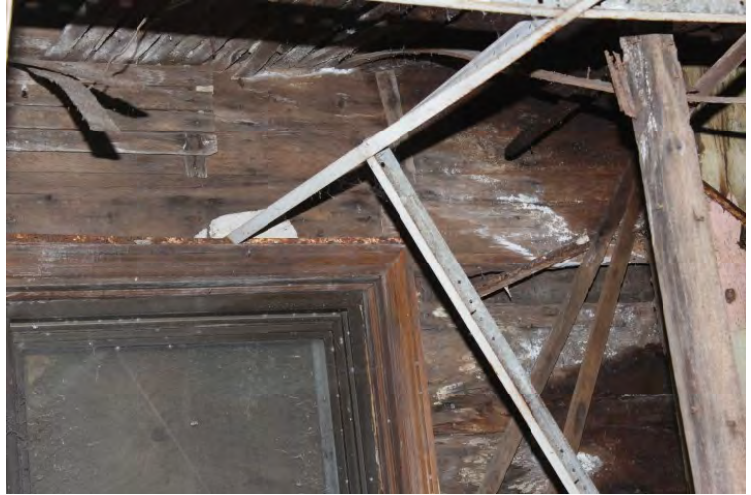
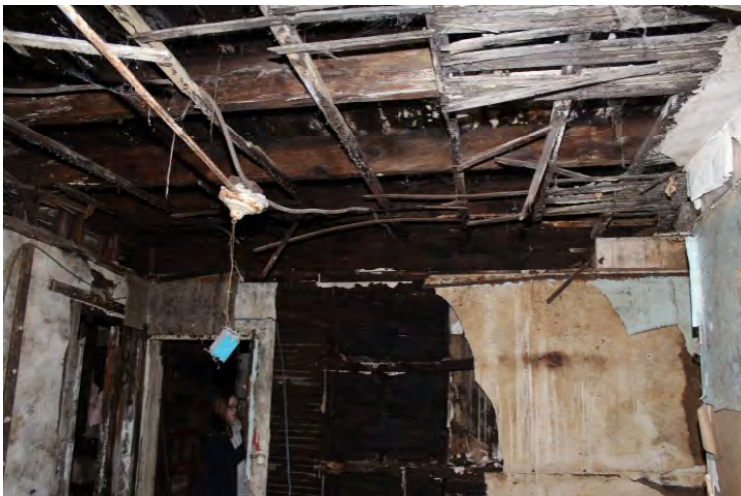
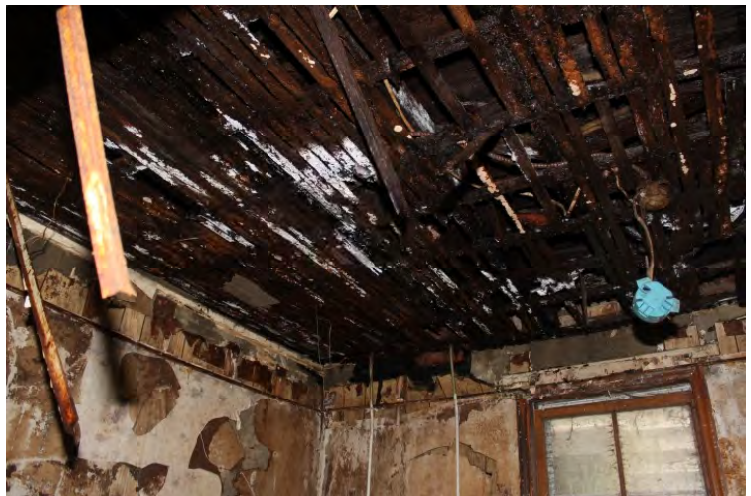
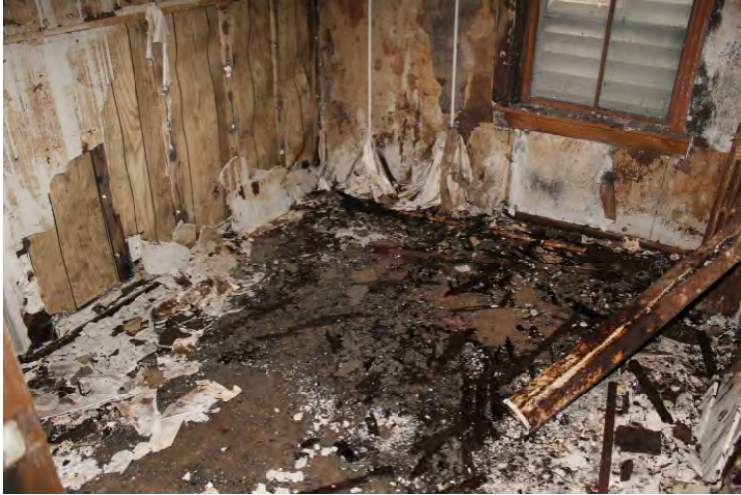
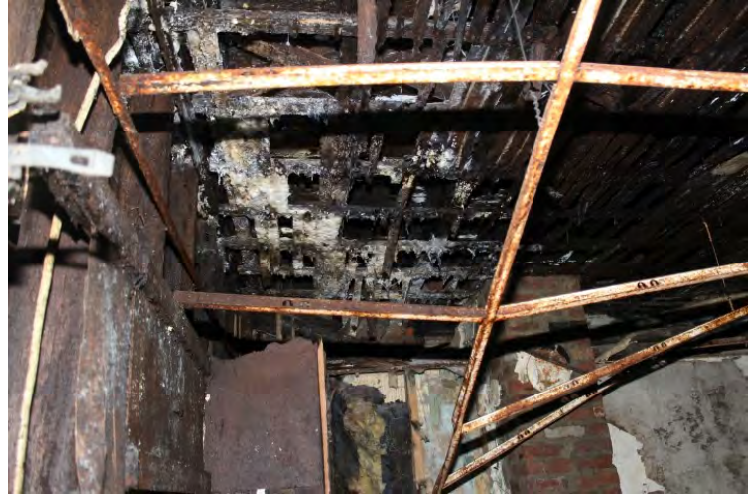
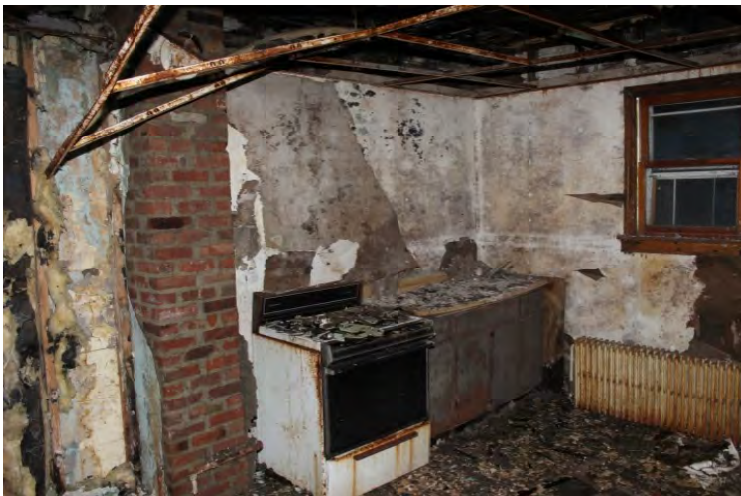
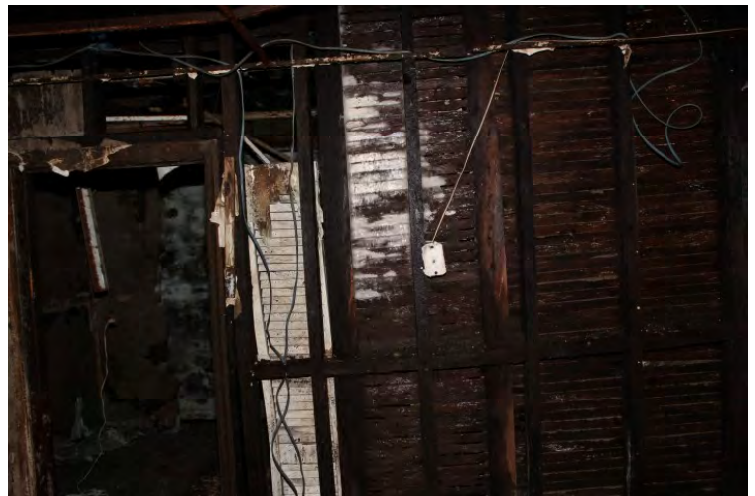
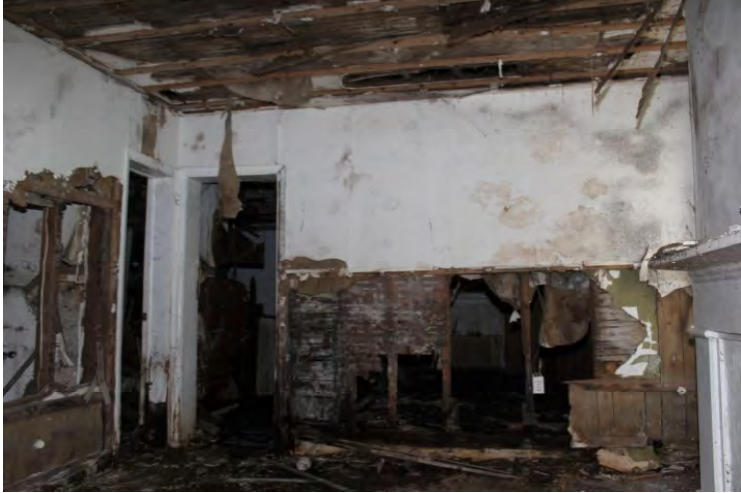
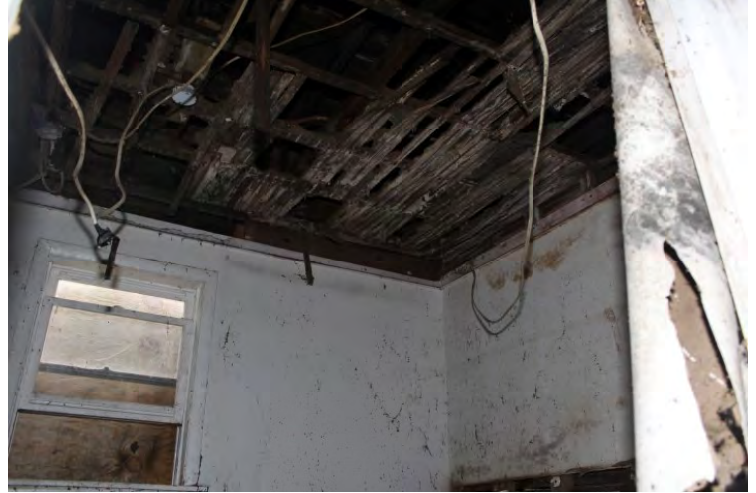
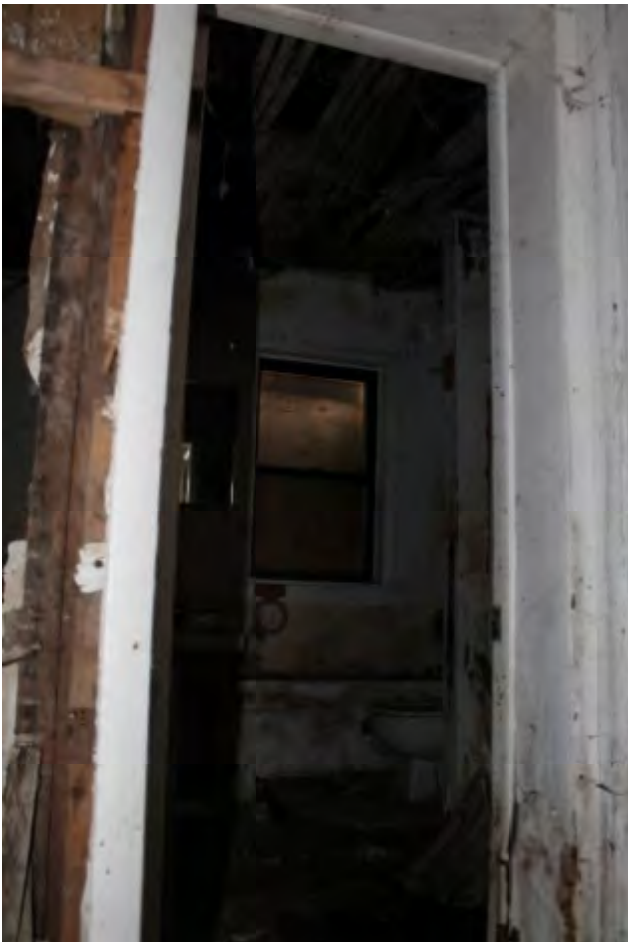
- Floor framing and sheathing and wall framing are significantly deteriorated over the back 2/3 of the main building. See photos 05-15.

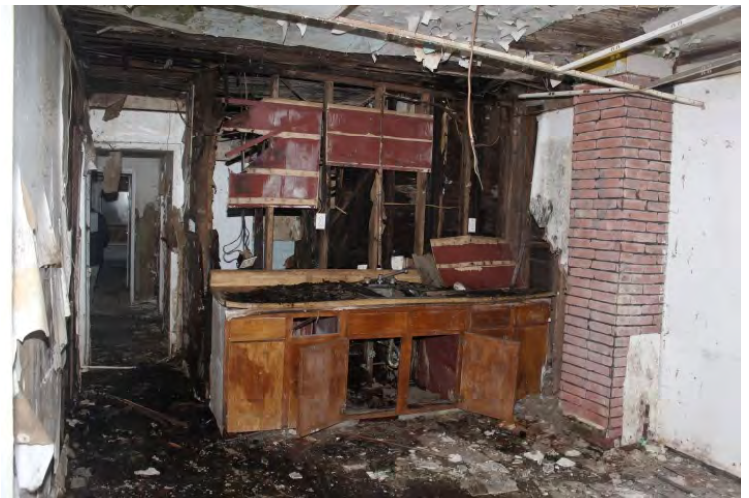
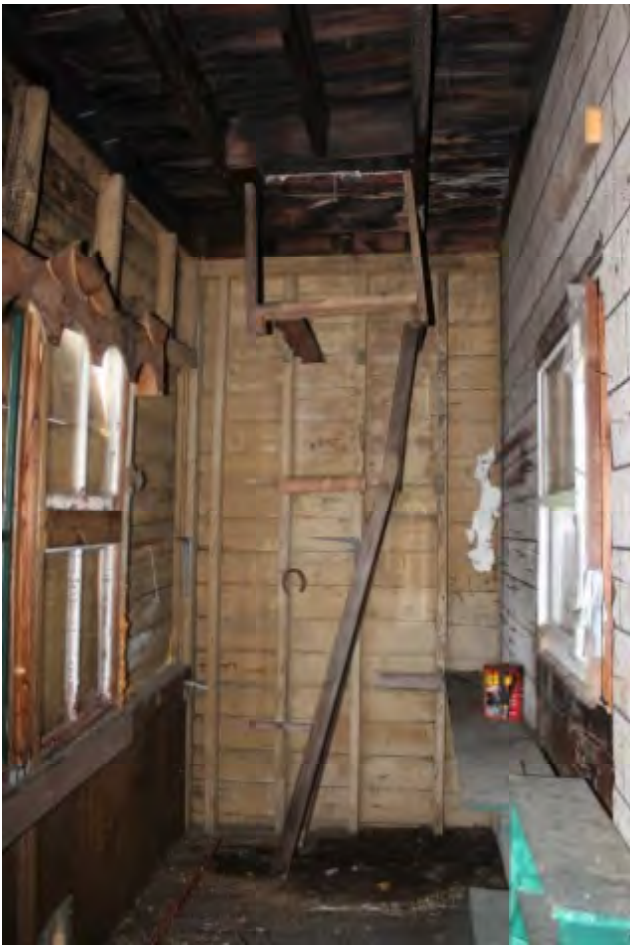
- Floor framing, floor sheathing sheathing and wall framing are significantly deteriorated over the back 2/3 of the main building. See photos 16-17.
