# C.T. MALE ASSOCIATES

Re: *Visual Structural Evaluation*  
*309 Second Street*  
*Albany, NY 12206*  
*C.T. Male Associates Project No. 15.5188*

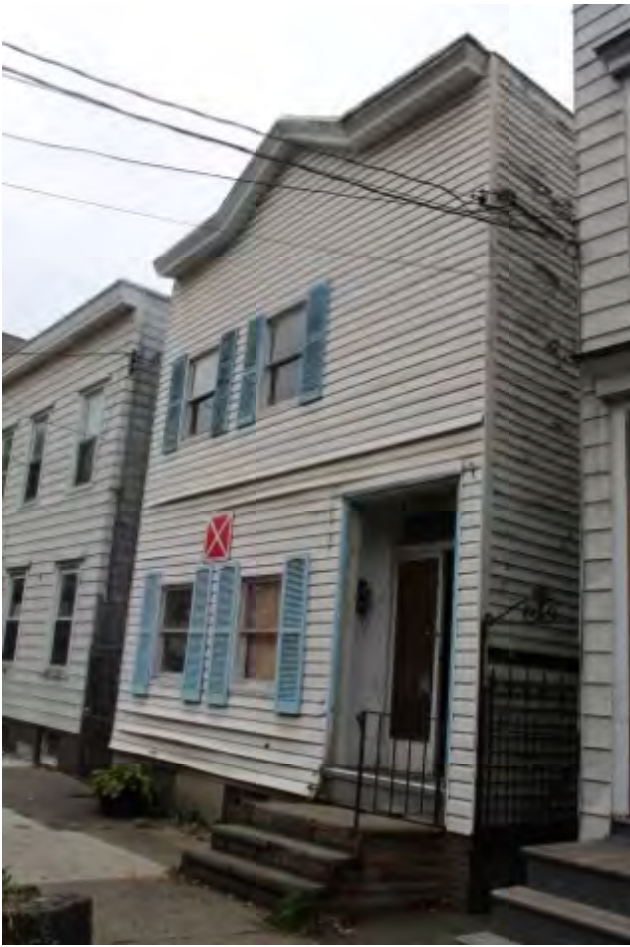
309 Second St 01.JPG

Exterior – See photos 01-02 and 04-05

- Overall, walls are generally plumb.
- The back yard of the building was not accessible at the time of the site visit.

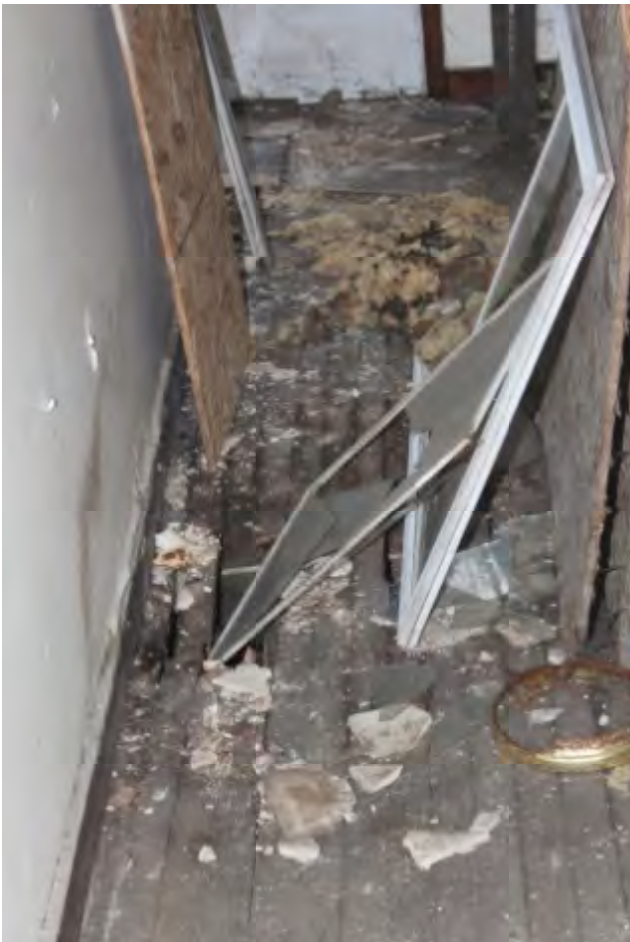
309 Second St 03.JPG

- Floor boards are significantly deteriorated and have punched through in many isolated locations on the first floor. Entire sections of floor joists have collapsed in the back of the building. See photos 03 and 05-12.

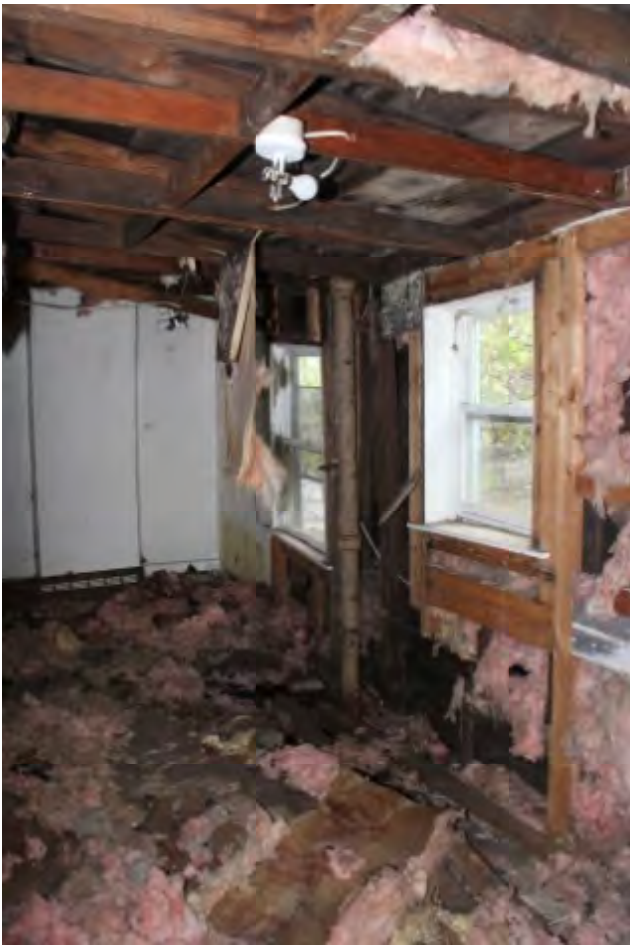
309 Second St 13.JPG

- Floor boards are significantly deteriorated and have punched through in many isolated locations. Floor joists are significantly deteriorated, but have not collapsed. See photos 13-16.

- Roof leaks are active and roof framing has isolated water damage at areas of leaks. The roof is pitched. See photos 13 and 15.

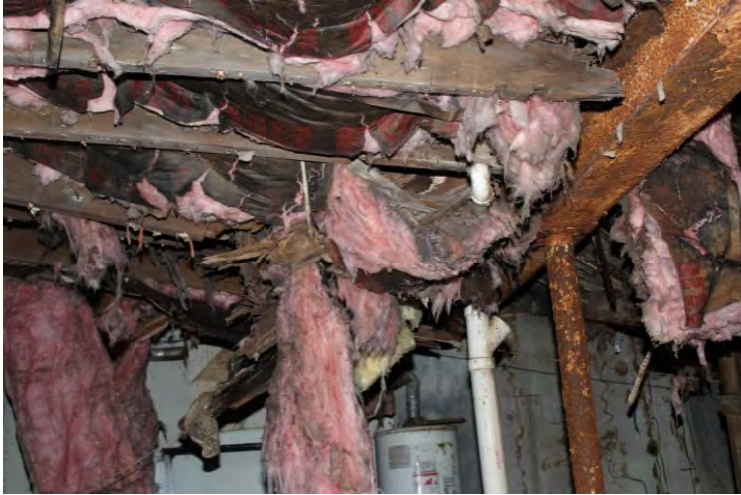
309 Second St 17.JPG

- First floor framing is collapsing into the basement over the back half of the building. See photos 17-20.
- Basement walls are typically brick or parged concrete block. Walls are typically intact, but are partially collapsed in one location (photo 20). See photos 17-20.
