Re: *Visual Structural Evaluation*
48 Swinton St.
Albany, NY 12206
C.T. Male Associates Project No. 15.5188

*Visual Structural Evaluation
48 Swinton St., Albany, NY
February 13, 2018
Page 2*

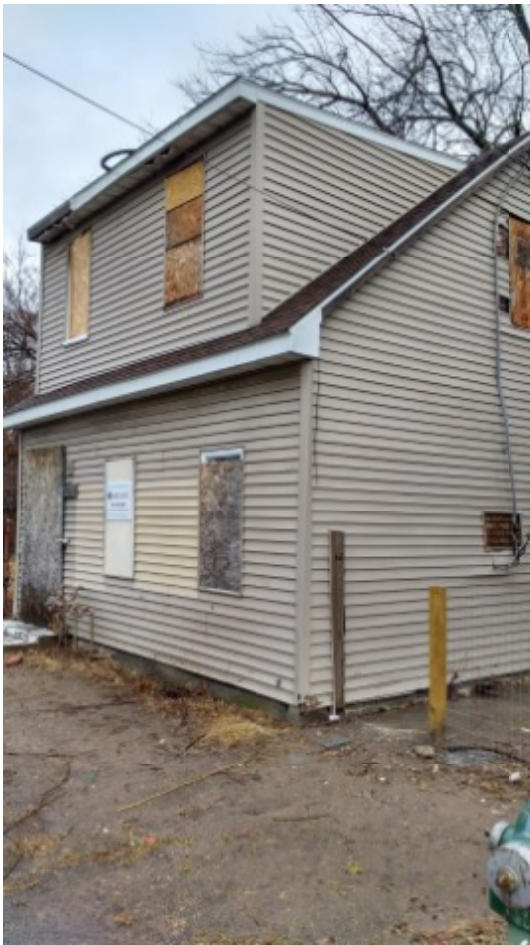
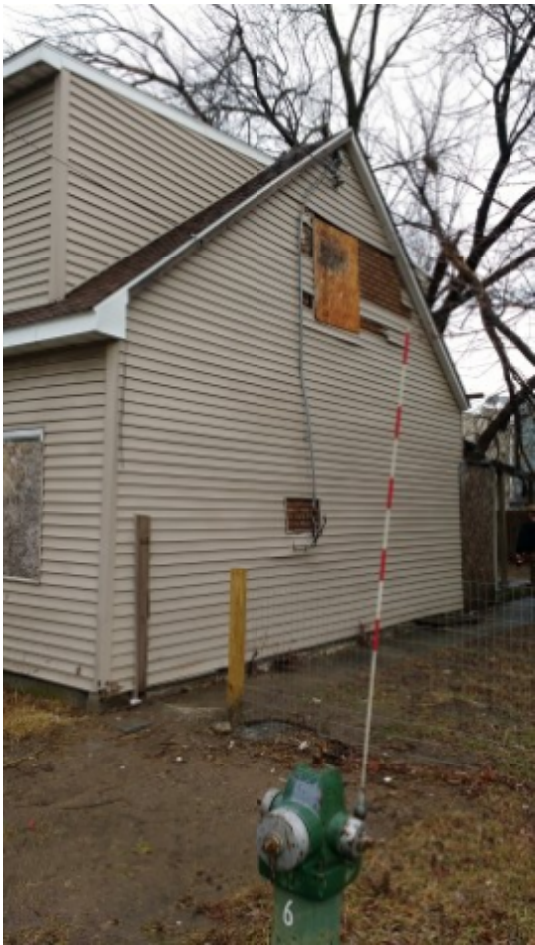
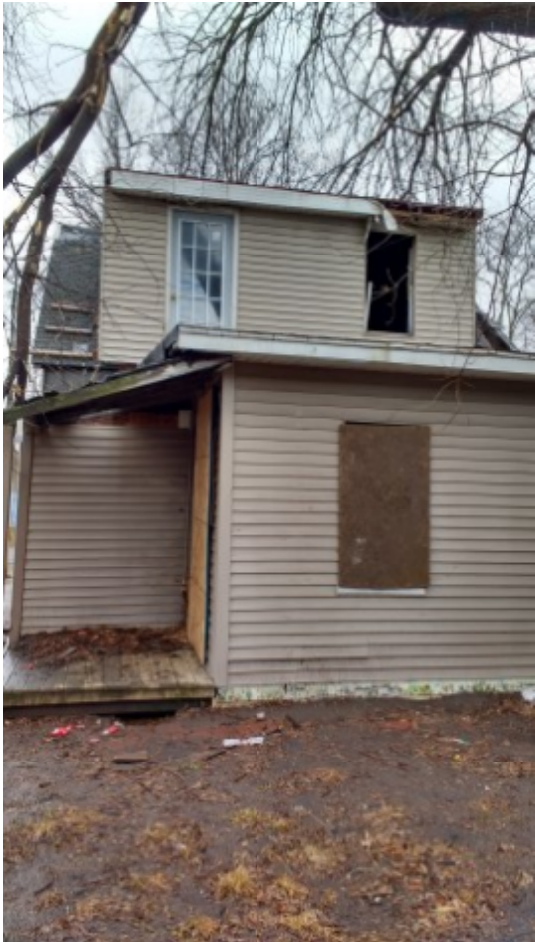
- Except for fire damaged locations, walls appear to be in structurally acceptable condition. Fire damage is worst at the northwest (left) face of the building. See photos 01-04.

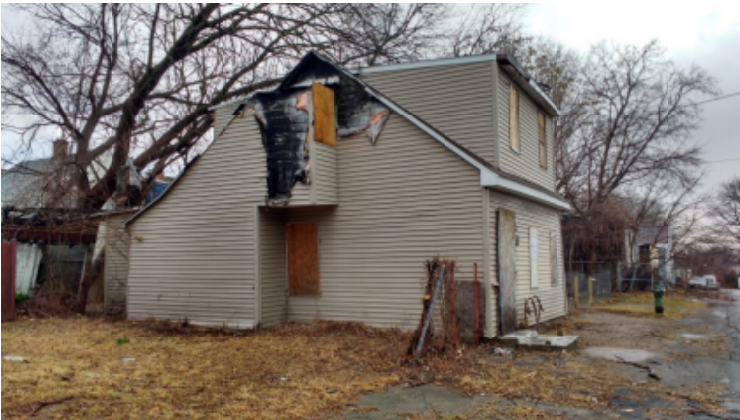
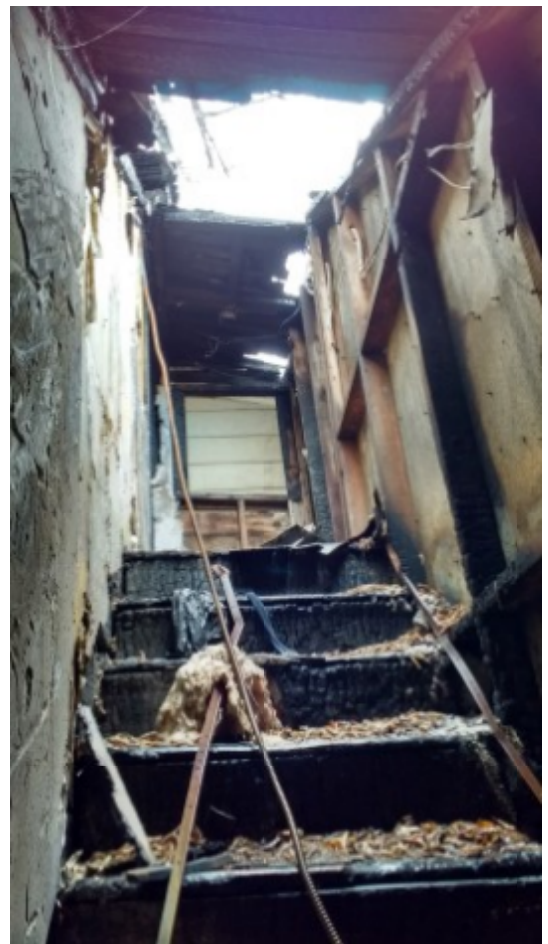
- Stairs to the second floor have experienced significant fire damage. See photos 03 and 08.
- Second floor walls have experienced some fire damage. See photos 9-10. As of the 1/25/18 site visit, the stairs were further damaged and the second floor was not safely accessible. See photo 12.
- Floors have some water damage. See photos 9-10.

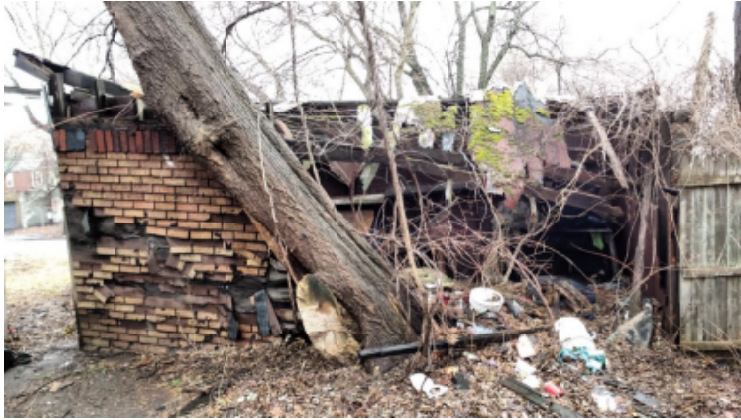
48 Swinton 05.jpg

- The structure is wood framed, 2-stories high with vinyl siding.
- There is an old shed on the site in a state of partial collapse. See photo 05.
- The interior has gypsum board finishes.

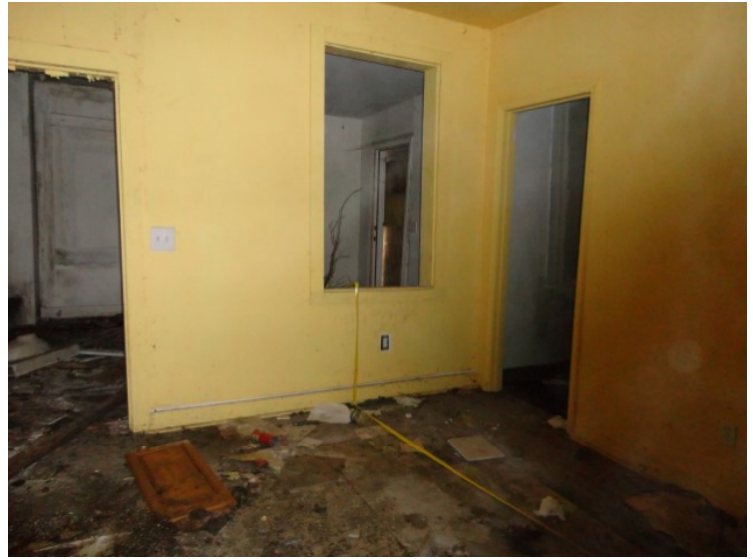
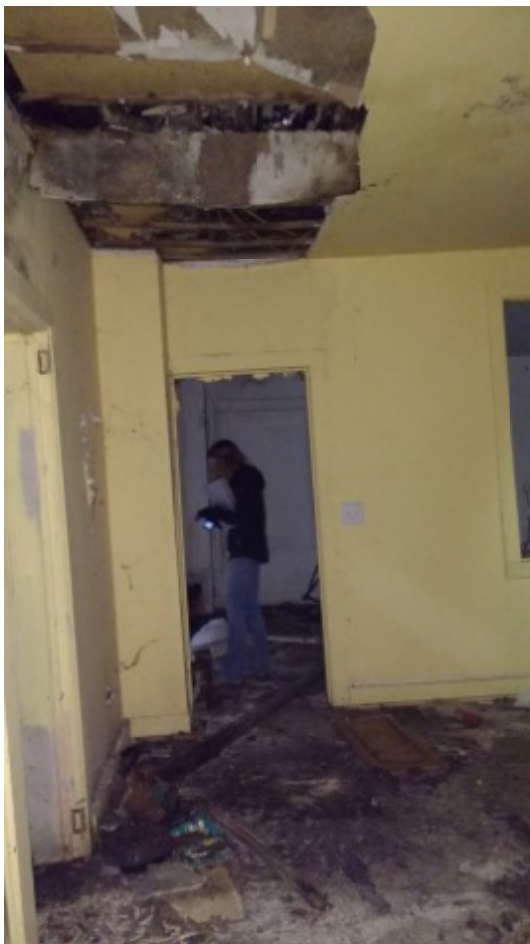
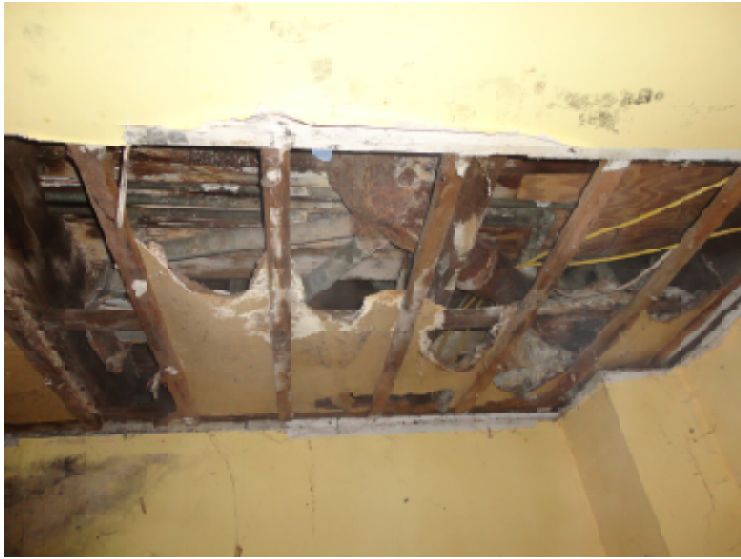
- Floors and ceilings have experienced some water damage. See photos 06, 07 and 11.

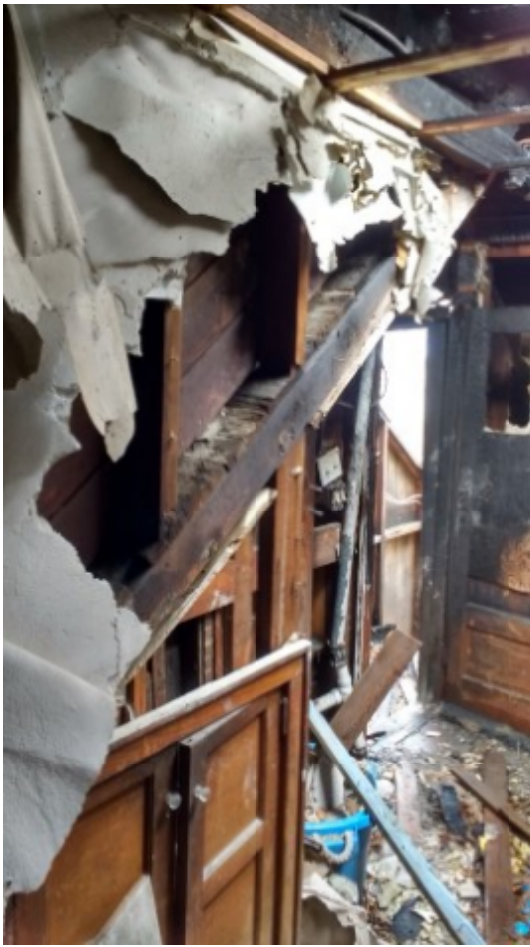
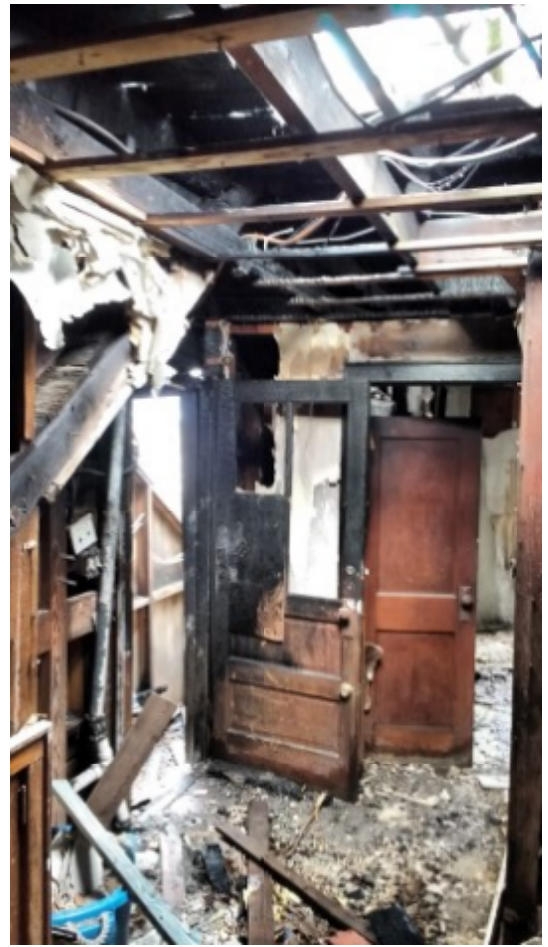
- Roof framing has extensive fire damage and is open over the stairwell and adjacent areas. damage, especially at the back of the building. See photos 09, 10, 13 and 14.
