# C.T. MALE ASSOCIATES

Re: *Visual Structural Evaluation*  
*320 Second Street*  
*Albany, NY 12206*  
*C.T. Male Associates Project No. 15.5188*

*Visual Structural Evaluation  
320 Second St. – Albany, NY  
January 17, 2018  
Page 2*

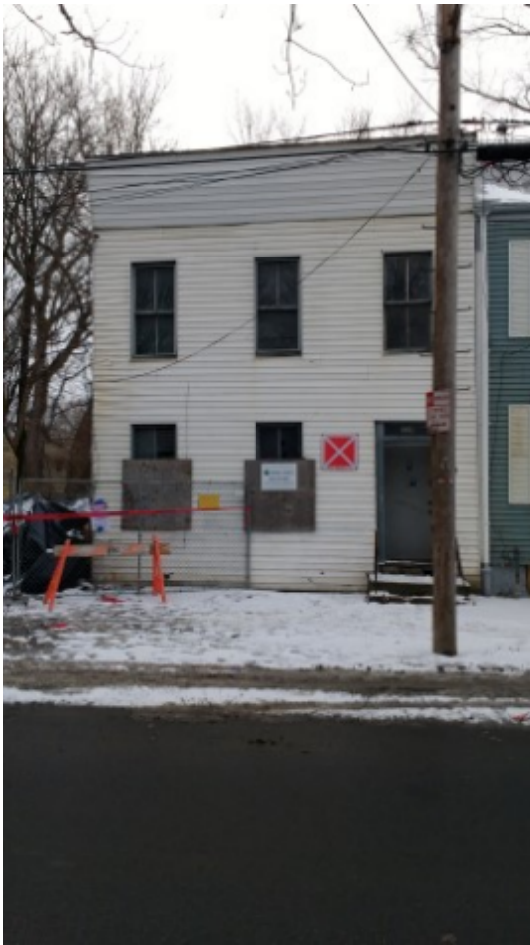
320 Second St 01.jpg

## Exterior – See photos 01-05

- Overall, walls are generally plumb.
- There appears to have previously been a back porch which has been removed.
- Most windows and doors are damaged and are not air/water tight.
- The exterior wall is significantly deteriorated around the roof drain at the asphalt sided (southeast) wall.

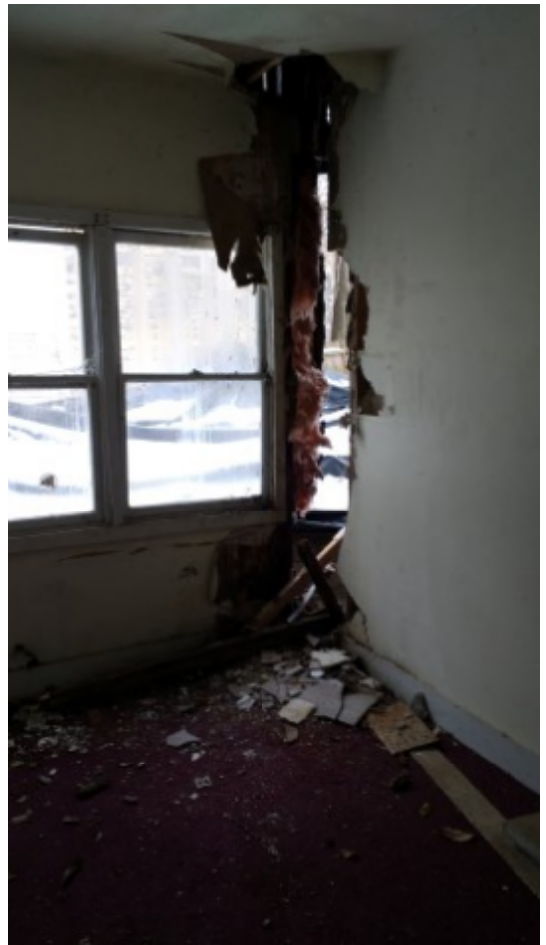
320 Second St 06.jpg

- Floor boards and framing have some deterioration over the main portion of the building. Flooring and framing are collapsed around the roof/bathroom drain. The rear portion of the building has more uneven floors which indicate framing and/or foundation deterioration. See photos 06-07 and 10.

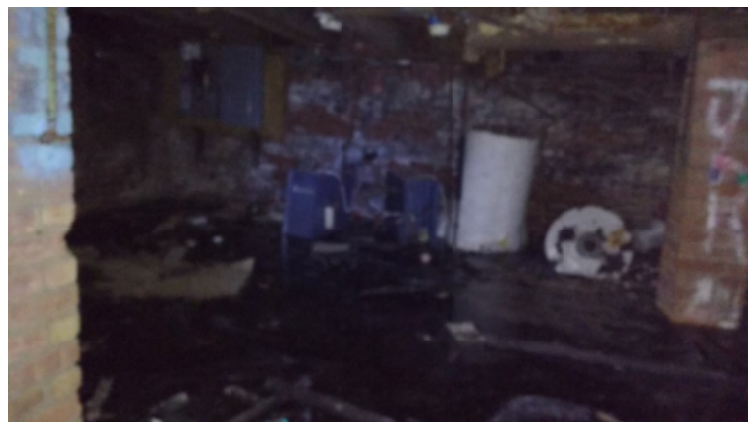
320 Second St 08.jpg

- The front 2/3 of the house has a basement. See photos 08-09. There is likely a crawl space at the back third of the basement which was not visible for inspection.
- Standing water was present at the basement.
- Basement walls are brick and are mostly intact, but have isolated damage to the brickwork. See photo 09.

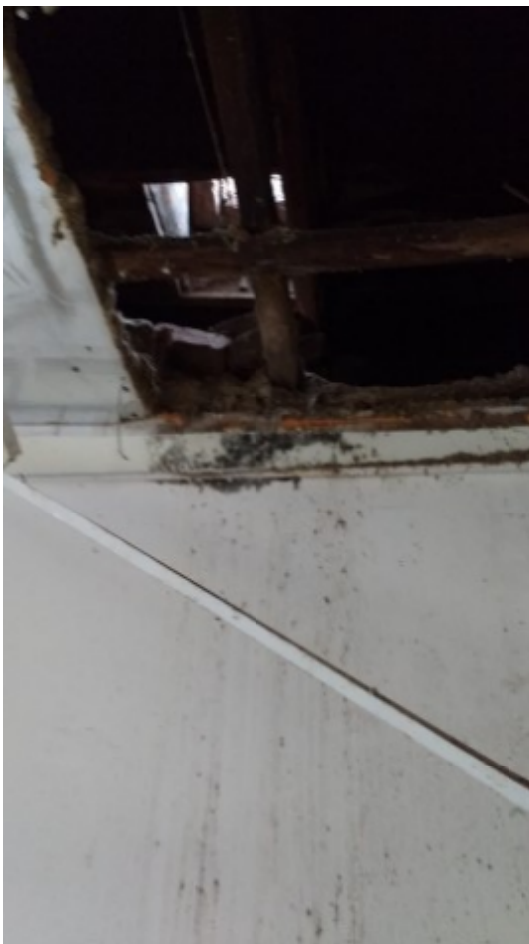
320 Second St 11.jpg

- Floor boards and framing have some deterioration over the main portion of the building. Flooring and framing are significantly damaged around the roof/bathroom drain. See photos 11-13.

- Roof leaks are active and roof framing has isolated water damage at areas of leaks. Roof damage is most severe around the roof drain. See photos 11 and 13.
