Re: *Visual Structural Evaluation*
436 Third Street
Albany, NY 12206
C.T. Male Associates Project No. 15.5188

As requested, C.T. Male Associates Engineering, Surveying, Architecture & Landscape Architecture, D.P.C. (C.T. Male Associates) conducted a visual structural evaluation of the above-referenced building on November 9, 2017. The purpose of this evaluation was to visually observe the condition of the building and to list all observed areas of structural concern.

Visual Structural Evaluation
436 Third St. - Albany, NY
November 15, 2017
Page 2

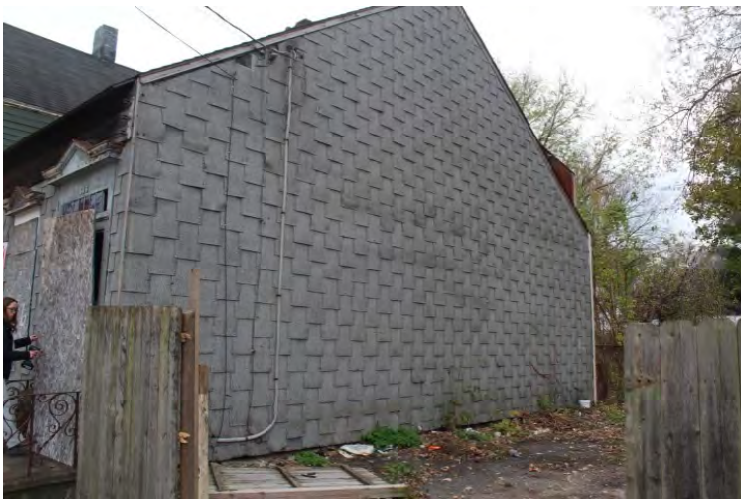
436 Third St 01.JPG

Exterior - See photos 01-06

- Exterior walls appear to be generally plumb and stable.
- Masonry at the original building foundation wall near grade needs to be repointed. See photos 02 and 04.
- There are big gaps into the crawl space below the back addition. Wood framing near grade is deteriorated. See photos 04-06.

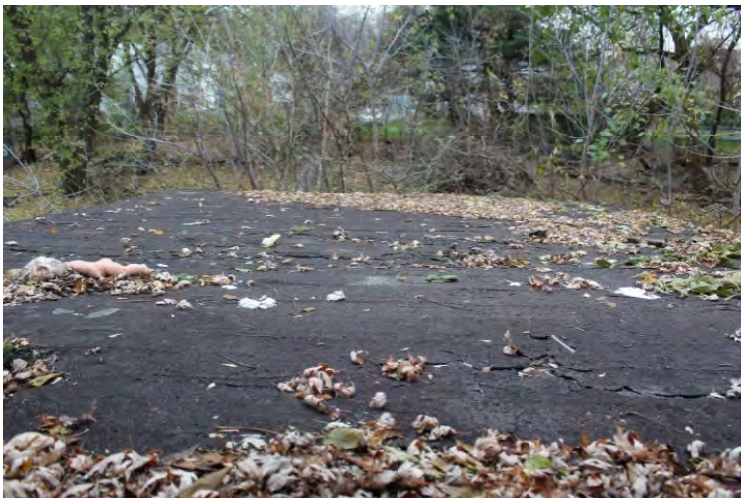
436 Third St 07.JPG

- Roof framing at the original building is generally in acceptable structural condition. No roof leaks were observed at this portion of the building. See photos 08-10.
- The roof at the back addition has many leaks and roof framing is starting to deteriorate. See photos 07 and 12.

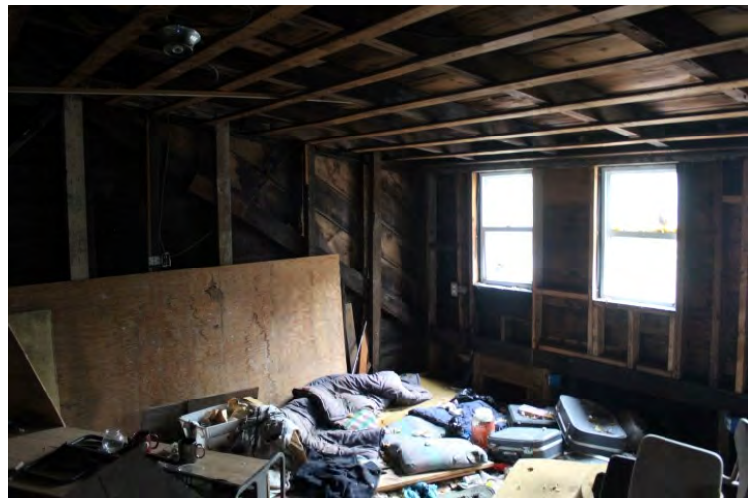
436 Third St 08.JPG

- The partial second floor at the original house generally appears in good structural condition. See photos 08-10.

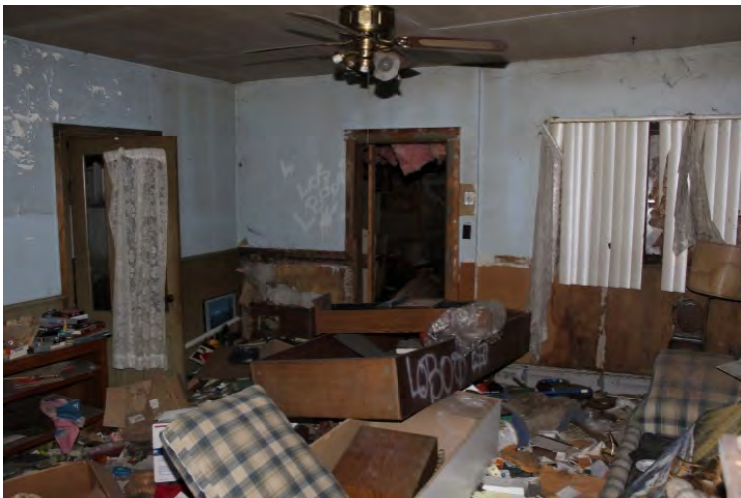
436 Third St 11.JPG

- Walls and floors at the original house generally appear in good structural condition. See photo 11.
- Flooring and framing at the back addition has water damage. See photo 13.

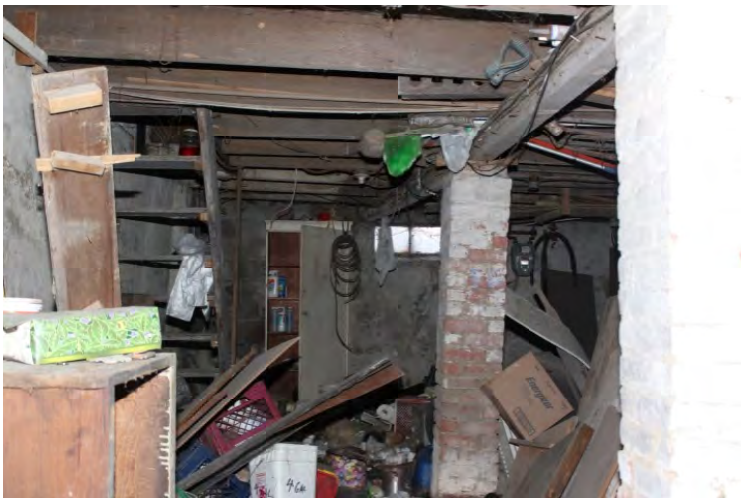
436 Third St 15.JPG

- The original house has a full basement and the back addition has a crawl space foundation.
- Brick foundation walls are generally plumb and intact, however there are several areas that need to be rebuilt or repointed, most notably near the access to the crawl space. See photos 15-17.
- First floor framing at the original house is generally in good condition. See photos 15-17.
- The crawl space foundation below the back addition has many areas where wood framing is in contact with soil and is deteriorating. See photos 18-19.
