# C.T. MALE ASSOCIATES

Re: *Visual Structural Evaluation*  
*64 Alexander St.*  
*Albany, NY 12202*  
*C.T. Male Associates Project No. 15.5188*

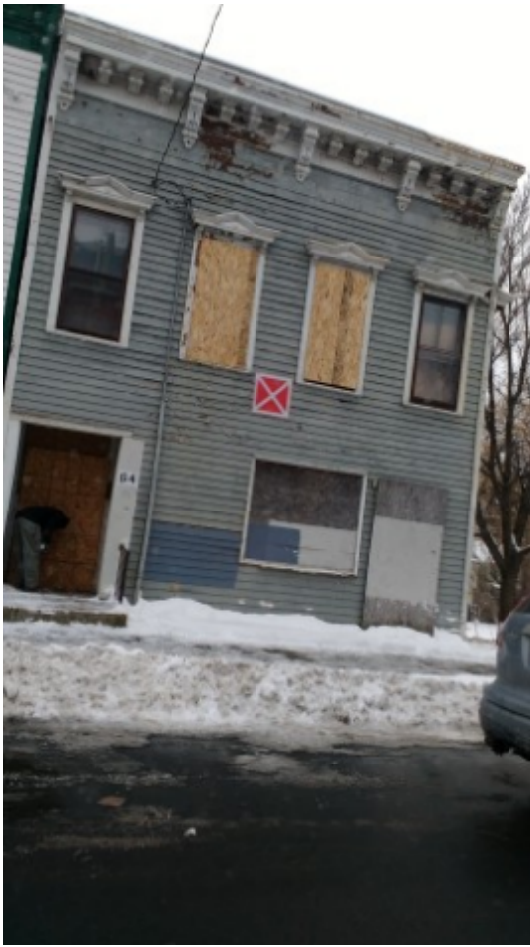
64 Alexander St 01.jpg

- Exterior walls of the building appear generally plumb, but are likely deteriorated behind finishes due to deteriorated exterior sheathing and broken windows. See photo 01.

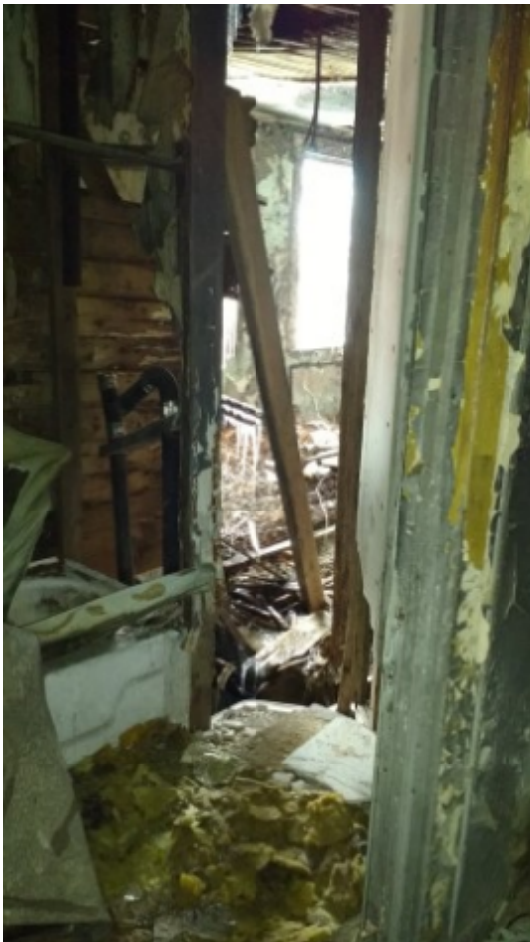
64 Alexander St 03.jpg

- Floor sheathing and framing typically have some deterioration. The floor is collapsing at one isolated location in the back apartment kitchen (see photo 06) and around the roof drain (see photo 03 and 05).

- There is some fire damage to the back apartment. See photos 03-06.

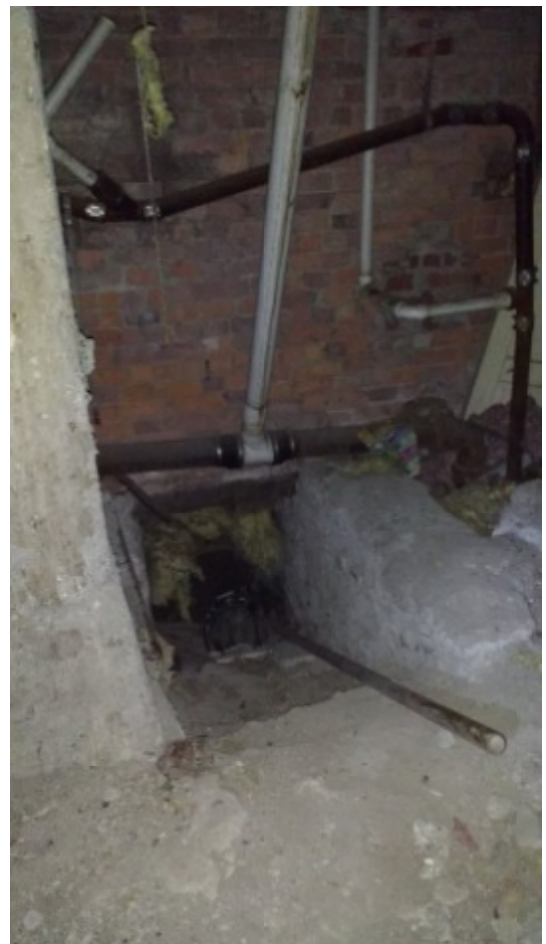
64 Alexander St 08.jpg

- Basement walls are typically brick. See photos 08-12. Some locations have deteriorated mortar and are pushing into the basement area. See photo 11.
- Portions of the basement have a sub-basement. See photos 08 and 12. Wood framing over the sub-basement did not appear to be safe to walk on.
