C.T. MALE ASSOCIATES

Re: *Visual Structural Evaluation*
64 Alexander St.
Albany, NY 12202
C.T. Male Associates Project No. 15.5188

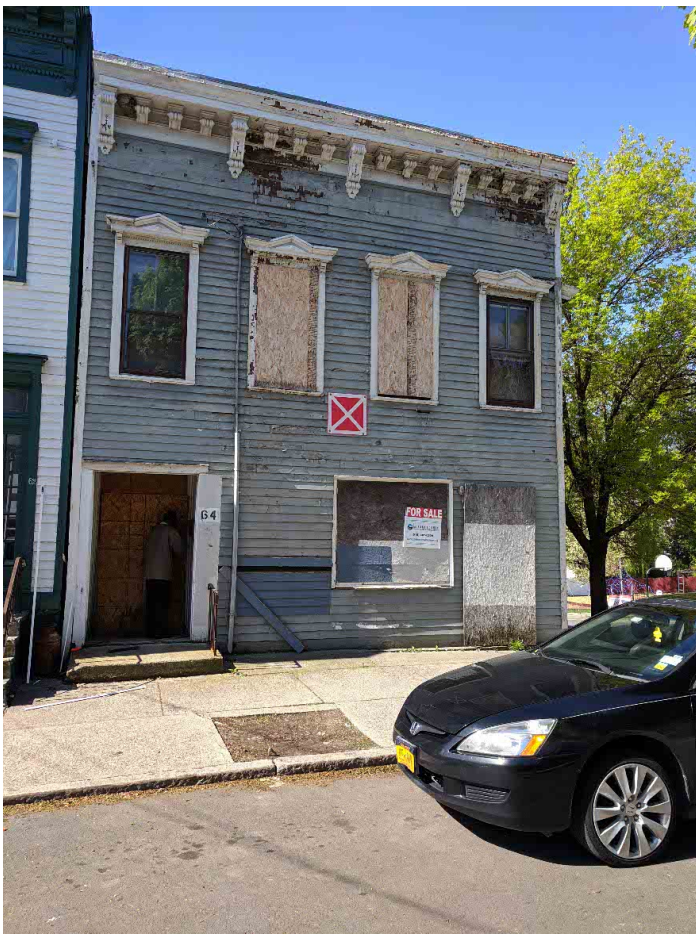
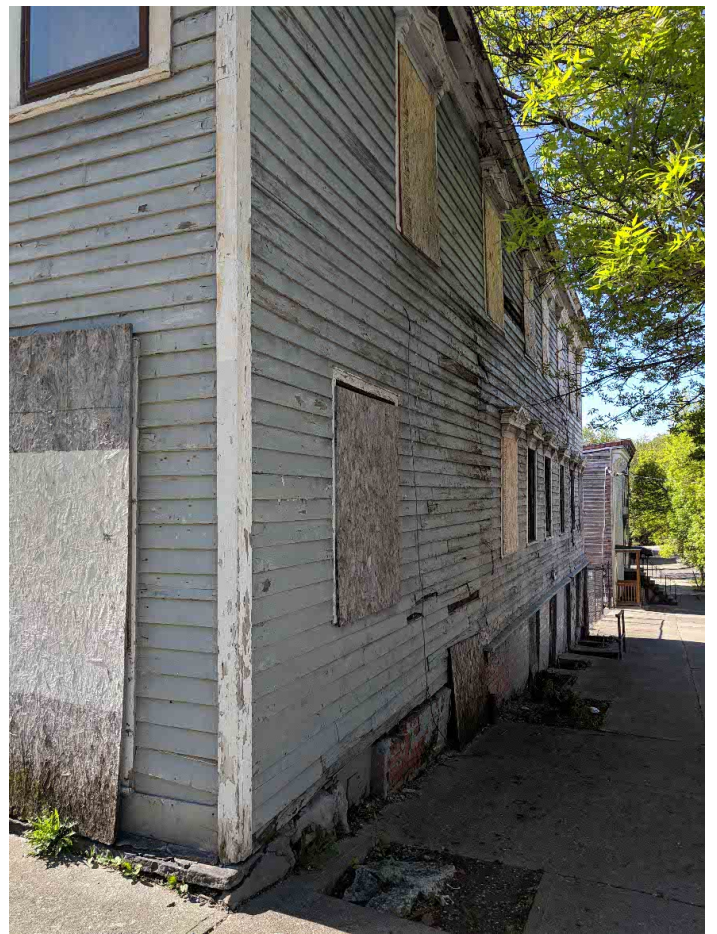
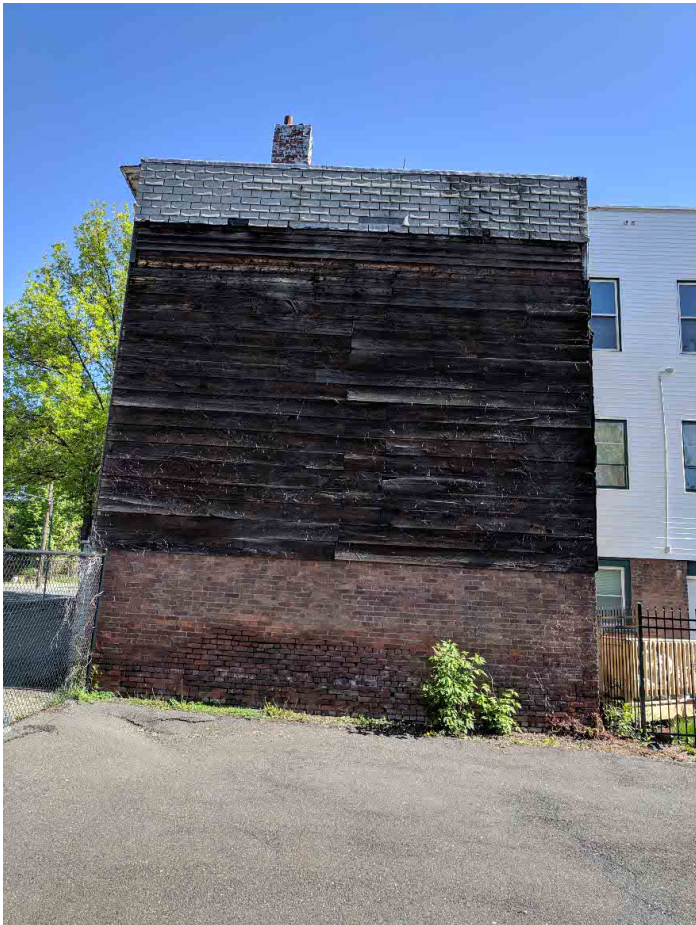
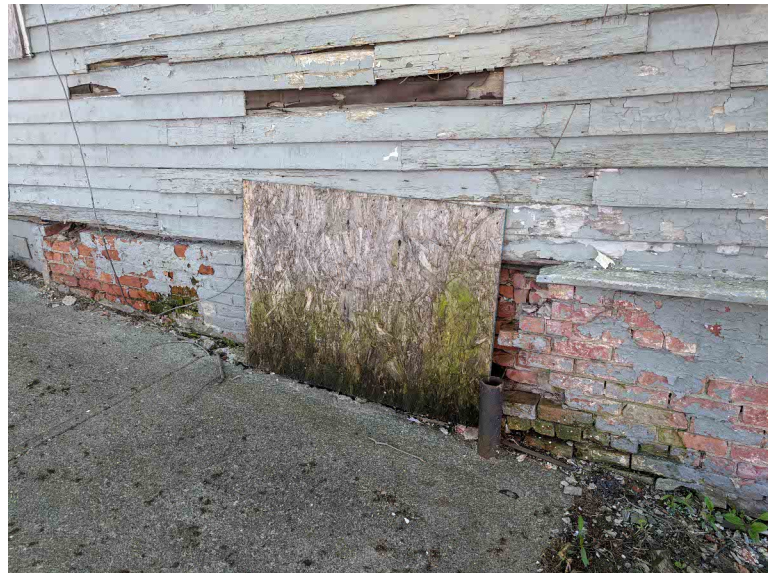
- Exterior walls of the building appear generally plumb, but are likely deteriorated behind finishes due to deteriorated exterior sheathing, broken windows and roof leaks. See photos 01-04.
- Exterior foundation brickwork has deteriorated mortar and missing bricks at some locations.

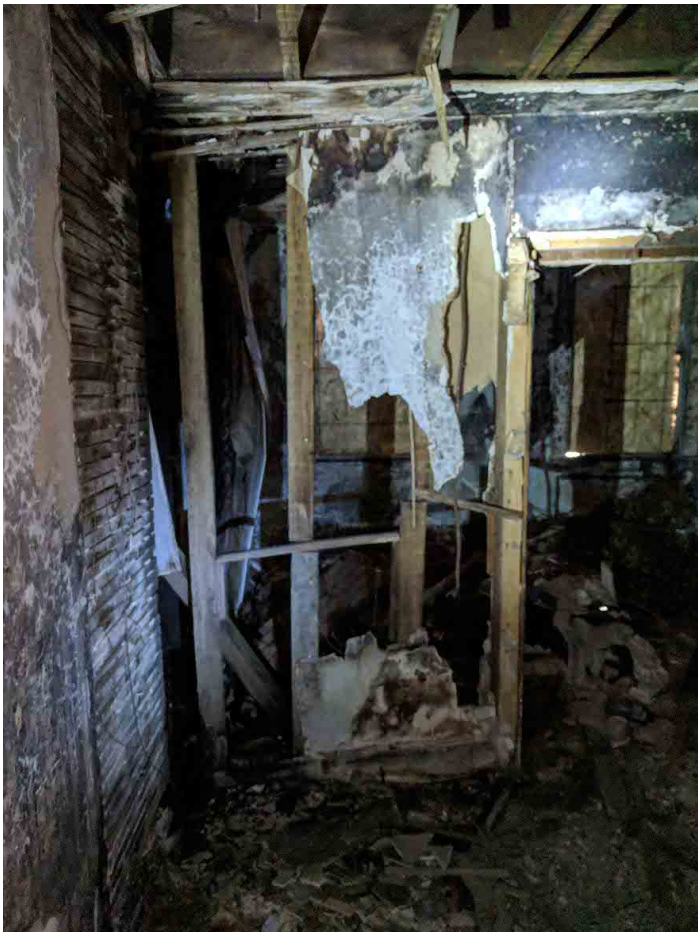
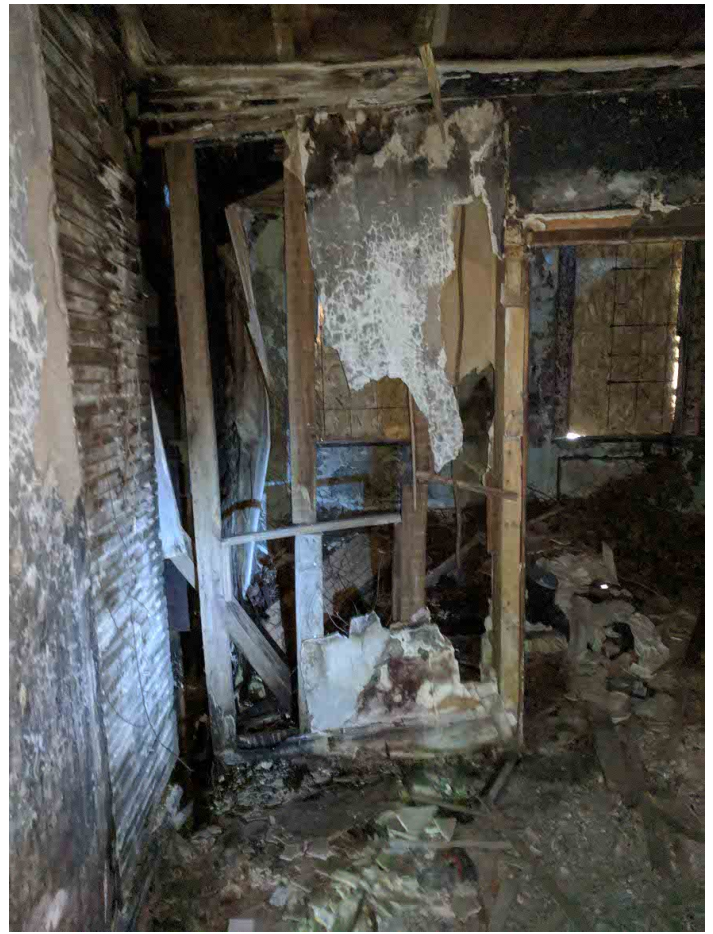
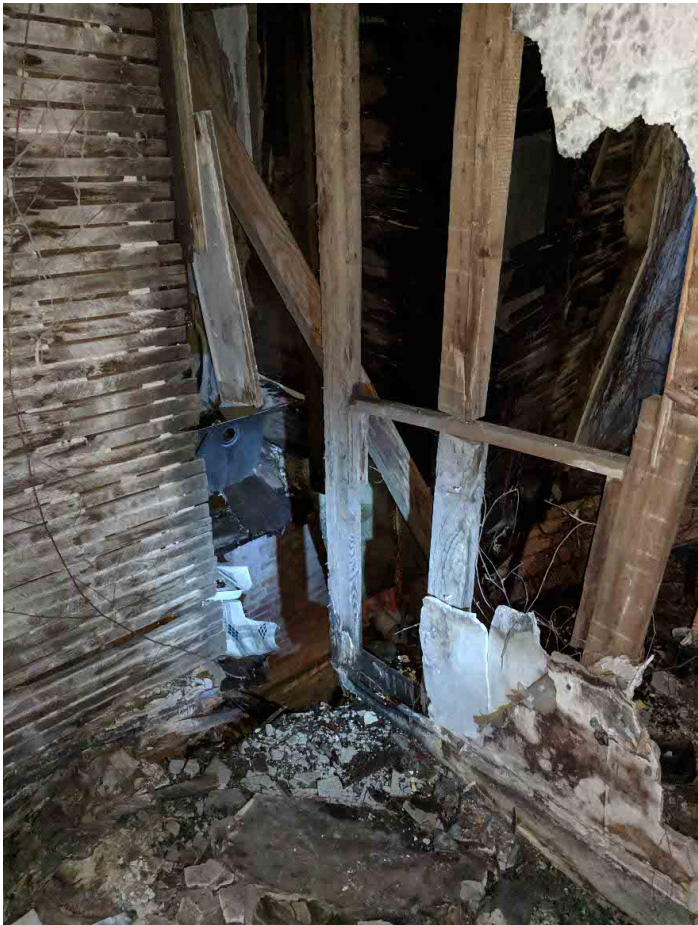
- Floor sheathing and framing typically have some deterioration. The floor is collapsing in the back apartment kitchen (see 2018 photo 06) and around the roof drain (see photos 05-07 and 2018 photos 03 and 05).
- There is some fire damage to the back apartment. See 2018 photos 03-06.

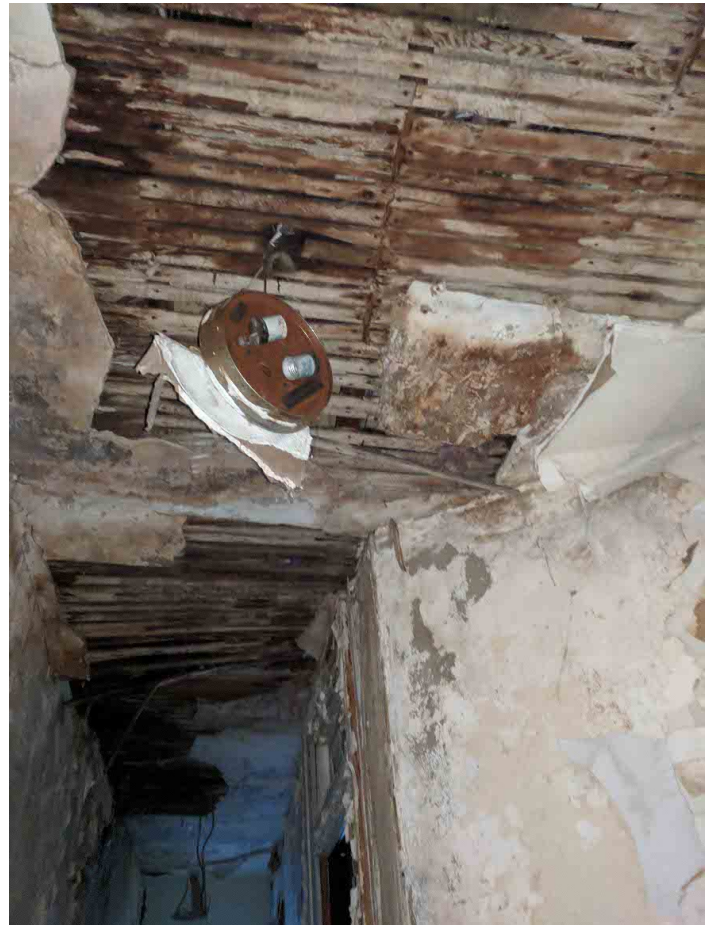
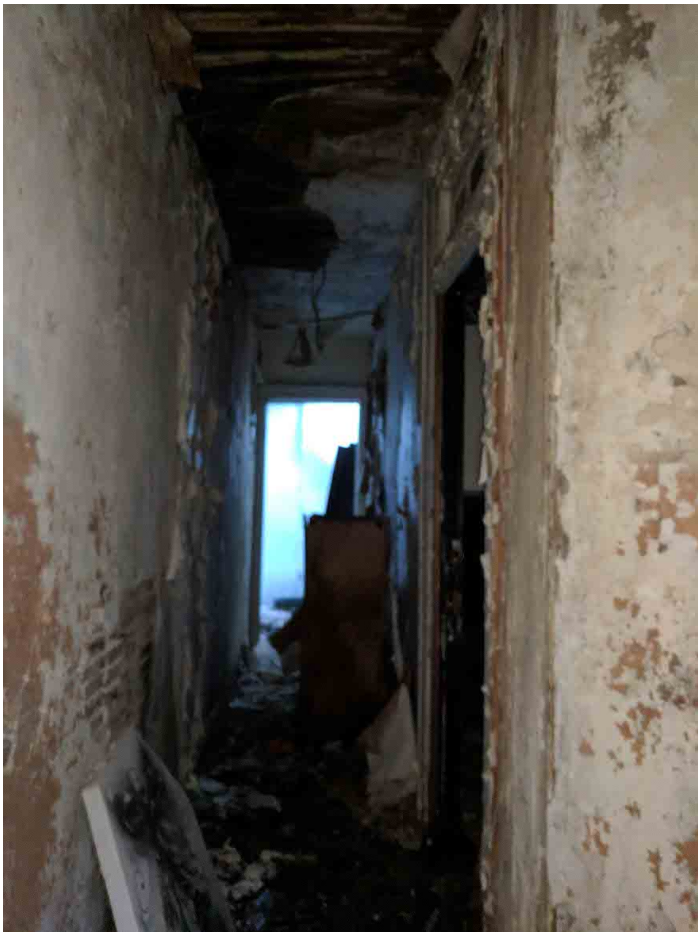
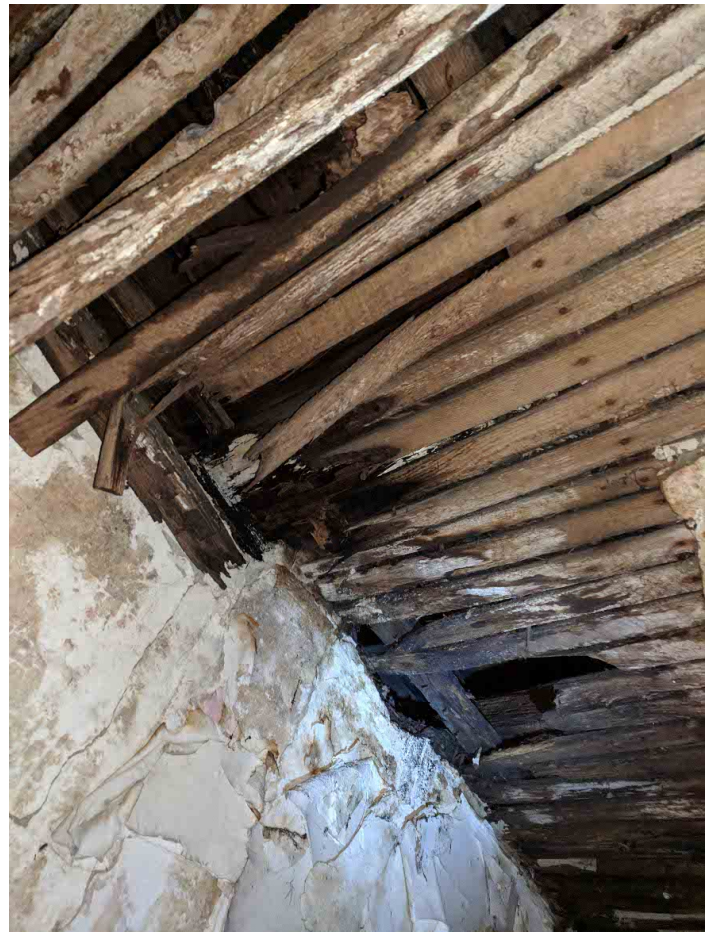
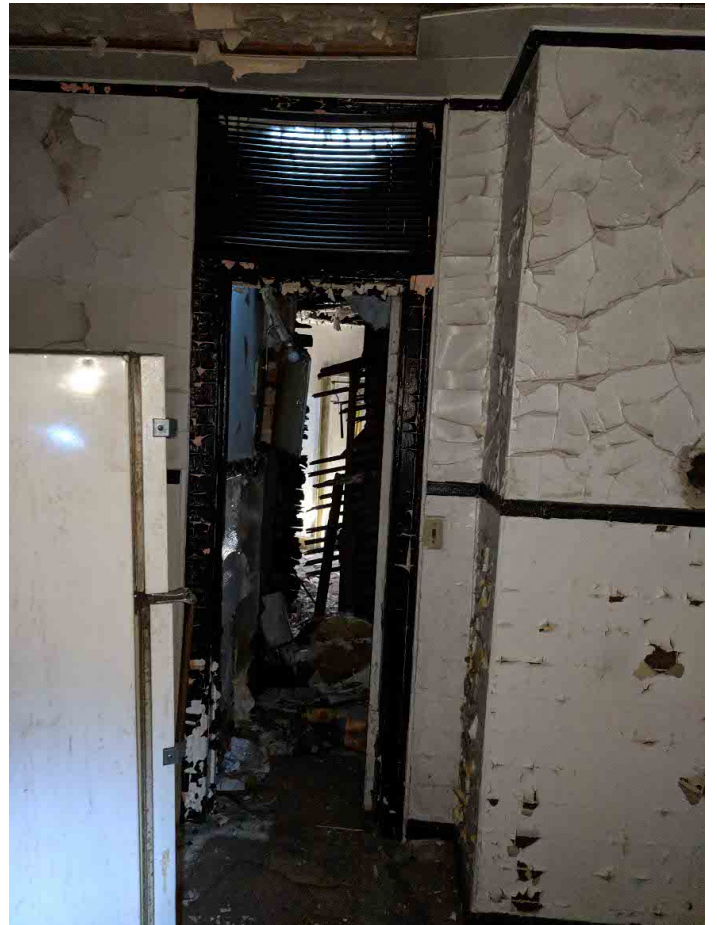
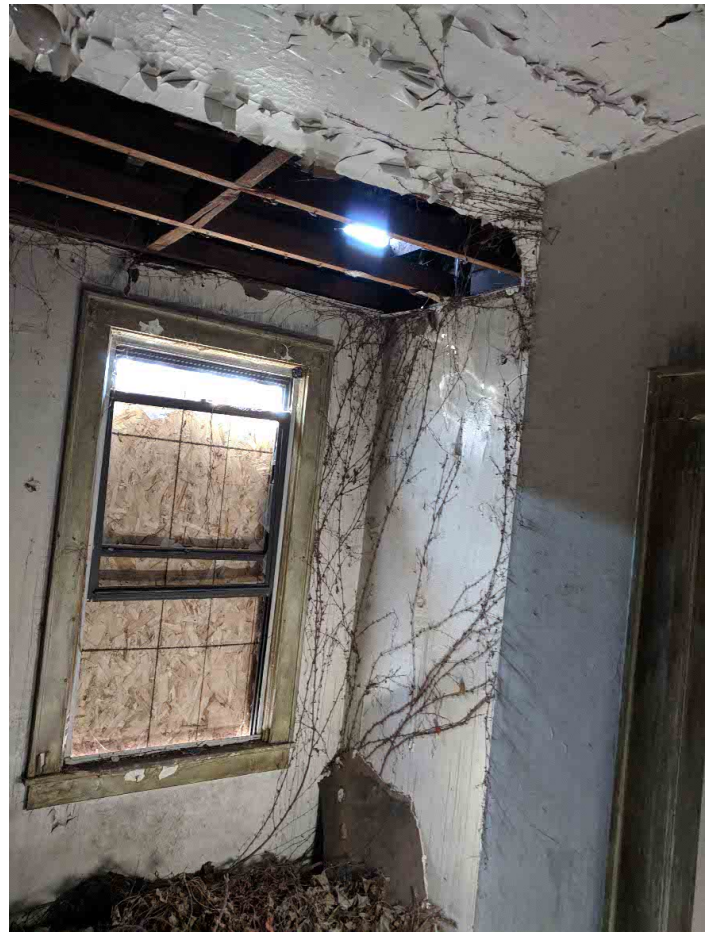
- Floor and wall framing are significantly deteriorated in many areas. See photos 08-14.
- The second floor is collapsing around the roof drain and at the base of the stairs to the roof. See photo 11 and 13.

- The roof is leaking in many locations and has visible holes in several locations. Framing and sheathing are significantly deteriorated. See photos 08-14
- The roof is not closed at the hatch, and the floor is collapsed at the base of the ladder to the roof. See photo 11.

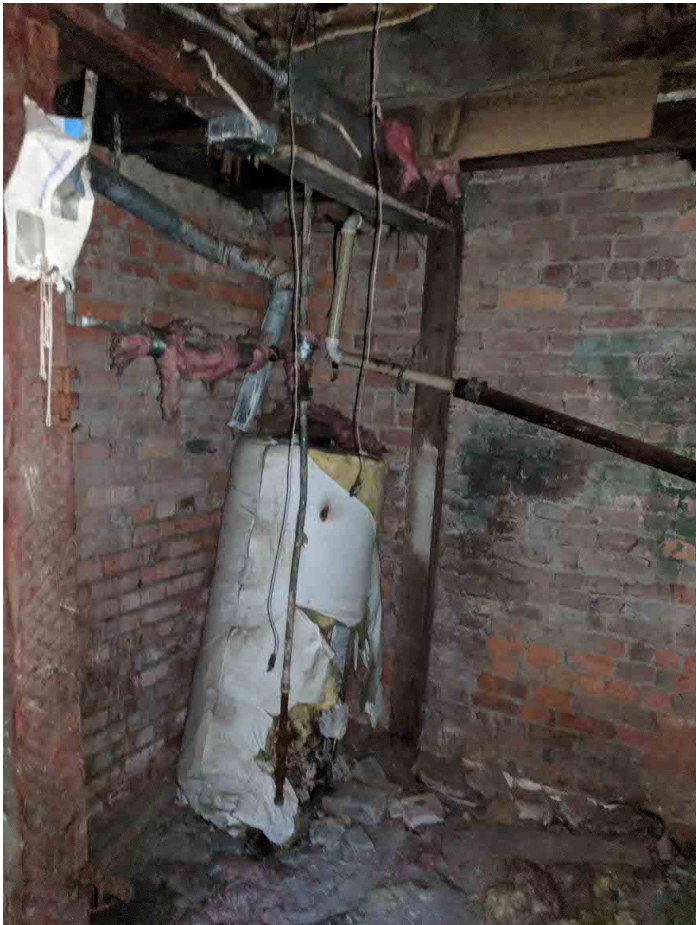
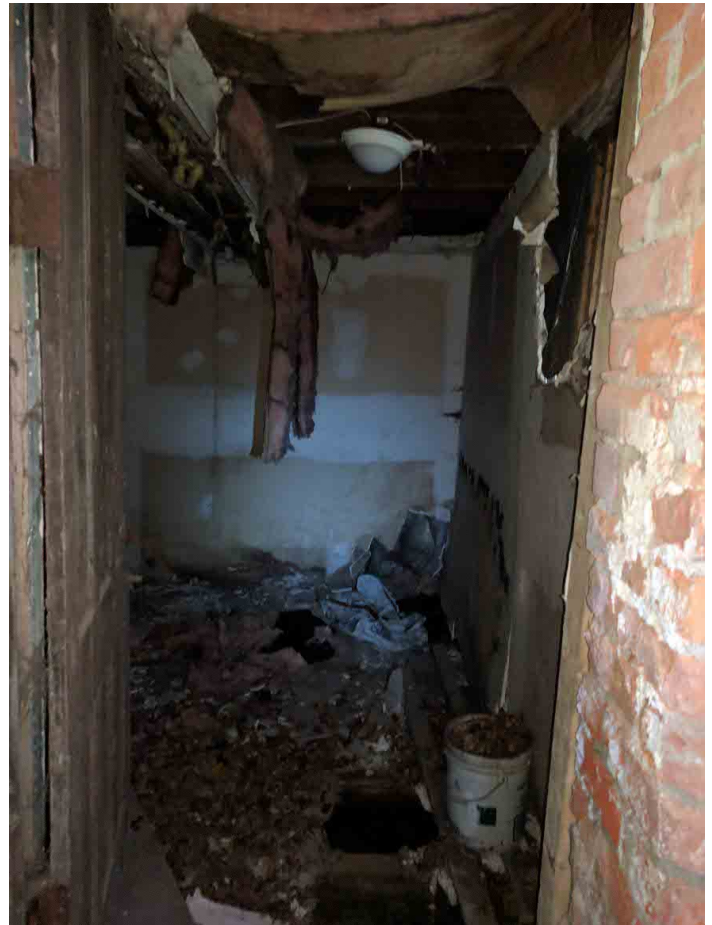
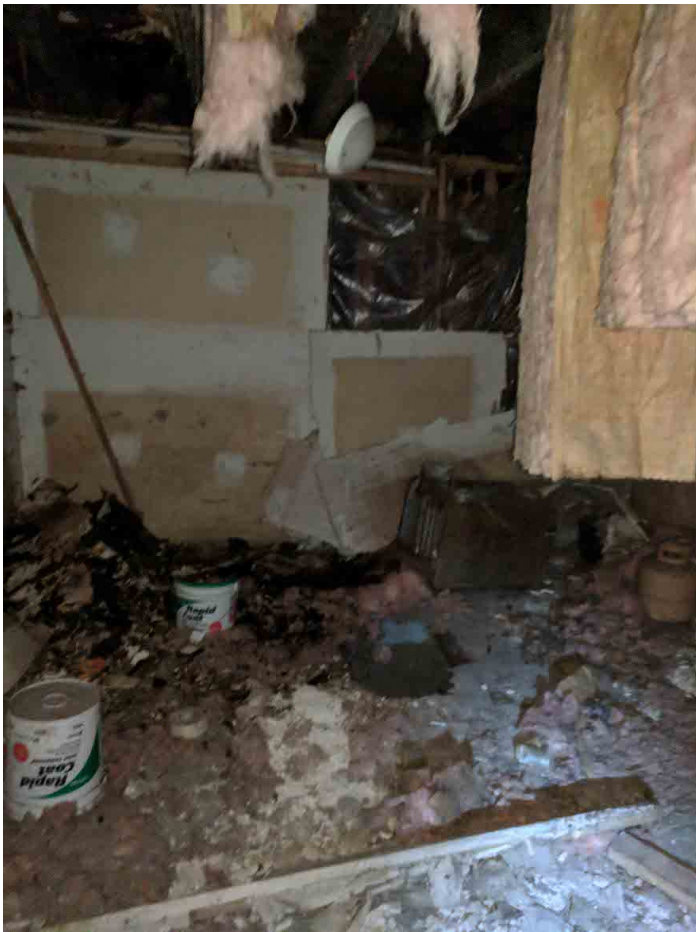
- Basement walls are typically brick. Some portions have been rebuilt with CMU. See photos 15*20 and 2018 photos 9-12. Some locations have deteriorated mortar and are pushing into the basement area. See 2018 photo 11.
- Portions of the basement have a sub-basement. See photos 16-20. Sub-basement sheathing is in danger of collapse in many locations.
- The sub-basement floor at the back of the building has collapsed. See photos 18-19.
