C.T. MALE ASSOCIATES

Re: *Visual Structural Evaluation*
296 Sheridan Avenue
Albany, NY 12210
C.T. Male Associates Project No. 15.5188

Visual Structural Evaluation
296 Sheridan Ave. – Albany, NY
January 31, 2018
Page 2

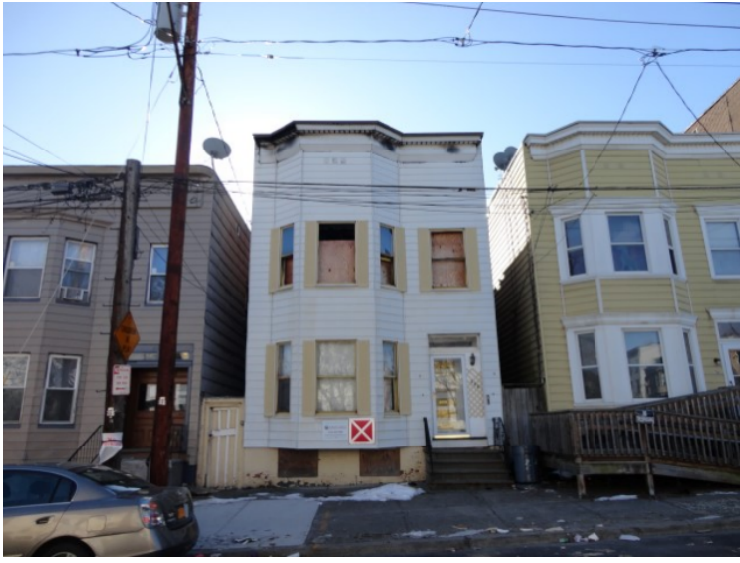
296 Sheridan Ave 01.JPG

- Exterior walls which were visible from the front of the building appear plumb. The back wall was not accessible at the time of the site visit. See photo 01 and 13-14

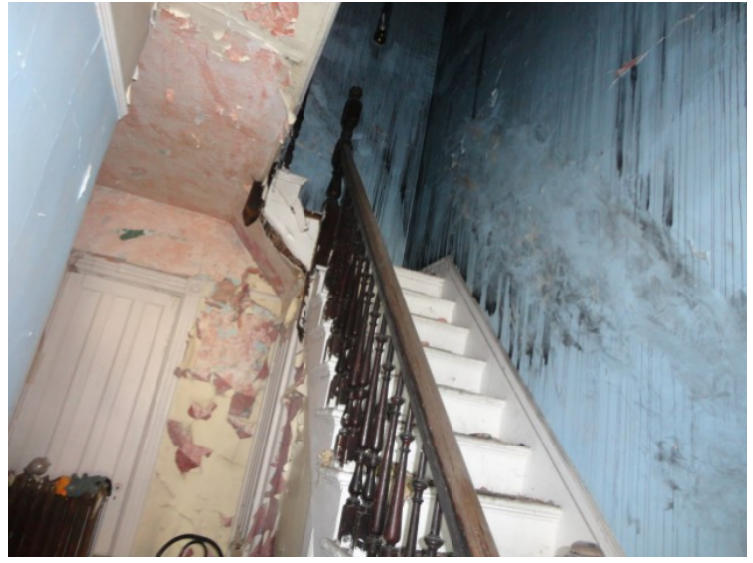
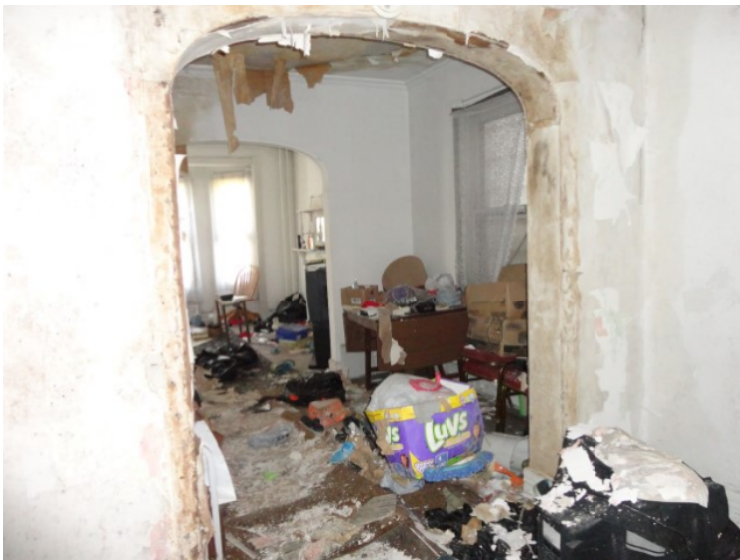
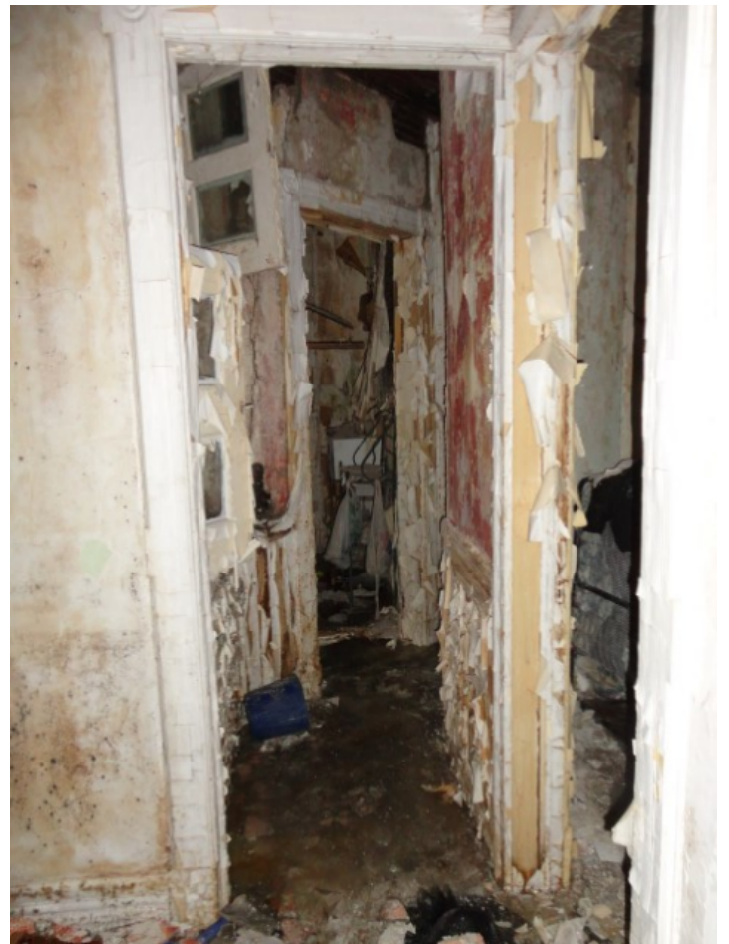
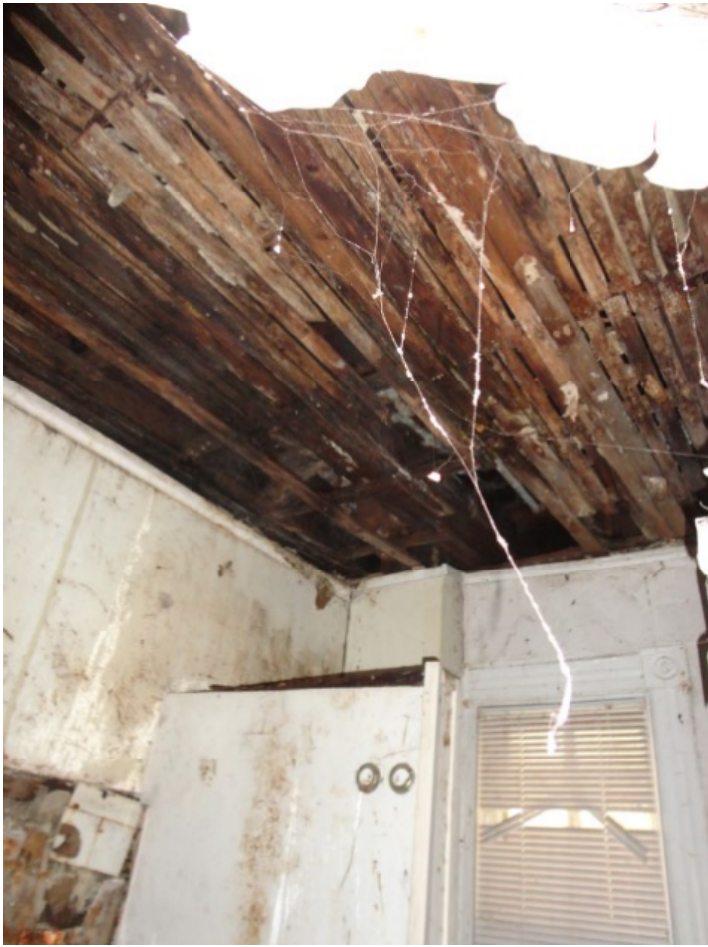
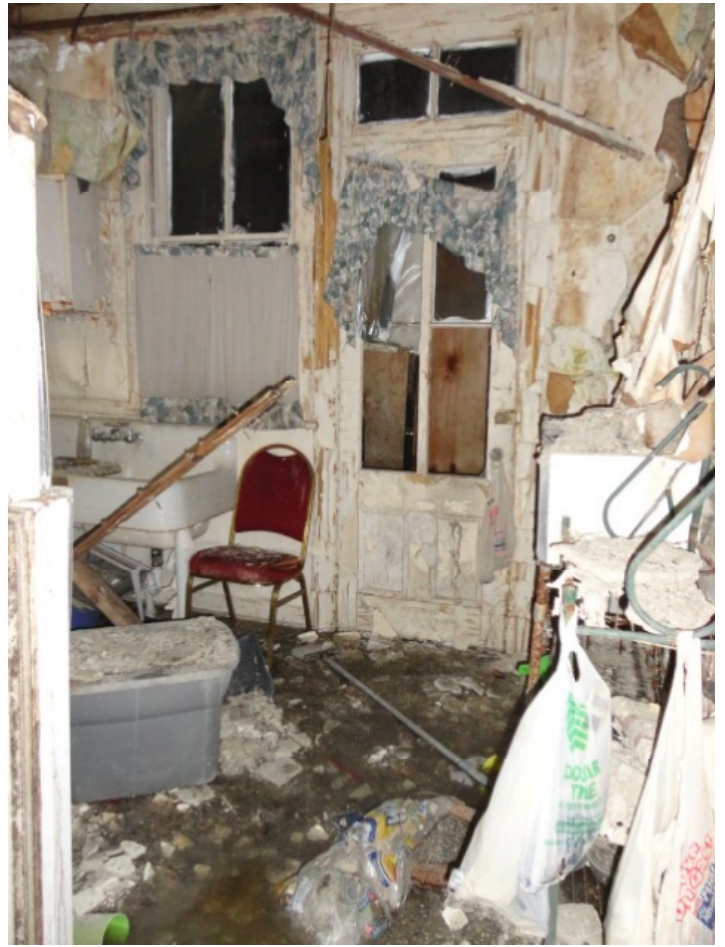
- At the front half of the building floors are buckling and finishes typically conceal structural elements. The rear portion of the building had a couple inches of ice on the floor and more significant damage to finishes. See photos 02-06.

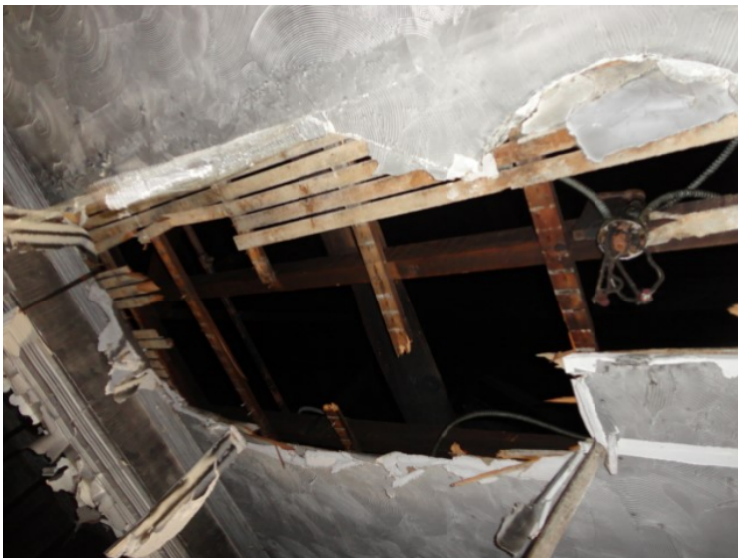
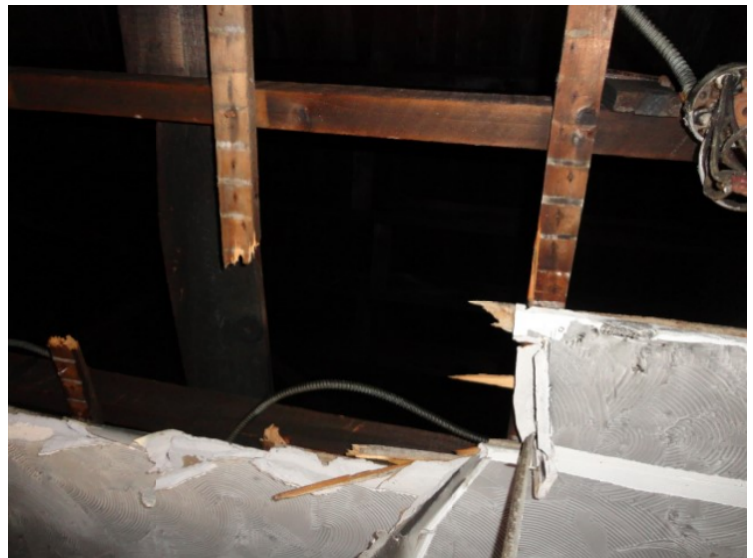
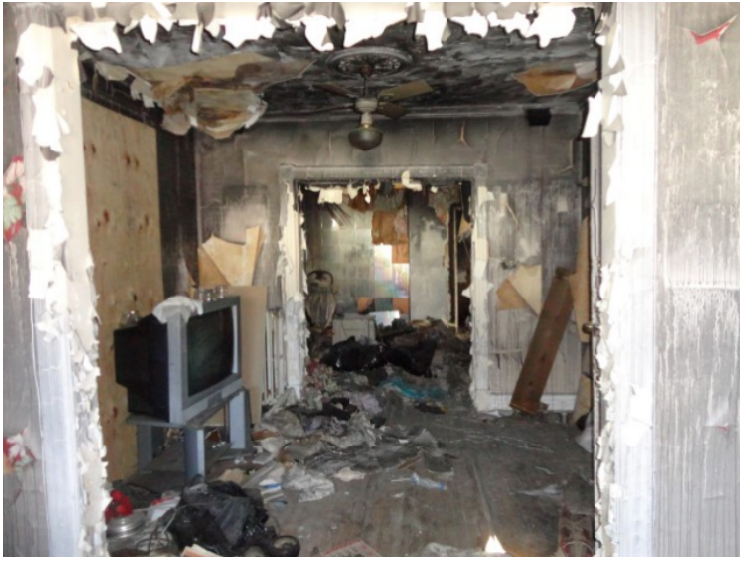
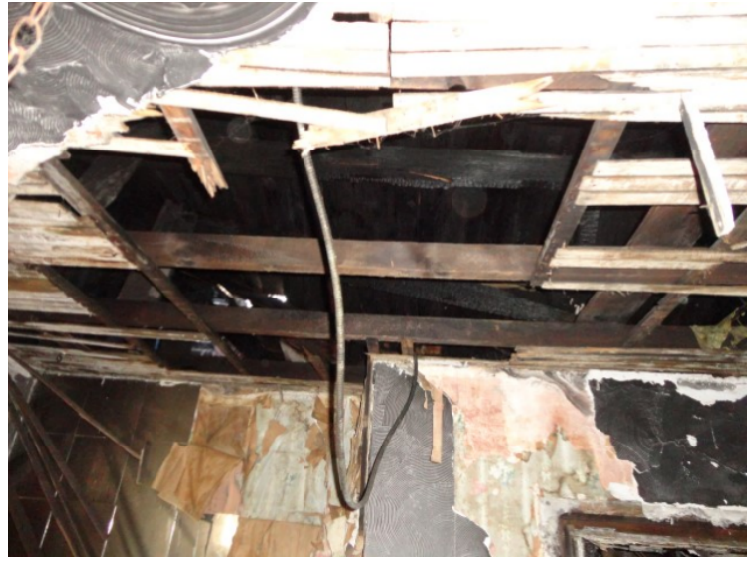
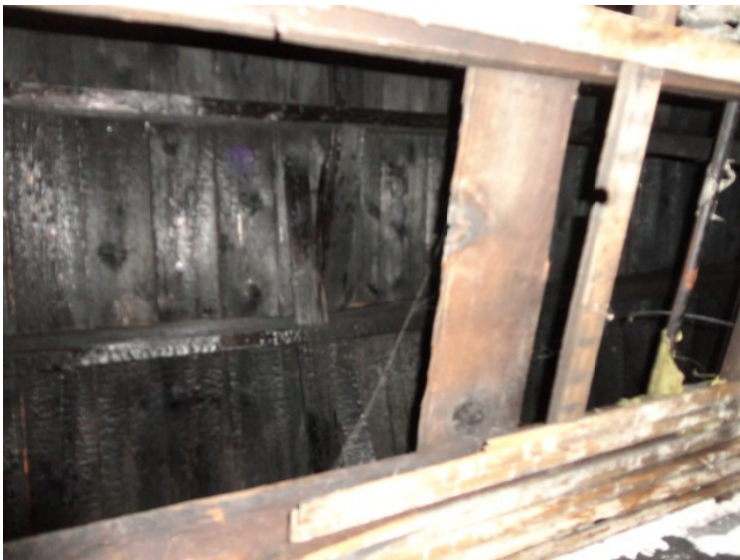
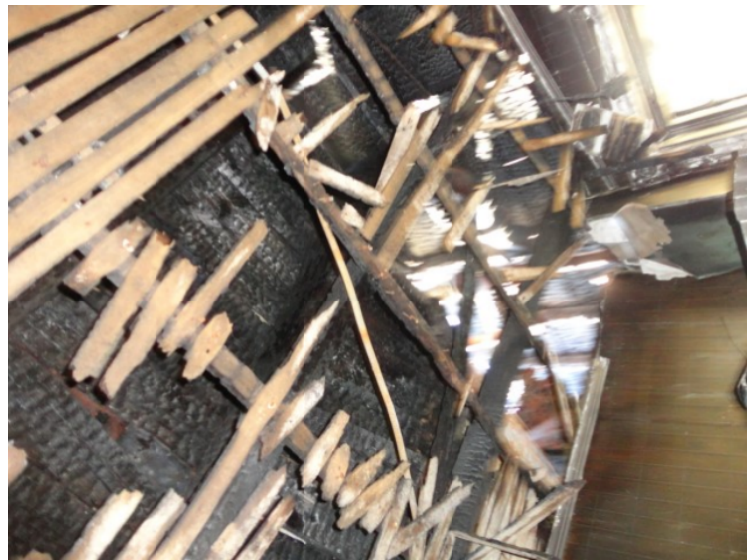
- There is smoke damage throughout the second floor. Holes in the ceiling appear to have been made to help fight the fire in the attic. See photos 07-12.
- The rear of the building has heavier water and fire damage.

- Roof framing and sheathing has some fire damage towards the front of the building and major fire damage towards the back of the building. See photos 07-12.
- The roof is leaking significantly towards the back of the building.
