# C.T. MALE ASSOCIATES

November 6, 2018

Re: *Visual Structural Evaluation*  
*350 Second St.*  
*Albany, NY 12210*  
*C.T. Male Associates Project No. 15.5188*

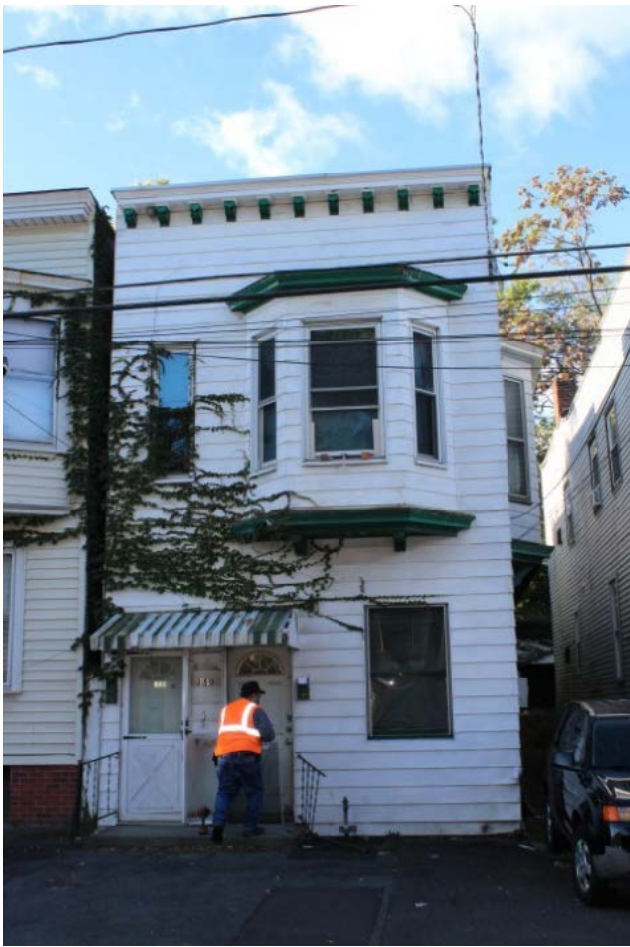
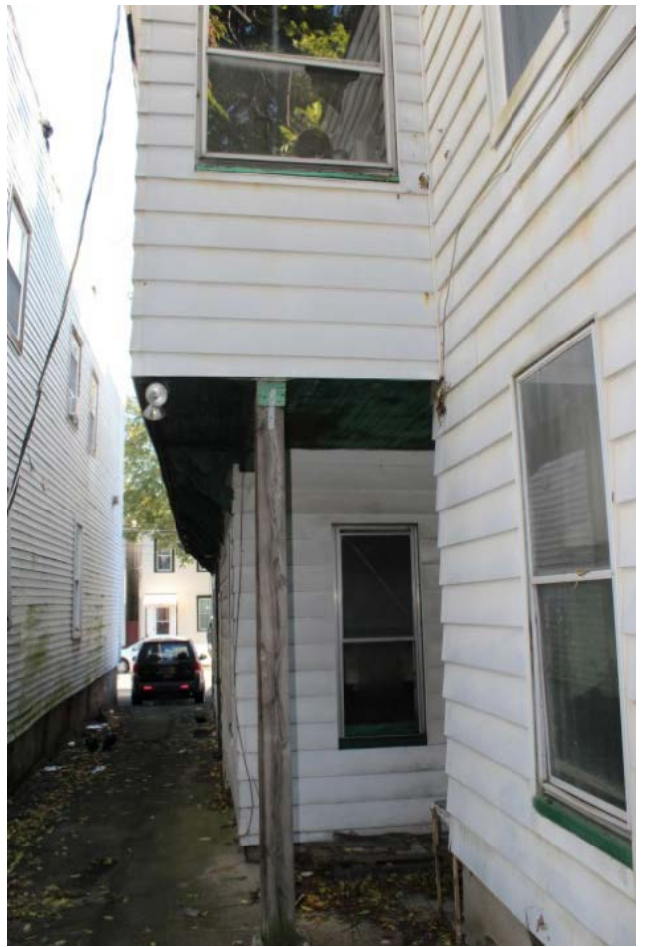
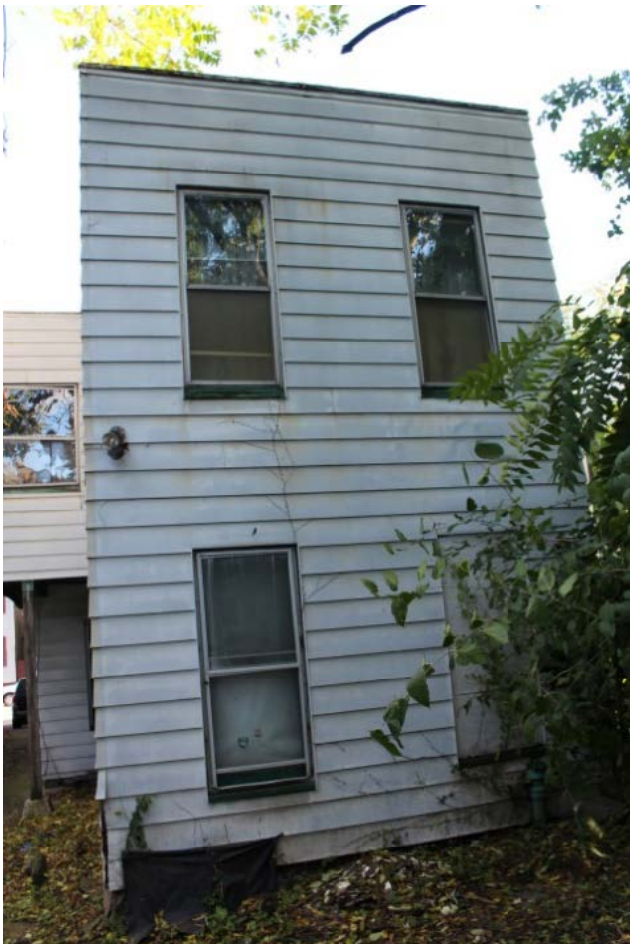
Exterior - See photos 01-03.

- The exterior of the building was originally wood sided and is currently aluminum sided.
- Exterior walls appear to be generally plumb.

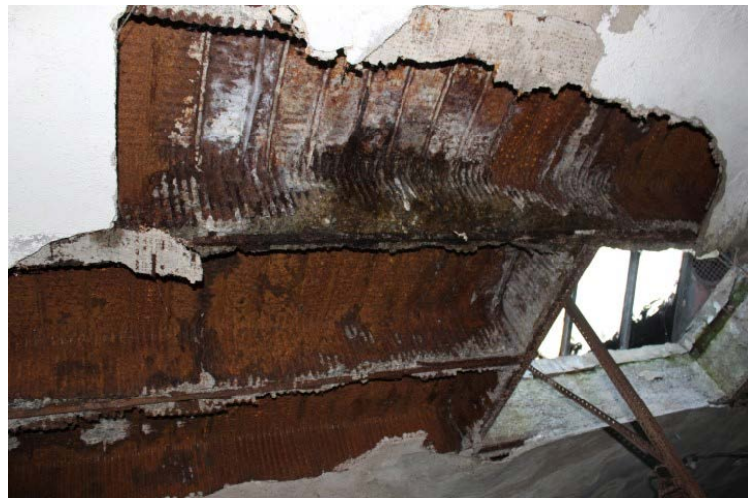
350 Second St 04.JPG

Garage - See photos 04-06.

- The brick walls are generally intact, but there are some locations where bricks have fallen out. See photo 04 above and to the left of the garage door.
- The roof was constructed of concrete poured over light gage metal formwork to form concrete joists spanning the depth of the garage. All ribs are significantly deteriorated; rebar at the ribs is exposed and is separated in some locations. See photo 04-05

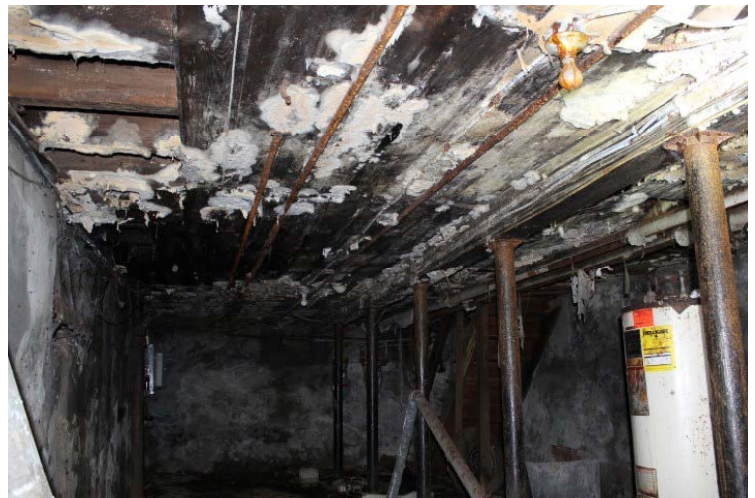
350 Second St 08.JPG

## Basement/Foundations – See photo 08.

- Brick/CMU foundation walls are generally intact.
- There is organic growth on many surfaces due to high humidity in the basement. Framing is generally intact.

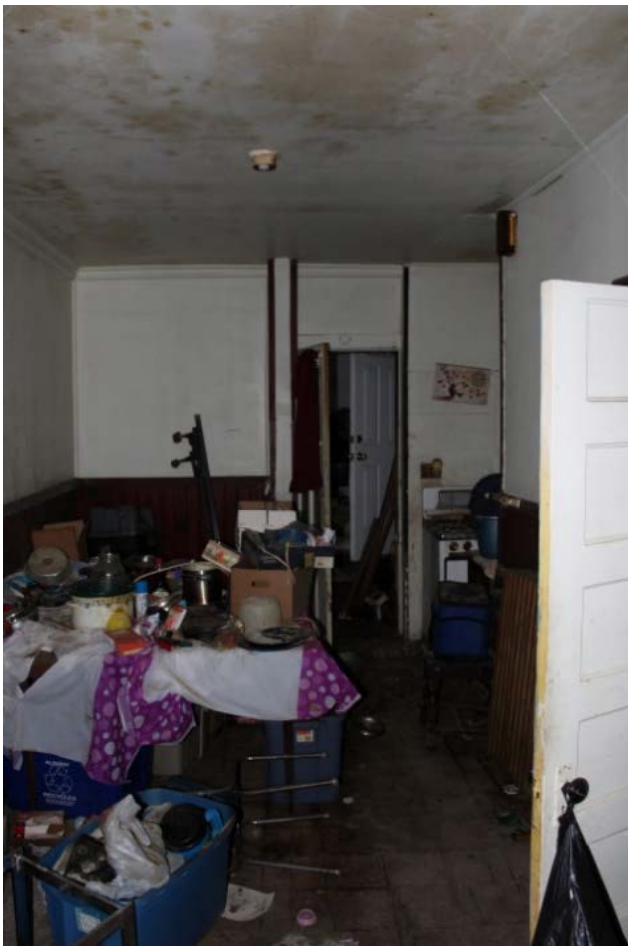
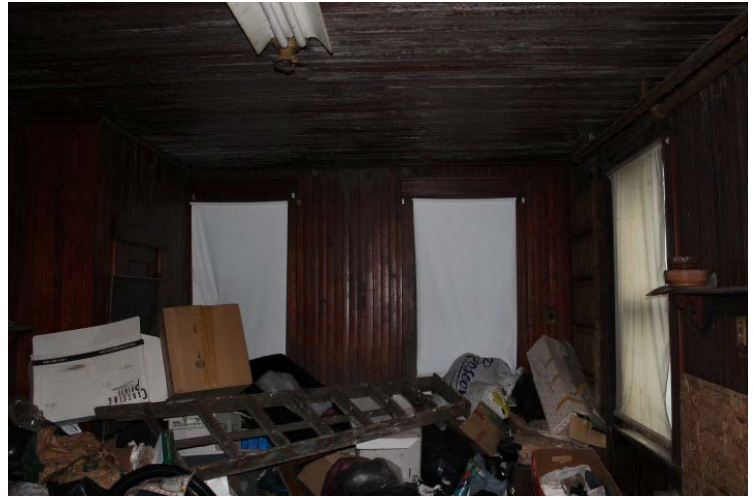
## First Floor – See photos 09-10.

- Wall finishes are typically intact. There is some damage to finishes that may be caused by humidity and moisture in the building.

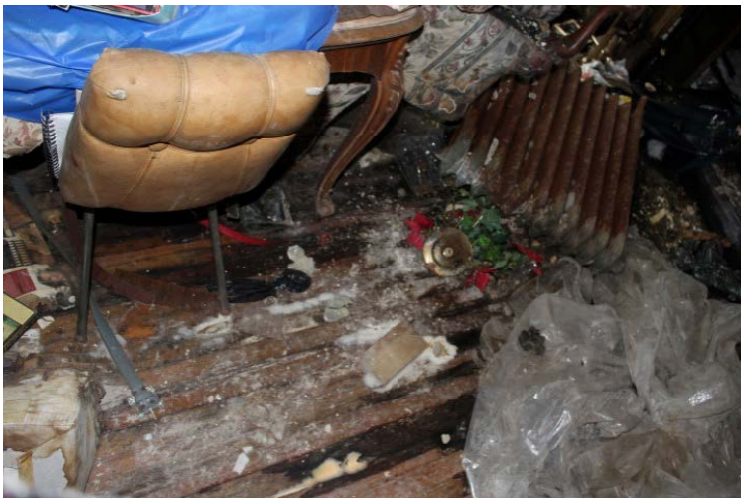
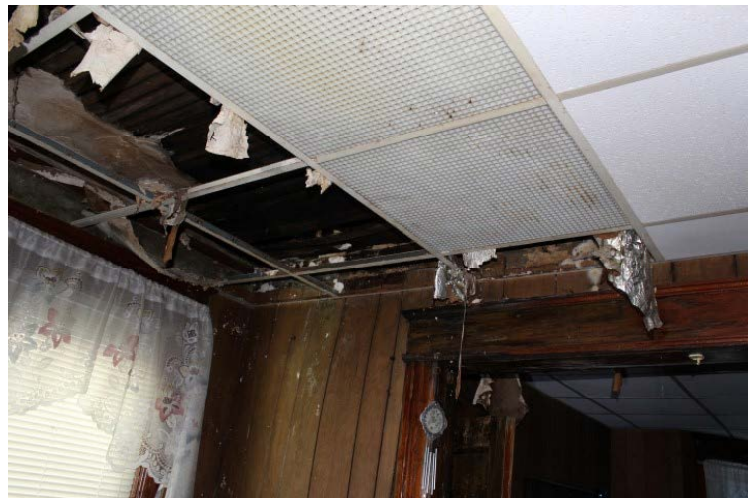
## Second Floor – See photos 11-12.

- Wall finishes are typically intact. There is damage to the flooring in the dining room near the middle of the building below the roof leak above. See photo 11-12

## Roof/Attic – See photos 11-12.

- Framing is covered by finishes. There may be some water damage in the vicinity of the roof leak in the dining room in the middle of the house.
