C.T. MALE ASSOCIATES

July 18, 2019

Re: *Visual Structural Evaluation*
319 Sherman St.
Albany, NY 12206
C.T. Male Associates Project No. 15.5188

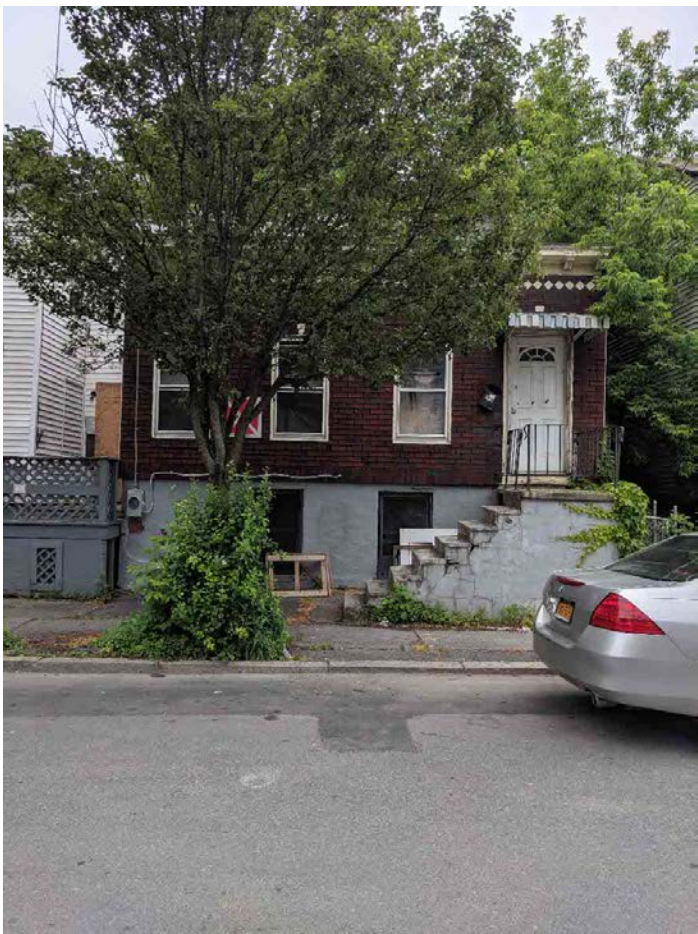
319 Sherman St 01

- Exterior walls generally appear plumb. See photos 01-05.
- Exterior wood framing is likely deteriorated at the front of the building due to roof leaks and broken front windows. See photo 04 and 06.
- The front steps are missing handrails and are leaning towards the street. See photo 01.
- The rear of the property was not accessible at the time of the site visit. There is significant vegetative growth at the side and rear of the property. See photos 01 and 05.

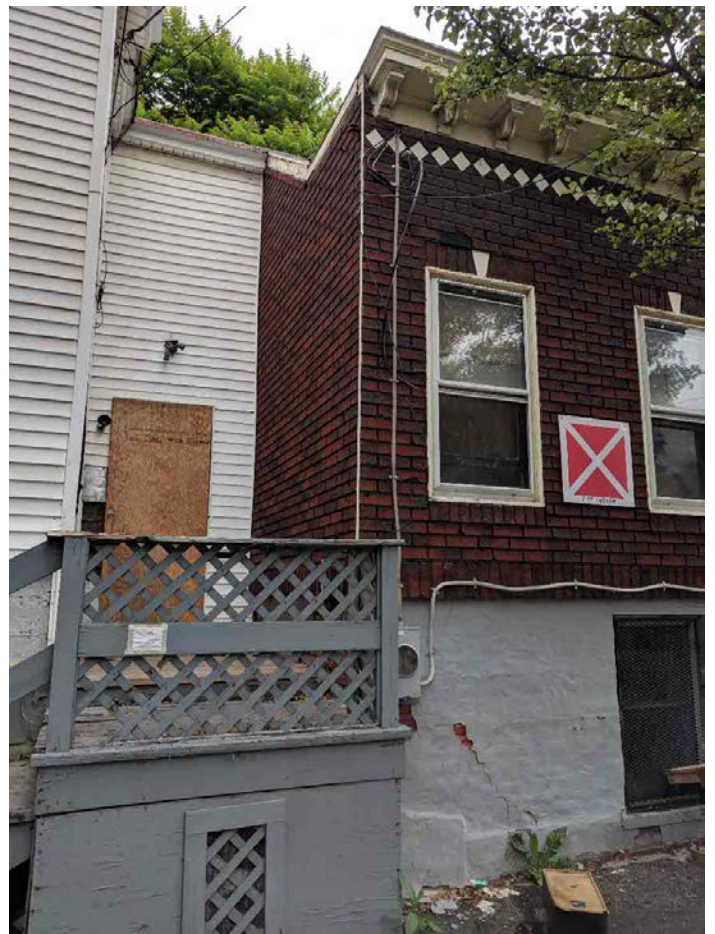
319 Sherman St 02

- The roof has a leak near the front of the building. Framing has some deterioration around the leak. See photo 06, 14-15 and photo 02 showing the trough at the front of the building.
- The middle and rear of the building appear intact and do not have obvious roof leaks.

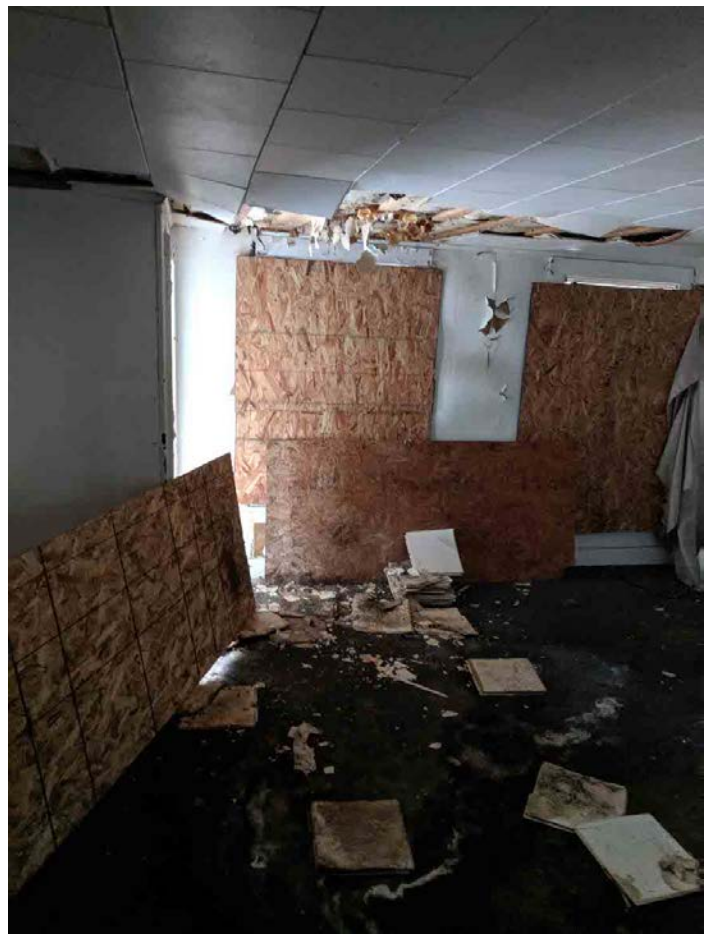
319 Sherman St 06

- Flooring and framing are deteriorated due to roof leaks near the front of the building. See photo 06.
- Other portions of the first floor are generally intact. See photos 07-08.
