C.T. MALE ASSOCIATES

November 1, 2019

Re: *Visual Structural Evaluation*
111 Third Ave.
Albany, NY 12202
C.T. Male Associates Project No. 15.5188

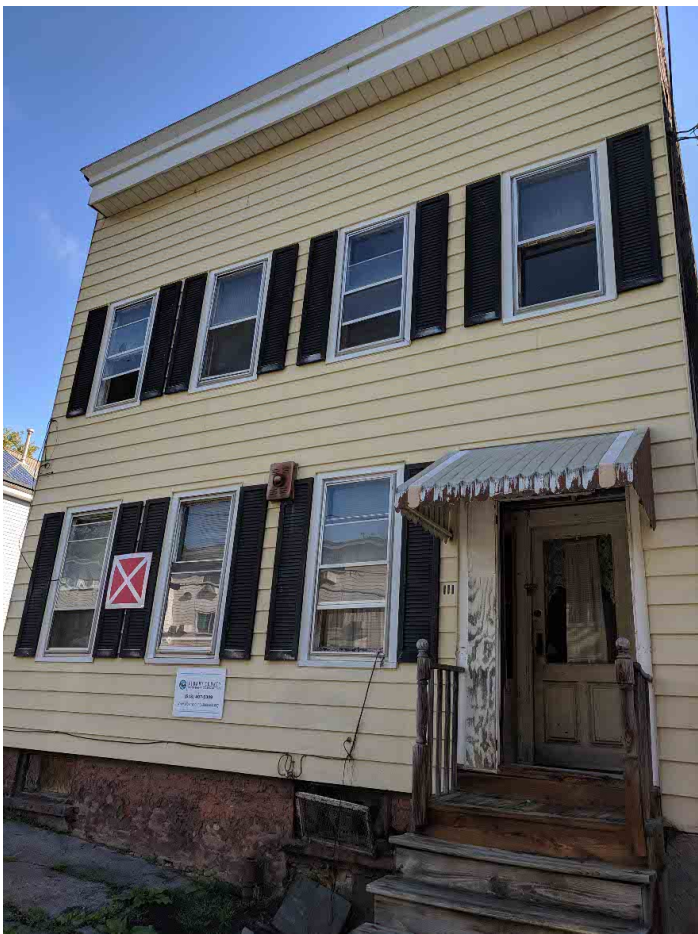
111 Third Ave 01

- Exterior walls of the building appear generally plumb and intact. See photos 01-03.
- Masonry foundation walls have some deterioration.

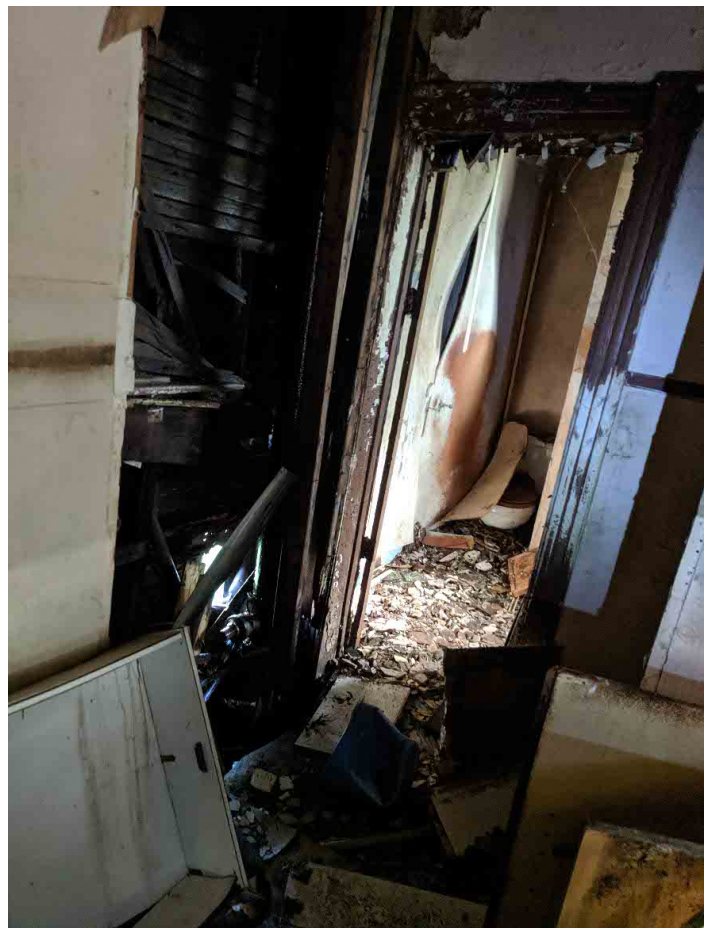
111 Third Ave 04

- Floor sheathing and framing are locally deteriorated in several areas around the house. See photos 04 and 12.
- Deterioration is significant near the roof drain location. See photo 04.

- The roof is significantly leaking near the roof drain in addition to smaller leaks elsewhere causing deteriorated framing.

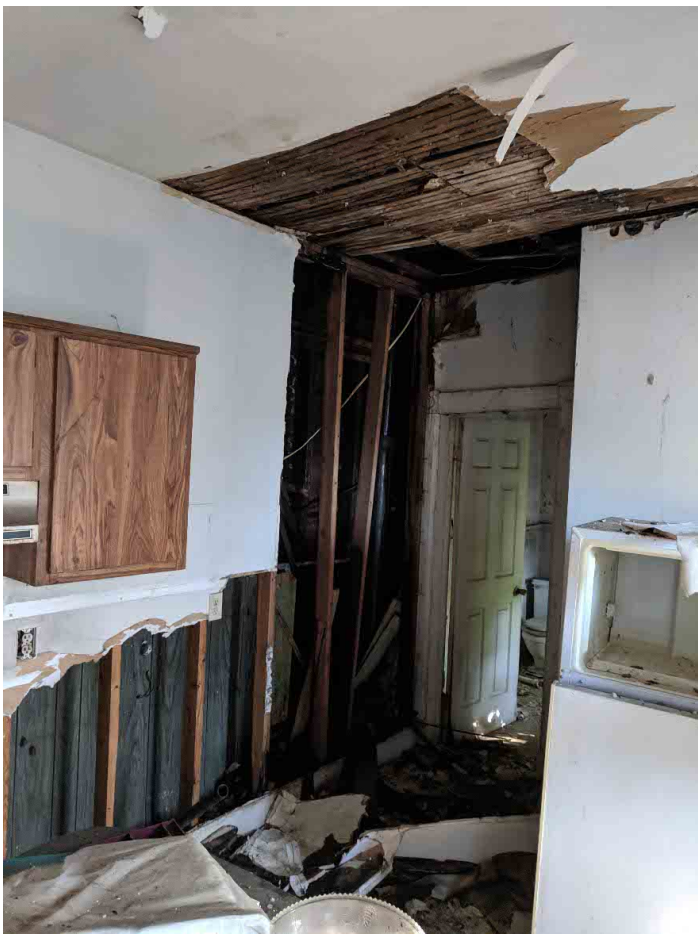
111 Third Ave 05

- The second floor is locally deteriorated in several areas around the house. See photos 05-08.
- Deterioration is significant near the roof drain location. A non-structural wall appears to have been built in front of the older deteriorated exterior bearing wall. See photos 05-08.

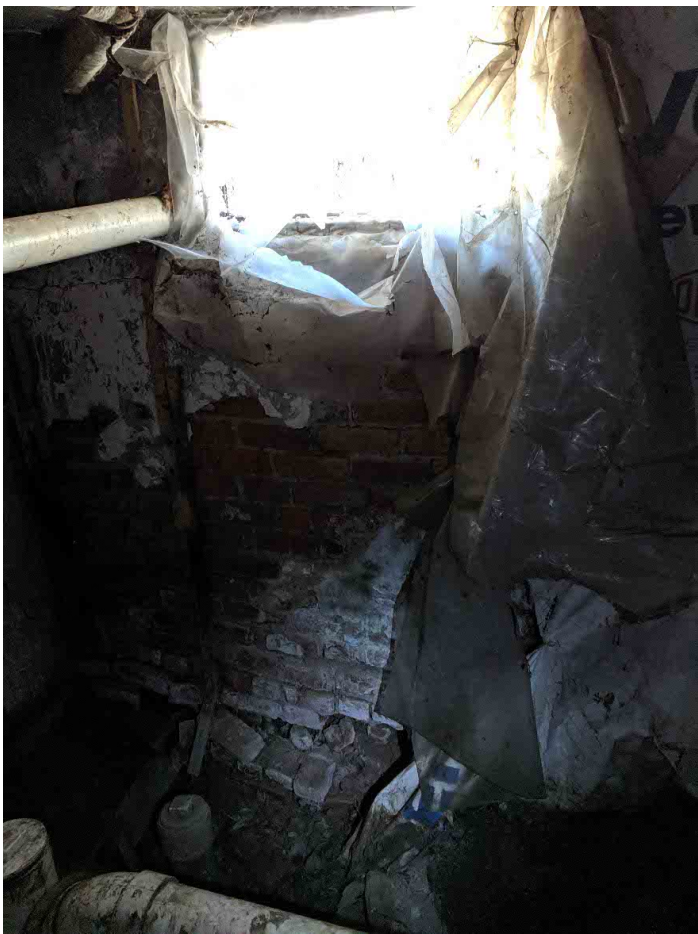
111 Third Ave 09

- Basement walls are typically brick. See photos 09-11. Some locations have deteriorated mortar and missing bricks.
- One of the interior brick piers is missing bricks. See photo 10.
