C.T. MALE ASSOCIATES

April 8, 2020

Re: *Visual Structural Evaluation*
298 Colonie Street
Albany, NY 12206
C.T. Male Associates Project No. 15.5188

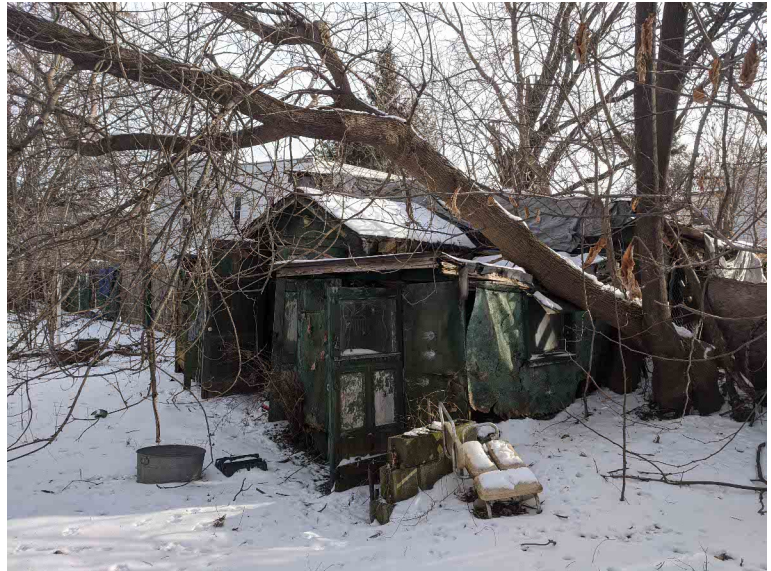
298 Colonie St 04

Dark Green Shed Building – See photo 04

- The structure is a wood framed shed structure that appears to have been built in several stages.
- Most wall and roof framing and sheathing is deteriorated.
- Walls are not plumb and there is significant rot/settling at sill plates.

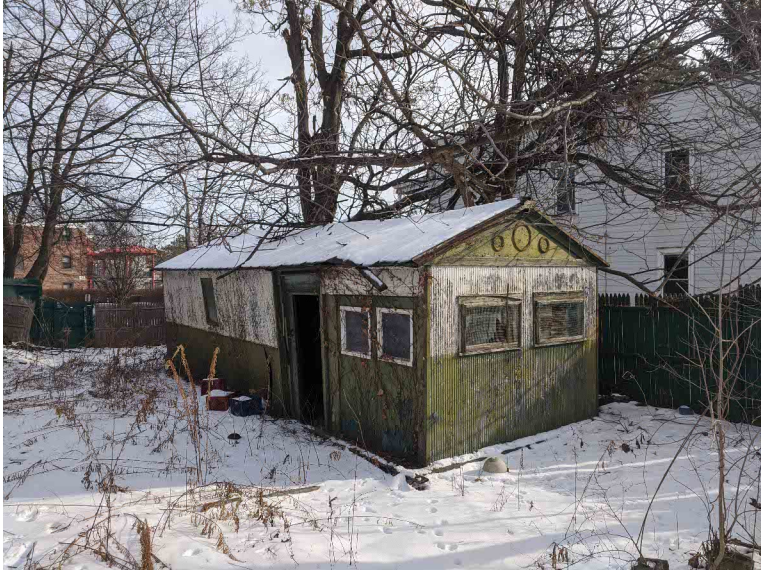
298 Colonie St 05

Light Green Shed Building – See photo 05

- The building utilizes corrugated metal siding and roof trusses and may have been constructed from a kit.
- Walls are not plumb and some interior truss members are bent.
- There is rot and settlement at some sill plate locations.

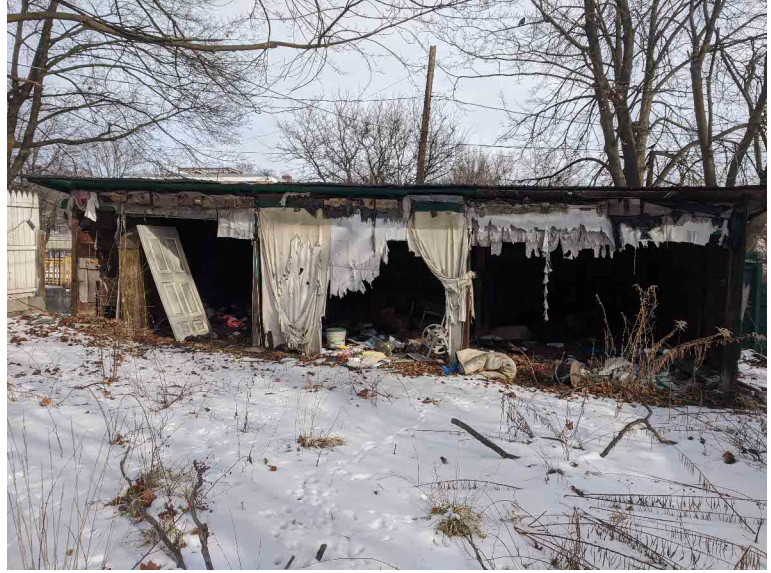
298 Colonie St 06

Rear Shed Roof Structure – See photo 06.

- The building is a wood framed, 1-story shed roofed structure open at the south side and is located at the Colonie St. side of the property.
- Roof sheathing and framing is deteriorated in many locations.
- There is rot at sill plates and at the bases of columns.

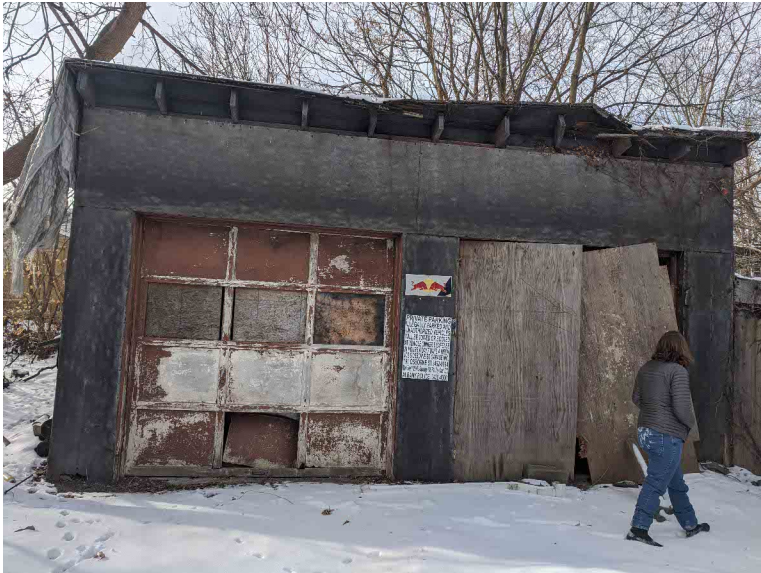
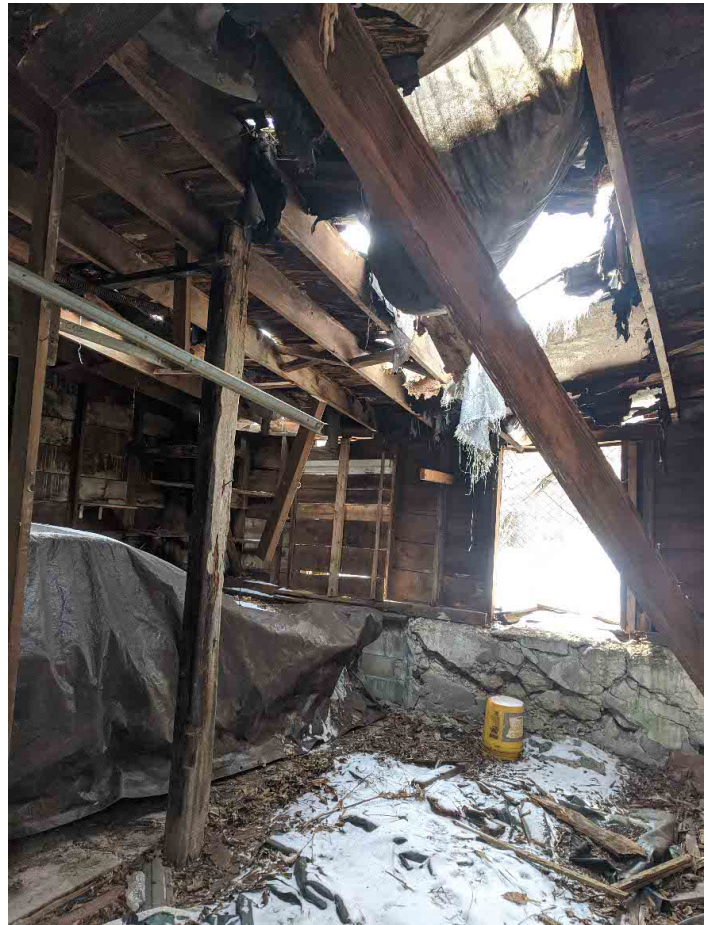
Garage – See photos 07-08.

- The structure is a wood framed 2-bay single story garage.
- A portion of the roof has collapsed, much of the roof sheathing is significantly deteriorated.
- Walls have some deterioration and more significant deterioration near sill plates.
- The concrete knee wall at the back of the structure is significantly deteriorated.
