C.T. MALE ASSOCIATES

Re: *Visual Structural Evaluation*
52 Emmet Street
Albany, NY 12204
C.T. Male Associates Project No. 15.5188

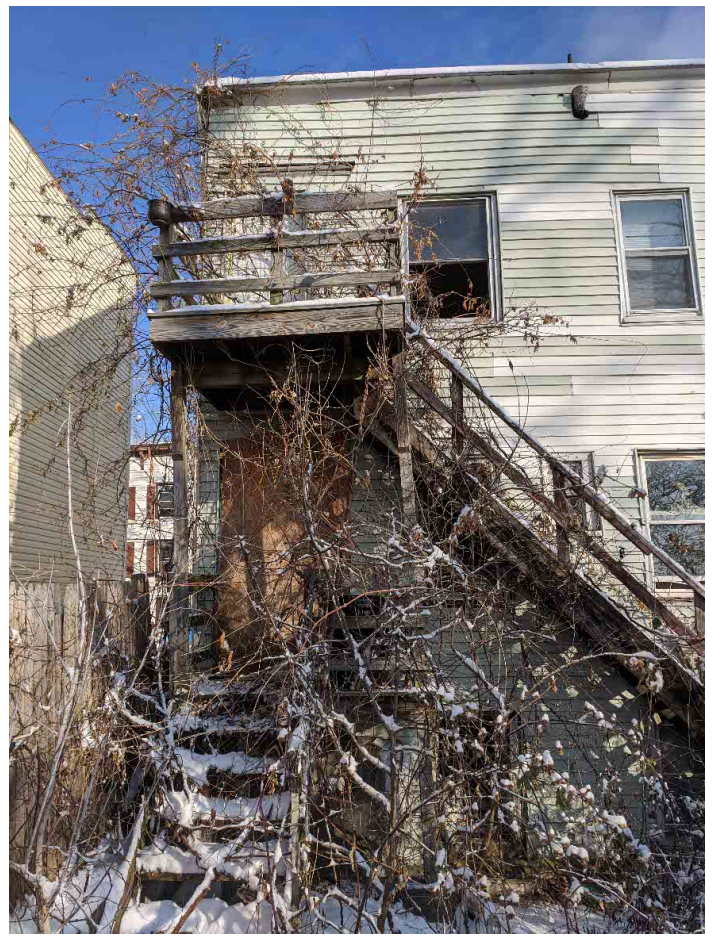
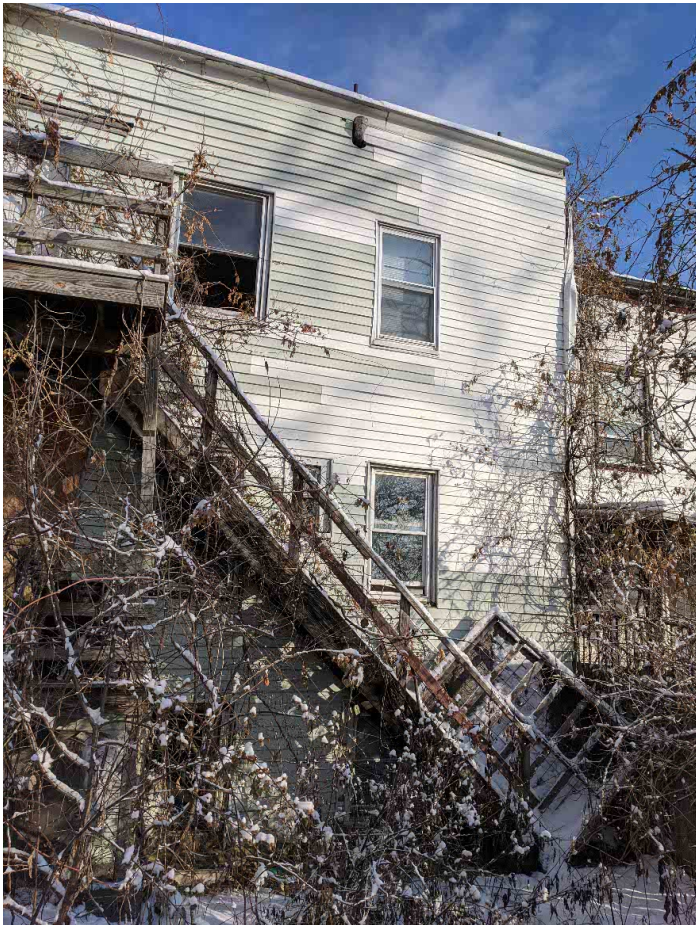
- The rear exterior stairs are deteriorated. See photos 02-03.
- Exterior walls are generally plumb.

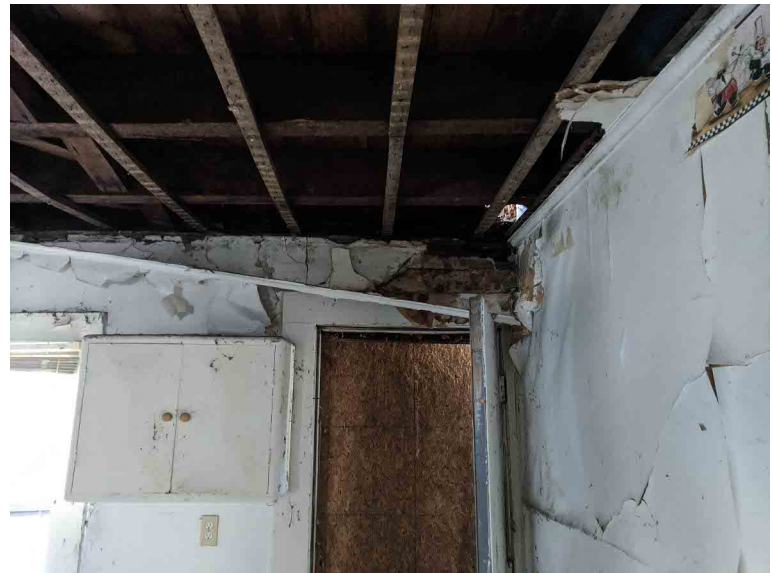
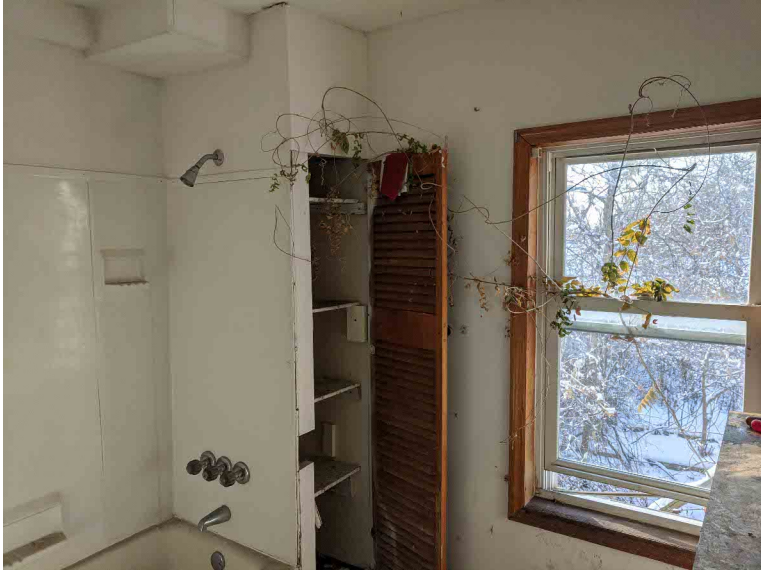
- There are isolated locations of framing deterioration, mostly located near the back wall. See photos 04-05.

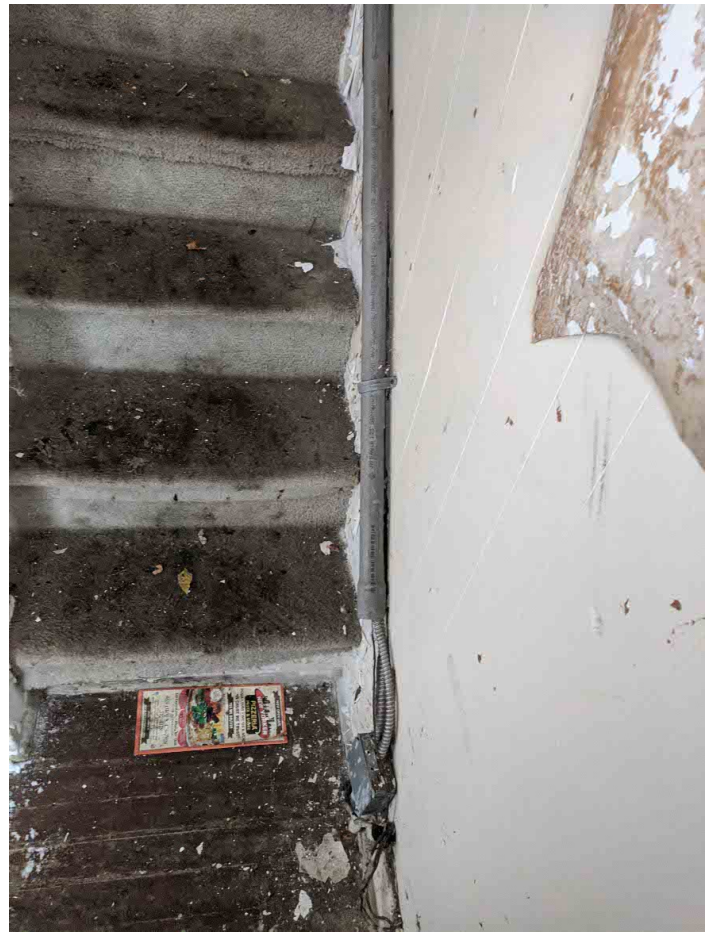
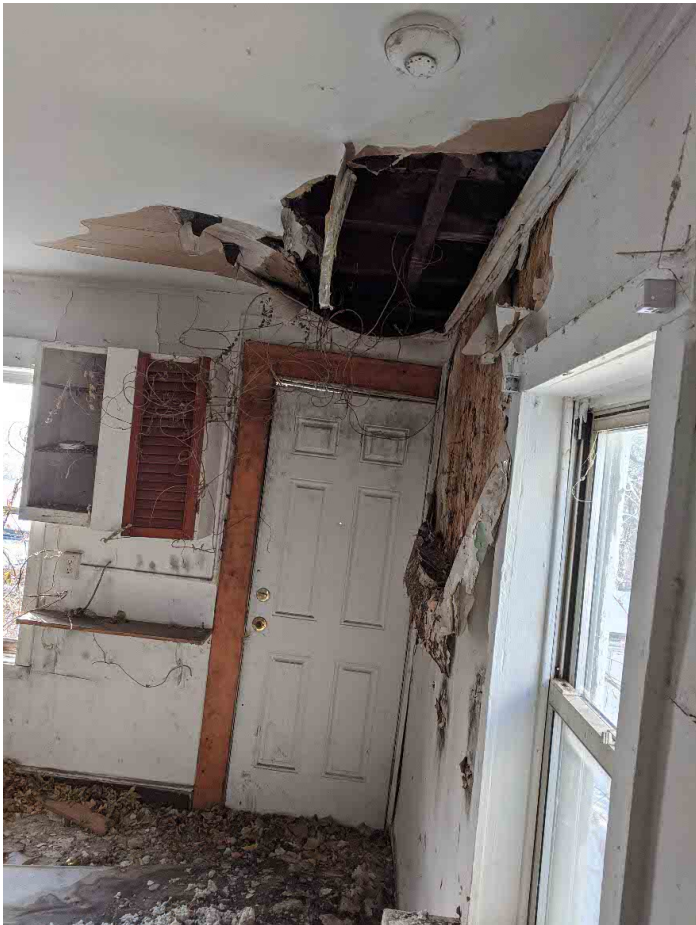
- There are isolated locations of framing deterioration, mostly located near the back wall. .
See photos 06-07.

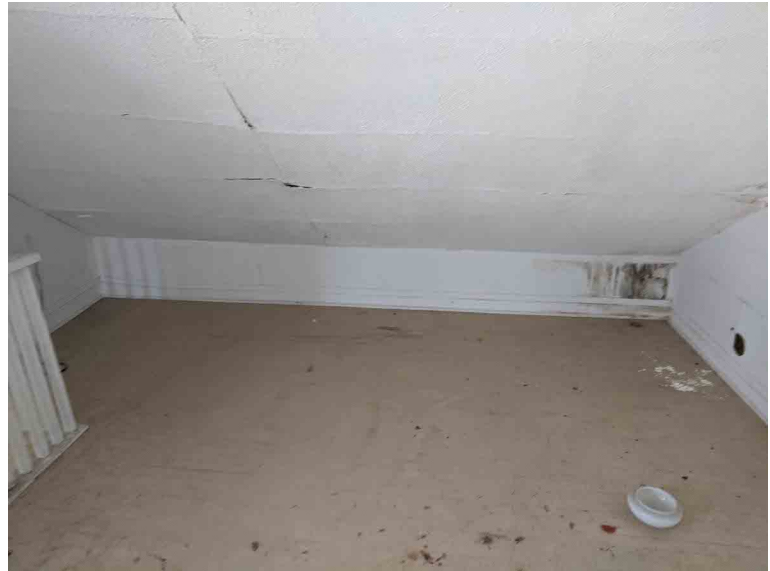
52 Emmet St 08

- There is a large hole in the southwest corner of the building. See photo 09.
- The north (front) eave end of the building shows evidence of water leaks in the wall finishes.
See photo 08 and 10.
- The roof is leaking around the chimney in the middle of the building. See photo 10.

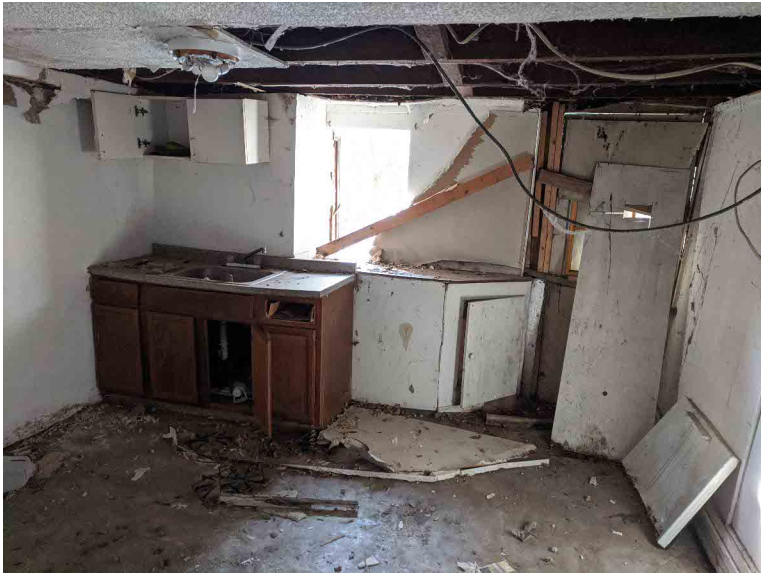
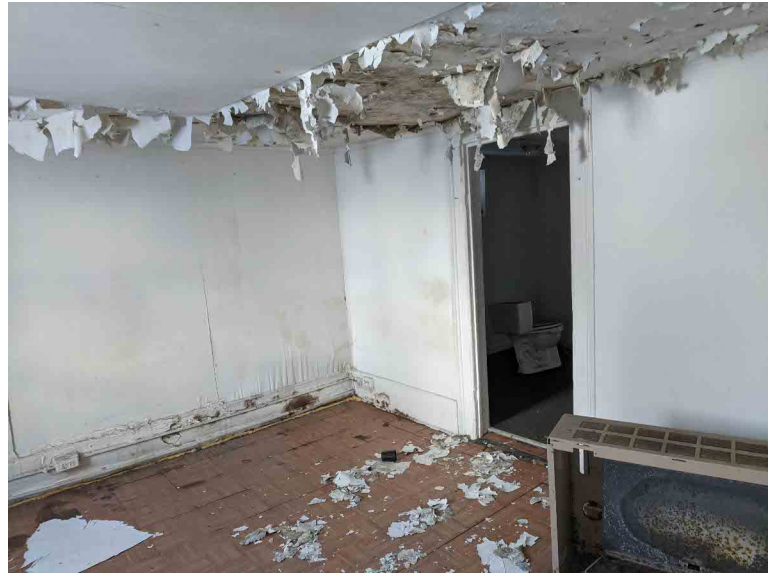
- The basement is finished. Portions of the ceiling are removed. There are isolated locations of deterioration, especially near the back wall. See photos 11-12
- Sub-basement and wall framing were not accessible/visible due to finishes. Given the building's differential settlement, it is likely that either building foundations are settling or wall framing is deteriorated at the foundation/ground.
