# C.T. MALE ASSOCIATES

April 8, 2020

Re: *Visual Structural Evaluation*  
*354 Second Street*  
*Albany, NY 12202*  
*C.T. Male Associates Project No. 15.5188*

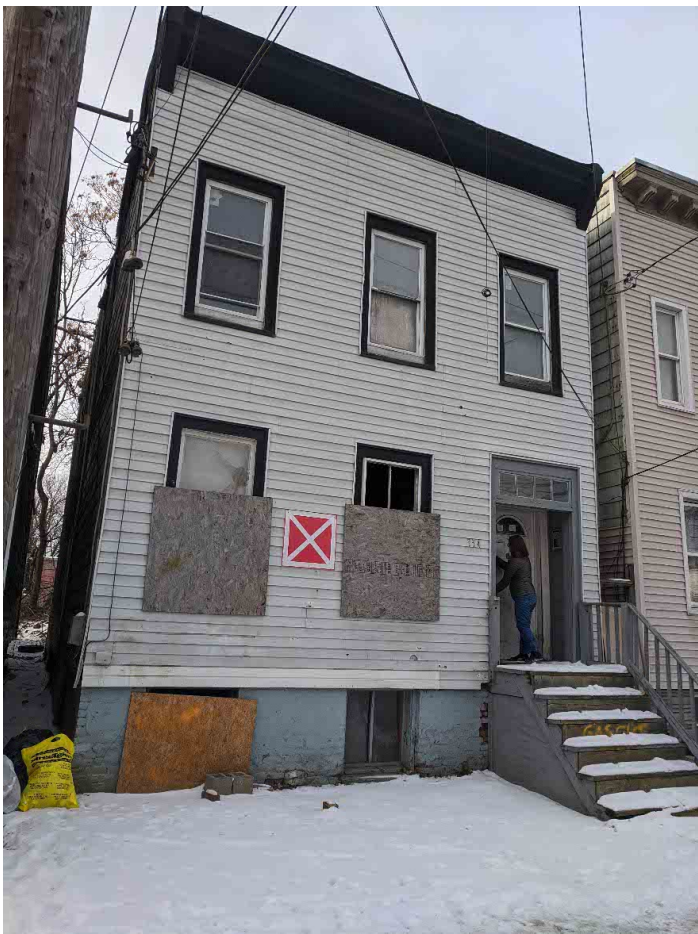
354 Second St 01

- The front stair is missing a handrail and stair framing is deteriorated. See photo 01.
- Exterior walls are generally plumb.
- Wood siding is deteriorated at exposed locations. See photos 02-03.

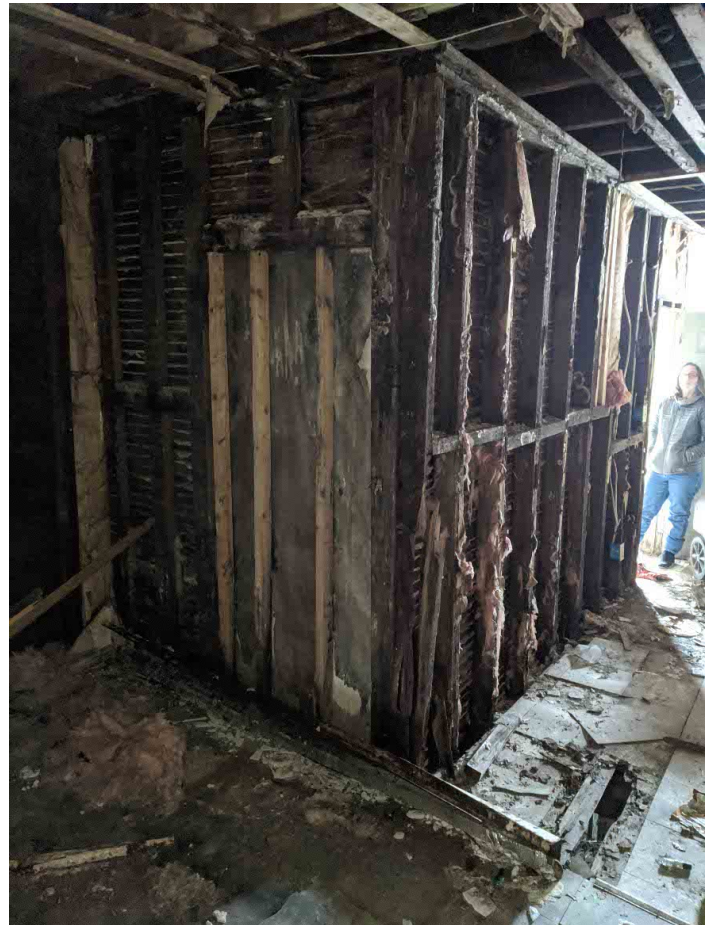
354 Second St 04

- Floor sheathing is deteriorated in many locations and there are several holes to the basement. See photos 04-05.
- The interior bearing wall near the front of the house and surrounding floor framing are deteriorated. See photo 04-05.

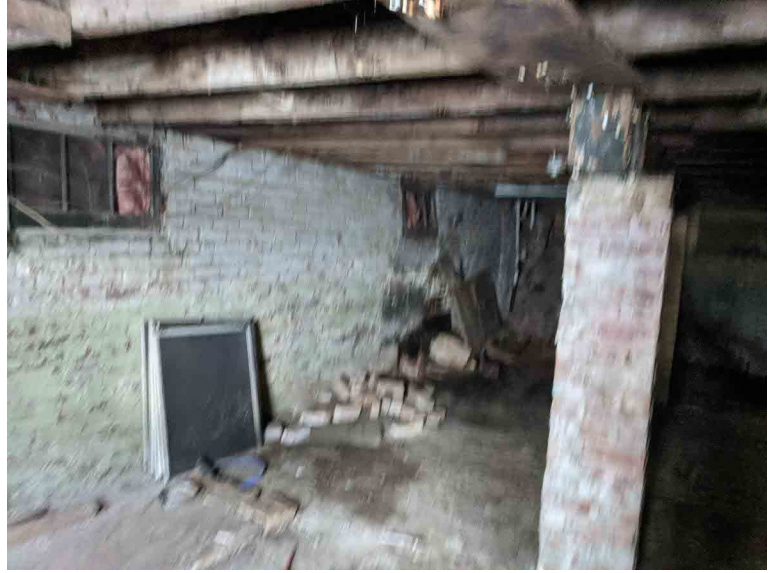
354 Second St 06

- Basement walls are typically brick or concrete block. See photos 06-10.
- Brick mortar is deteriorated, and walls have localized damage.

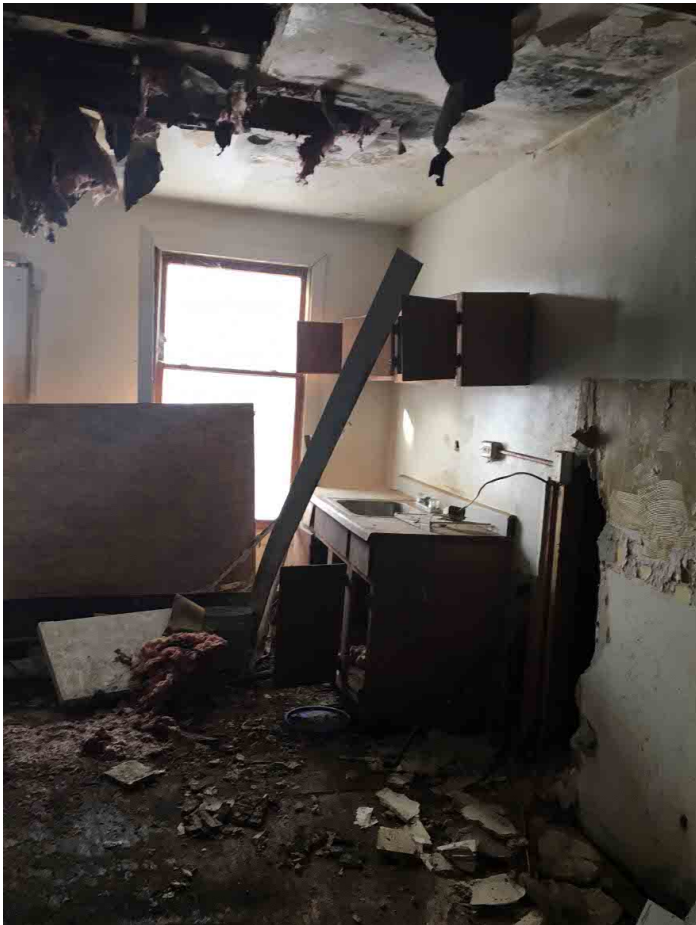
354 Second St 11

- Floor sheathing and framing are deteriorated near the rear of the building. See photo 11.

- There are significant roof leaks and framing/sheathing deterioration throughout the building. See photo 11.
