354 Second St, Albany, NY 12206

ALBANY COUNTY
LAND BANK CORPORATION

Interior Photos – 354 Second St

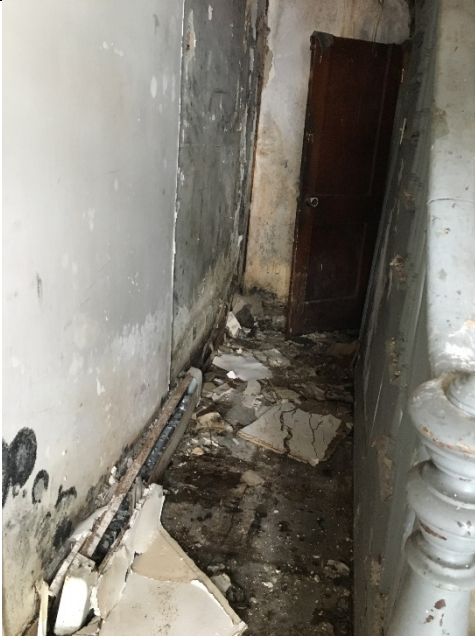
First floor entranceway

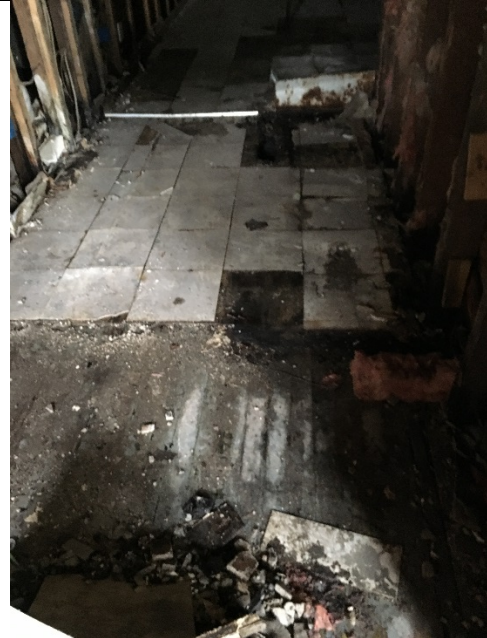
Deteriorating Floor near front entrance

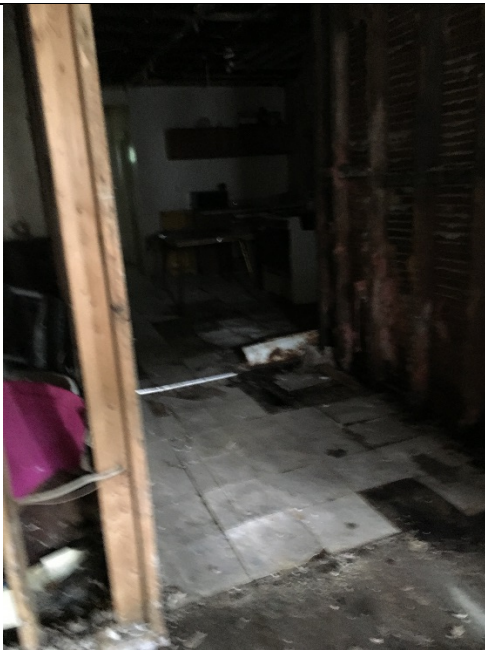
Gutted first floor to studs

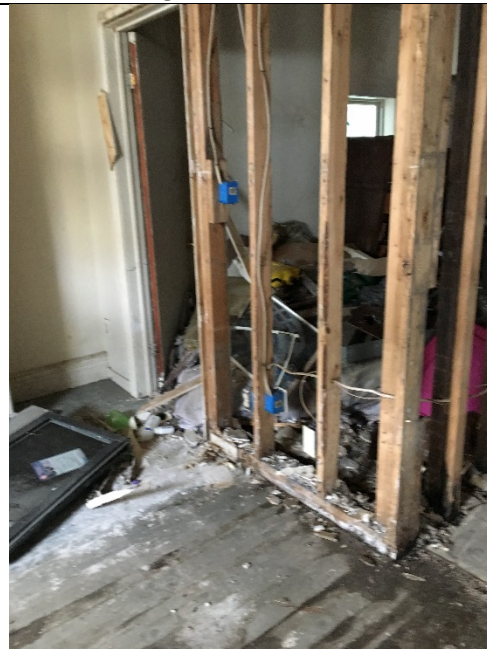
More walls down to studs

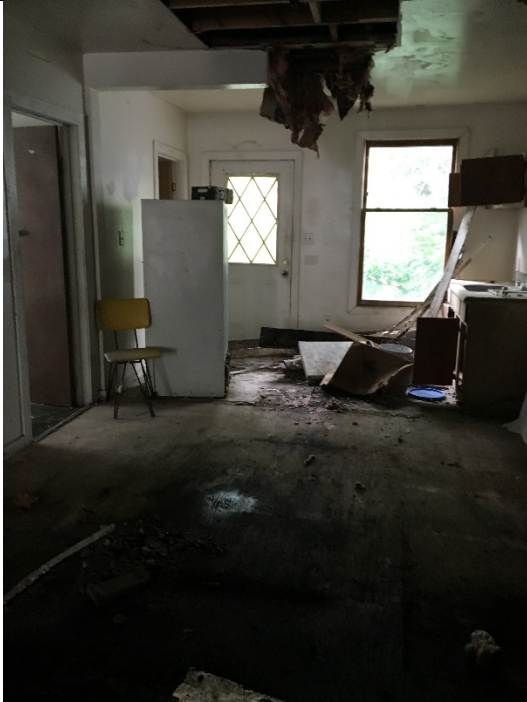
Kitchen, deteriorating ceiling

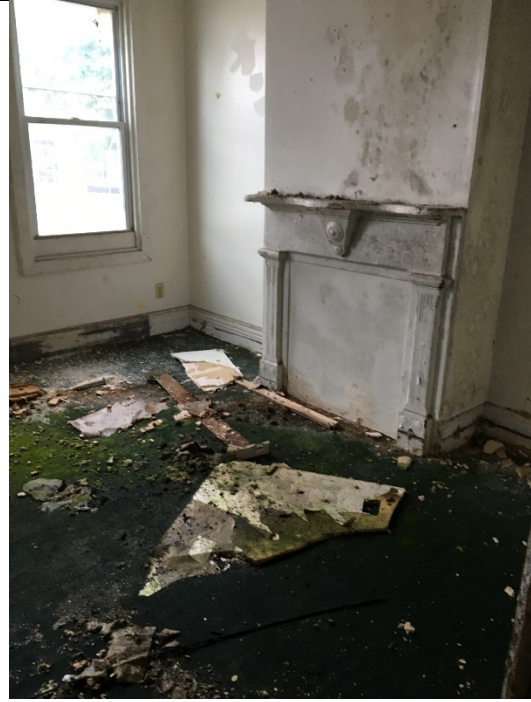
Mold & subfloor rotting in front room

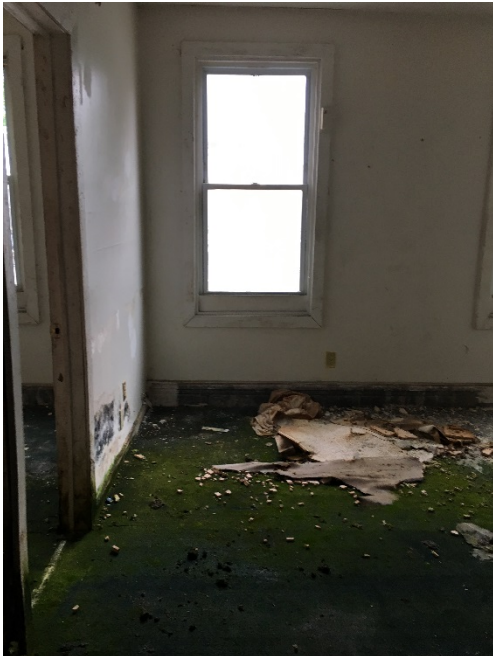
Spreading mold on doorframe, floors, and walls

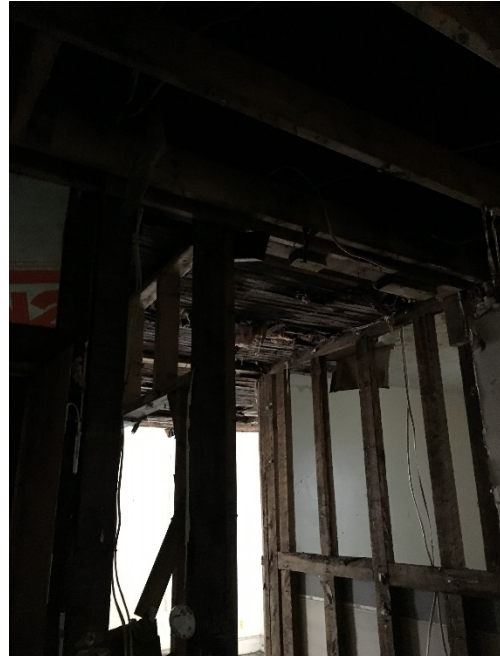
**Rotting studs and deteriorating ceiling
beamboard**
