February 3, 2020

Re: *Visual Structural Evaluation*
33 Alexander Street
Albany, NY 12202
C.T. Male Associates Project No. 15.5188

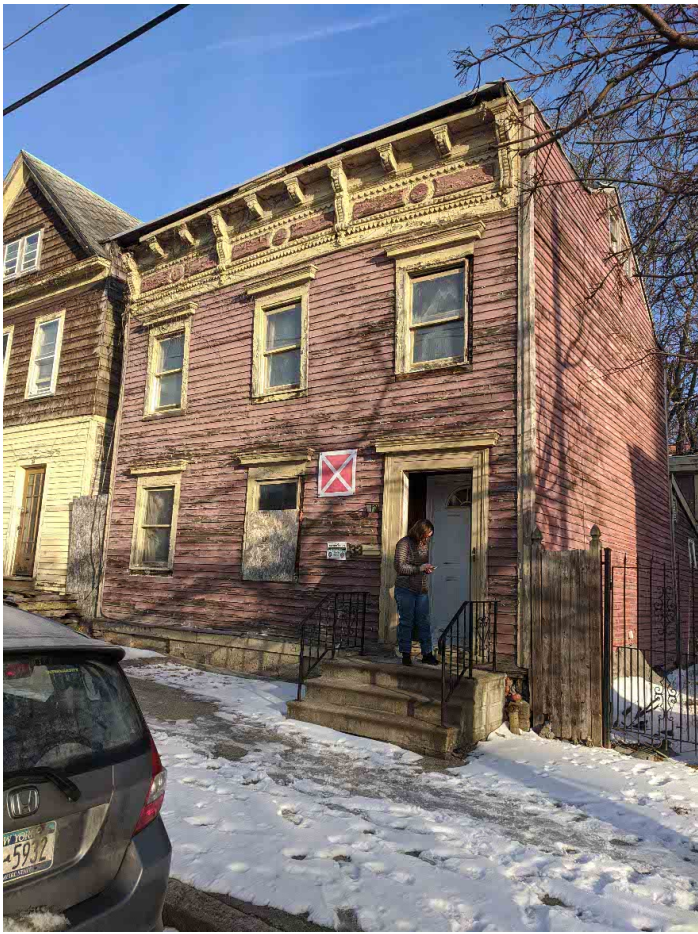
33 Alexander St 01

- The front wall is pulling away from the rest of the building at the second floor.
- The wood side porch framing has some deterioration. See photo 02.
- Wood siding is deteriorated at many locations. See photos 01-04.

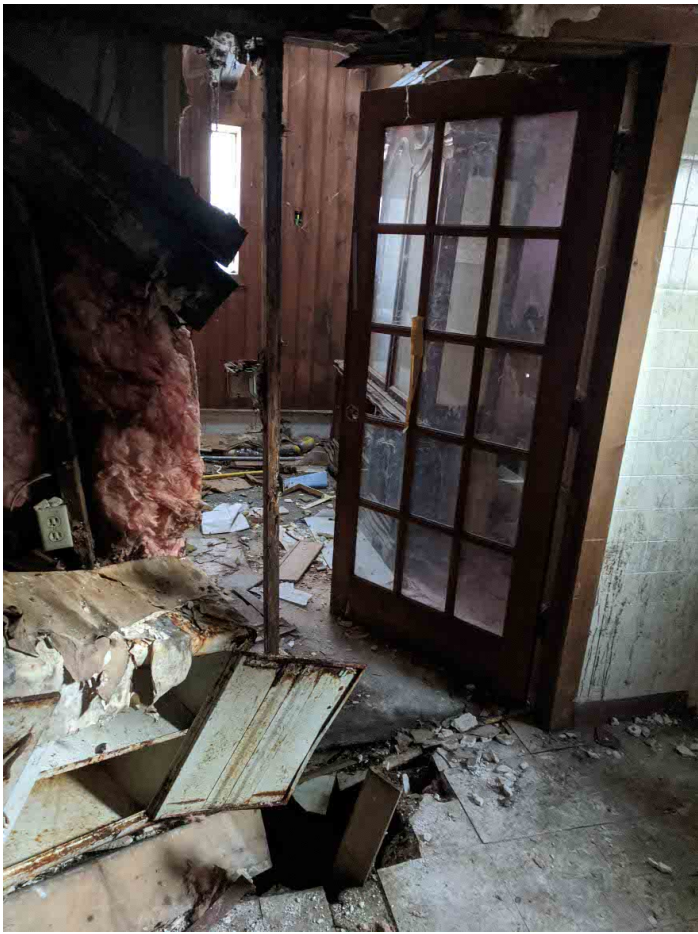
33 Alexander St 05

- Floor sheathing is deteriorated in many locations; there are several holes to the basement. See photos 05-07.
- Floor framing as well as sheathing is starting to collapse where the two additions meet at the back of the house. See photo 06-07.

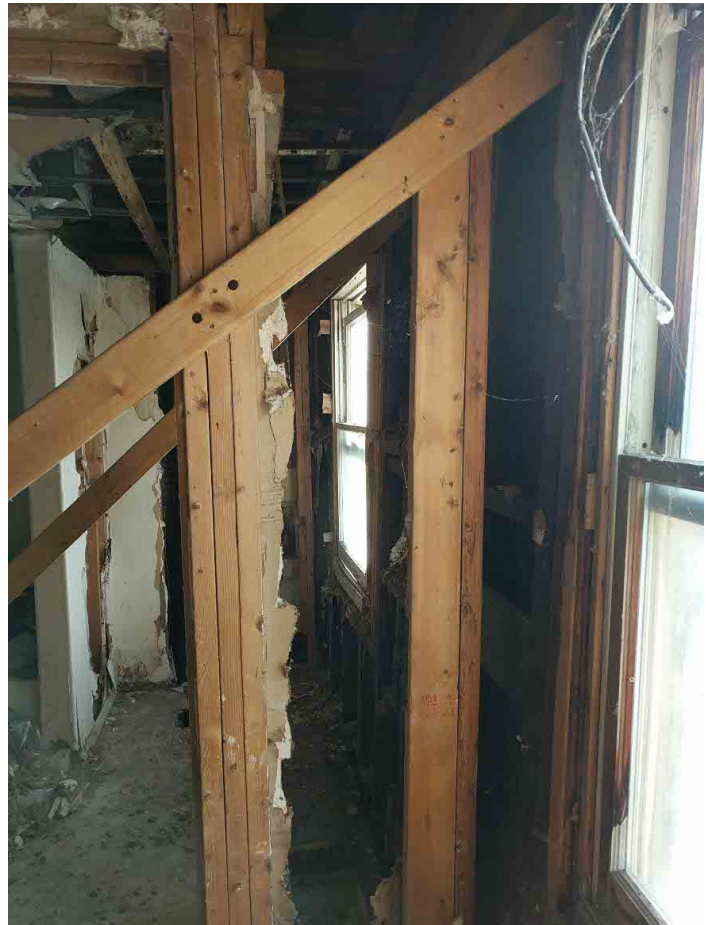
33 Alexander St 08

- The front façade of the building is pulling away from the rest of the building. This is being temporarily restrained by wooden diagonal bracing. See photos 08-11.

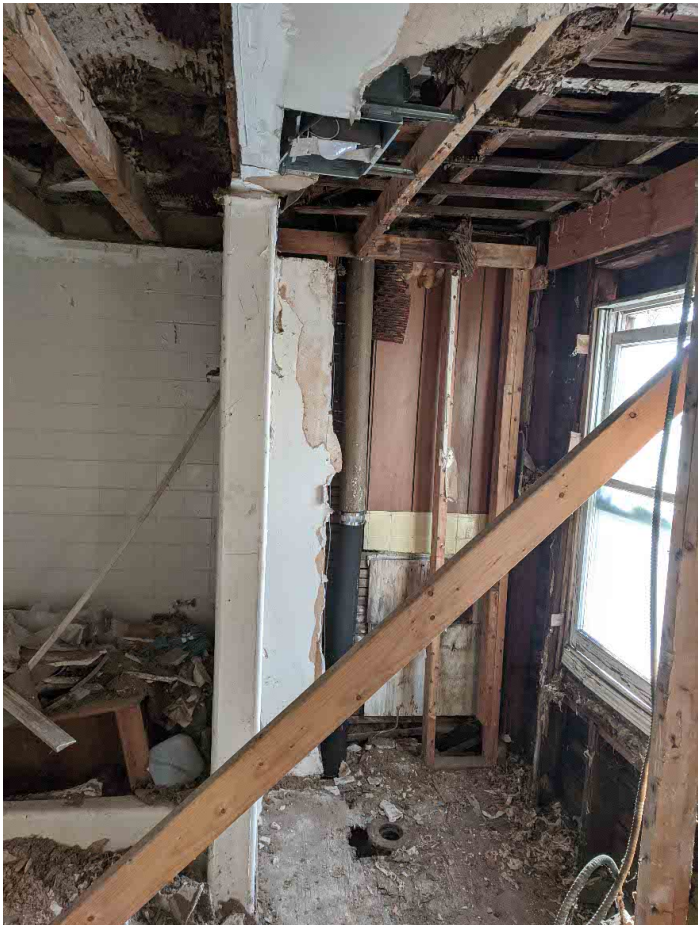
33 Alexander St 11

- Floor sheathing is deteriorated in some locations and one hole is visible. See photo 11.

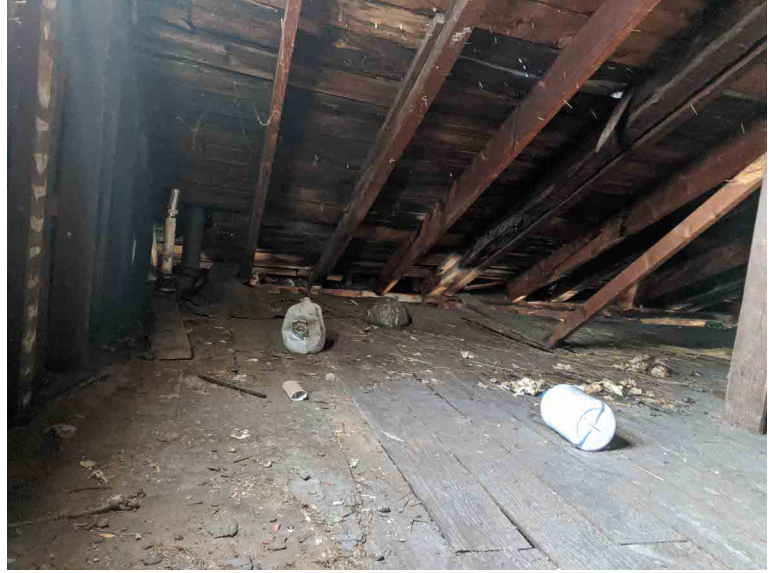
33 Alexander St 14

- The roof pitches to a Philadelphia drain at the front of the building. There are significant roof leaks at this area and sheathing and framing deterioration at this area, which is related to the front wall separation at the second floor. See photos 14-17.
- There are significant roof leaks and framing/sheathing deterioration below the skylight. See photo 18.
- There is a significant roof leak and framing deterioration at the valley where the back two additions meet. See photo 19.

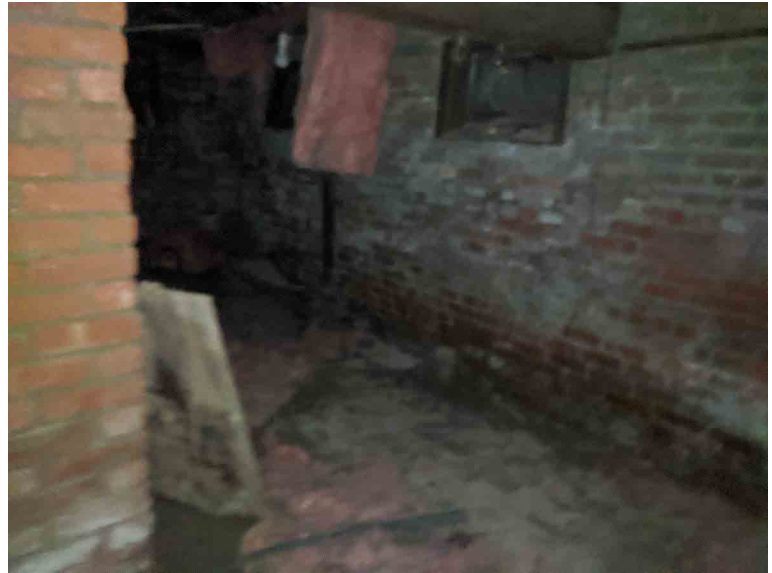
33 Alexander St 20

- Basement walls are typically brick or concrete block. See photos 20-23.
- Brick walls are generally intact.
