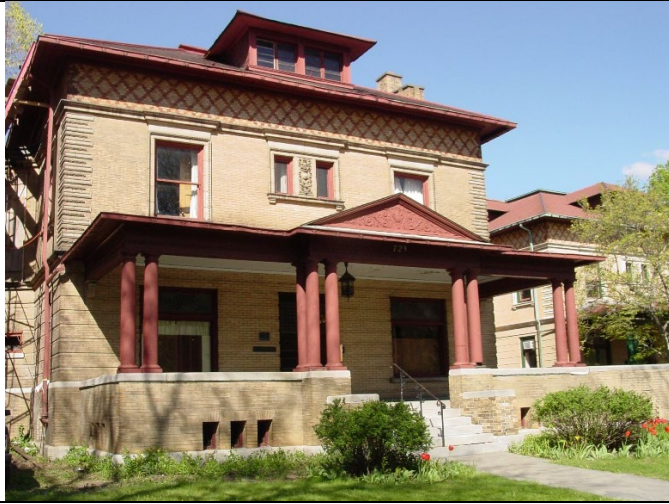
1. South Elevation. Stairs and area to east require full rebuilding, to foundation.

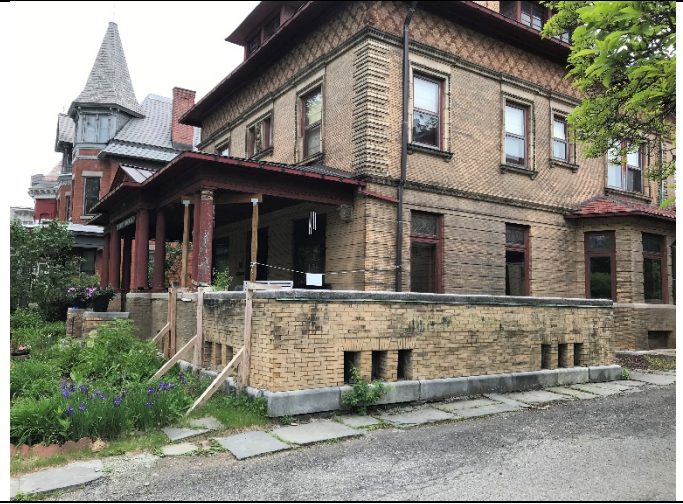
2. Southeast corner and East Elevation. Requires full rebuilding. New ramp to be located within porch walls, requiring no extension to the east, but expansion at north end.

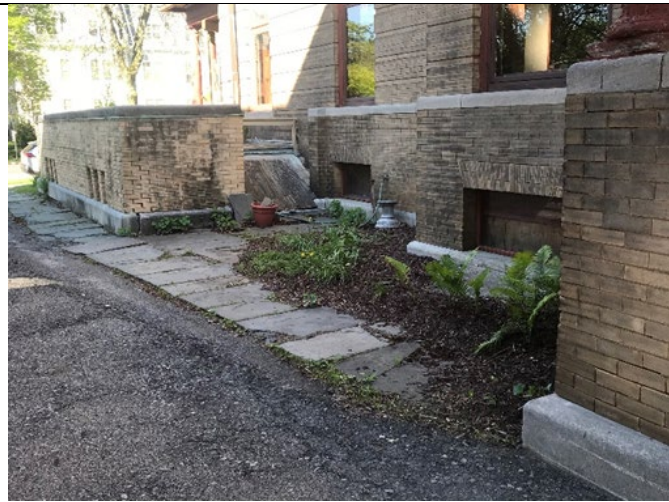
3. East Elevation. Porch to be extended 8'5" to north as required by ADA.

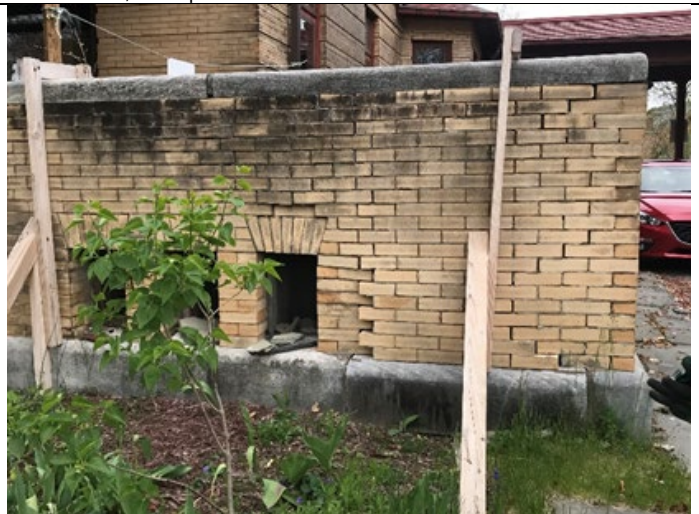
4. South wall, east end, where full rebuilding required.

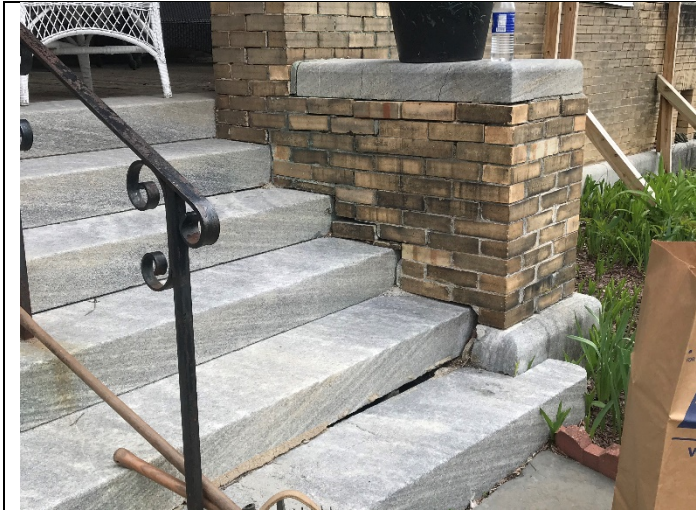
5. Center South Stair. Full rebuilding required; existing railing to be restored.

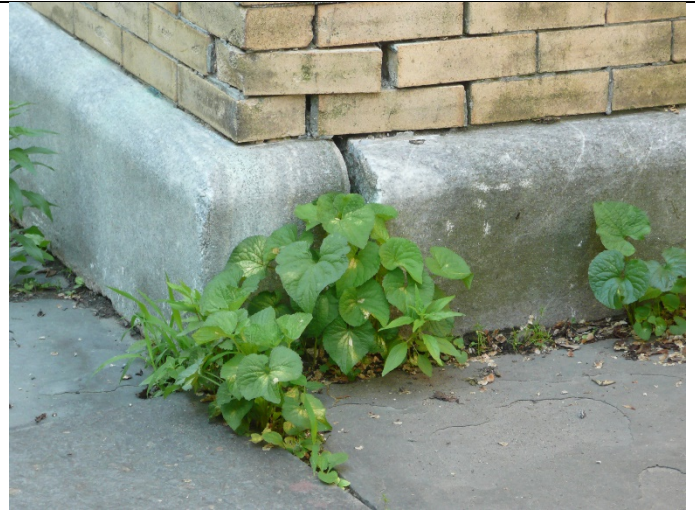
6. Foundation displacement, typical at eastern side of existing porch.

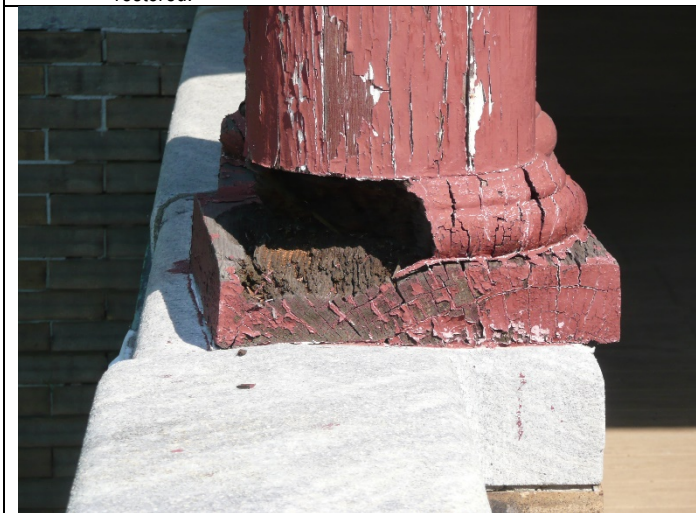
7. Wood columns requiring full restoration.

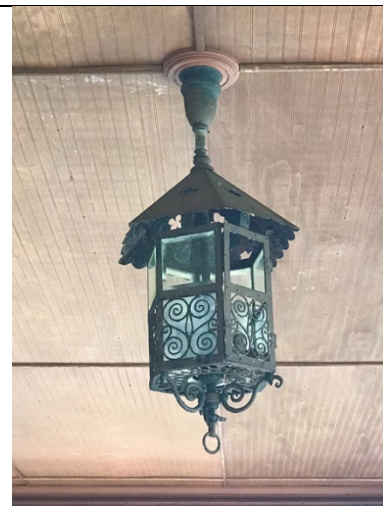
8. Existing pendant lighting to be restored.
