***RUSS REEVES, CEng., P.E.**
CIVIL-STRUCTURAL ENGINEERS

June 7th , 2021

Re: Structural Condition Assessment 507 First Street, Albany, New York

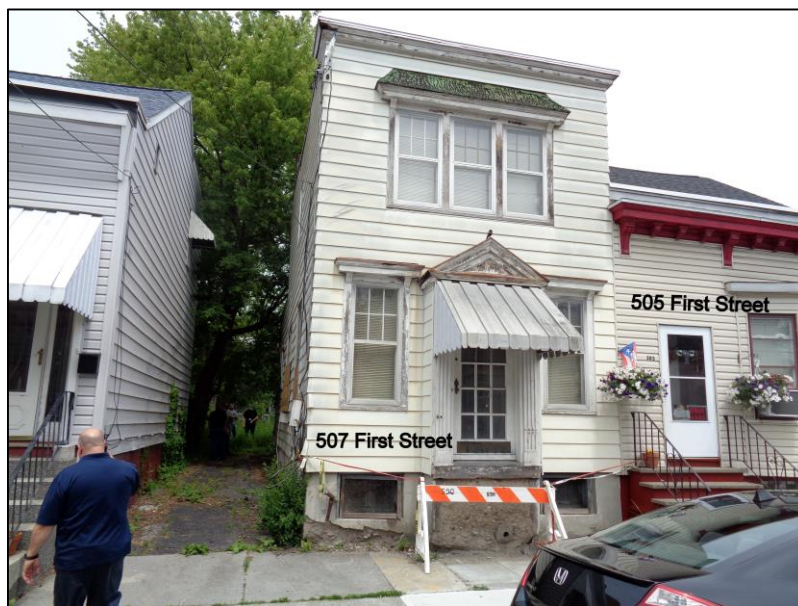
Photograph 1 shows the front Southerly elevation view of the structure situated at 507 First Street. The purpose of this engineering report is to discuss alternative measures for possible stabilization of the building and to determine actual material and labor costs that would be required for the structural stabilization and remediation measures for the renovation of the building.

The evaluation of this building was initiated by a series of ongoing complaints to the Mayor's Office and to the Department of Code Enforcement, which were began in 2019 by the adjoining neighbor to the East, Mr. Shaun Ford who is situated at 505 First Street (Mr. Ford's home is also depicted in photograph 1).

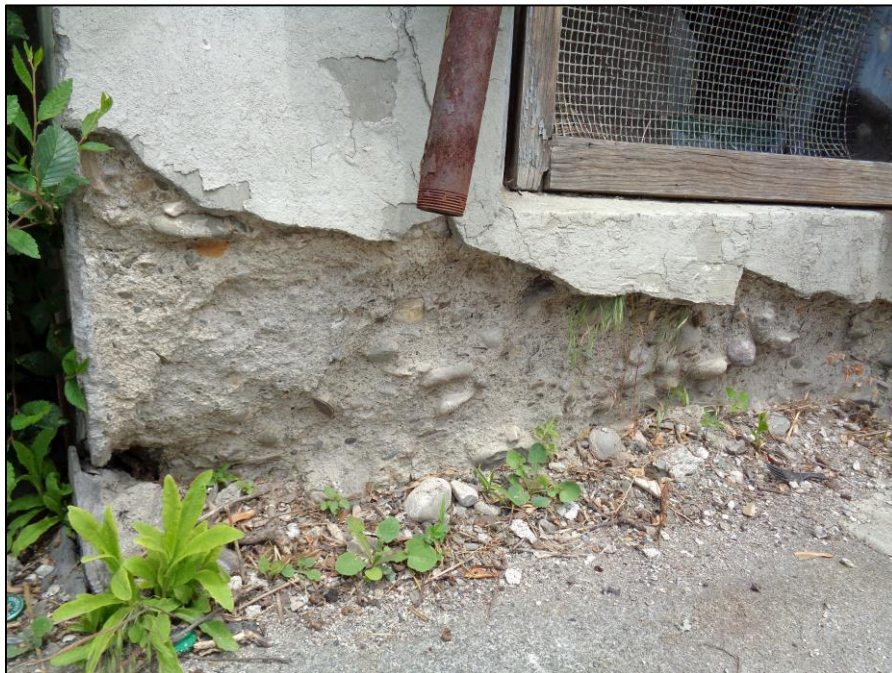
The existing structure which appears to have been constructed in the 1920's, consists of a perimeter concrete foundation wall with a mortar parging. The concrete is in varying states of deterioration specifically along the Westerly foundation wall. The concrete consists of native soils (silty clays with some round stone) that was excavated for the basement area and combined with Portland cement to form concrete. Because of the presence of silty clays and rounded stone in the mix, this represents a low grade form of concrete which at this this point has reached its life expectancy. Photograph 2 shows the substandard silty-clay Portland cement mixture.

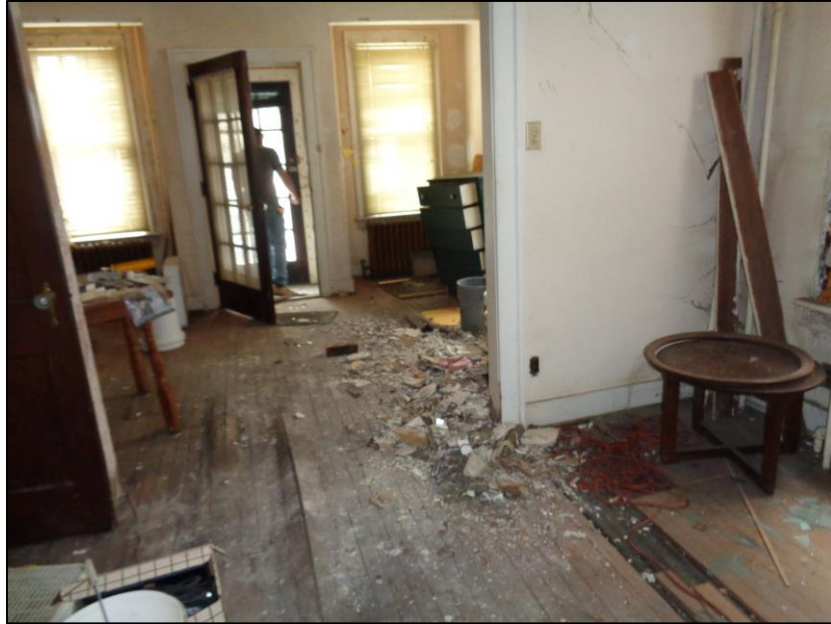
Photograph 3

Photographs 3 shows a typical view of the first floor area. Photograph 4 shows typically the extent of water damaged insulation and sheetrock on walls on the first and second floor levels to be replaced.

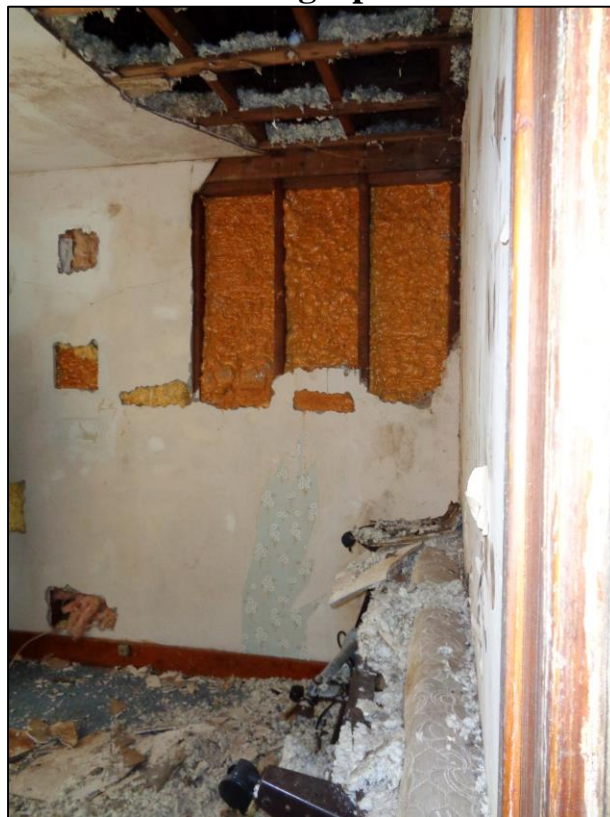
Photograph 4

Photographs 4, 5 and 6 show the typical condition of the second floor basement area.

- 5). Replace all damaged flooring with vinyl planking having a cork backing at the first and second floor levels: \$8,000.
- 6). Replace damaged and wet insulation in the second floor ceiling area with 12" of fiberglass bat insulation and 5/8" Type X fire rated sheetrock, and 6" of fiberglass bat insulation in the damaged wall sections along with 5/8" Type X fire rated sheetrock: \$8,000.

- 7). Replace damaged sheetrock areas and wet insulation in the first floor ceiling and wall areas on the first floor level along with the installation of 5/8" Type X fire rated sheetrock: \$6,000.

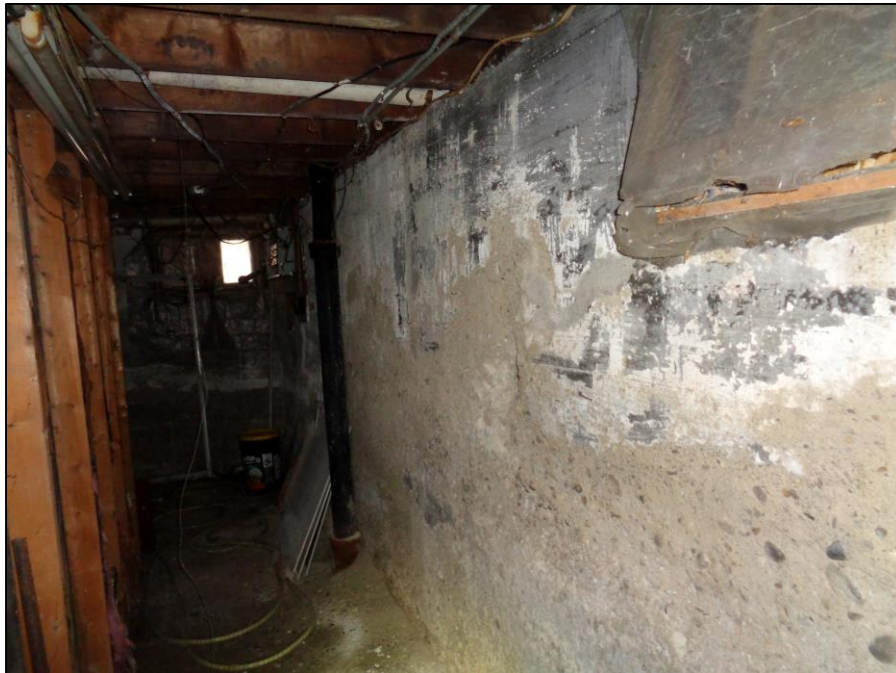
Photograph 7 shows a typical view of the Westerly foundation wall as seen in the basement area. It shall be noted that the Easterly, Southerly and Northerly foundation walls while consists of substandard concrete, are intact and can be restrained to resist horizontal earth pressures and rendered functional with the use of reinforced concrete block pilasters and footing configurations in conjunction with micro-lam beam sections used to support floor joists. This is more specifically shown in the enclosed engineering worksheets.

19). Provide 8" thick reinforced CMU block 64" in height (8 courses) and a 24" wide x 1' thick reinforced concrete strip footing along the Westerly foundation wall so as to restrain the entire 26' interior length of the foundation wall: \$4,200.

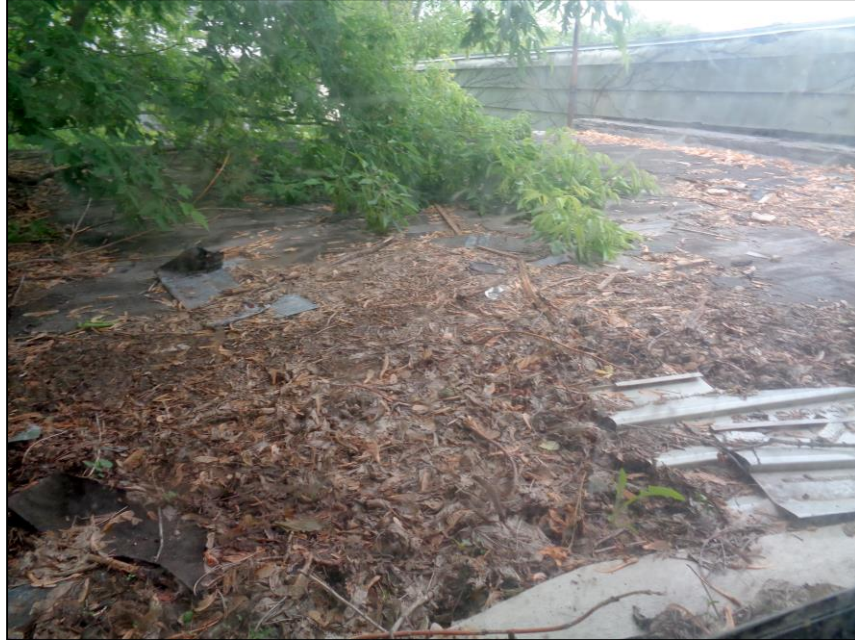
Photograph 8 (Lower rear roof section).
