700 Smith Boulevard Existing Conditions Photo Log

September 28, 2021

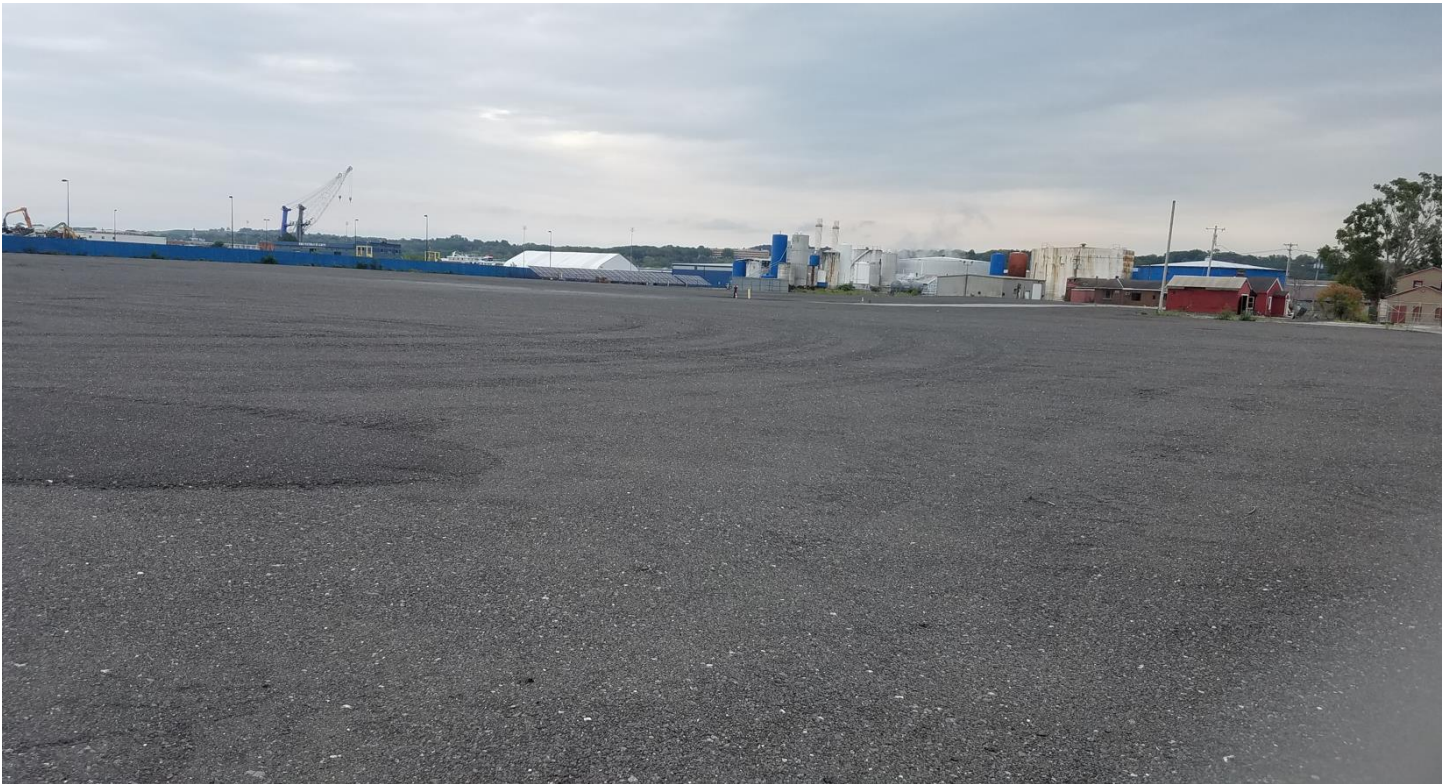
Photo #1 –Existing Site From SE Looking NE (Crushed Millings Remediation Cap)

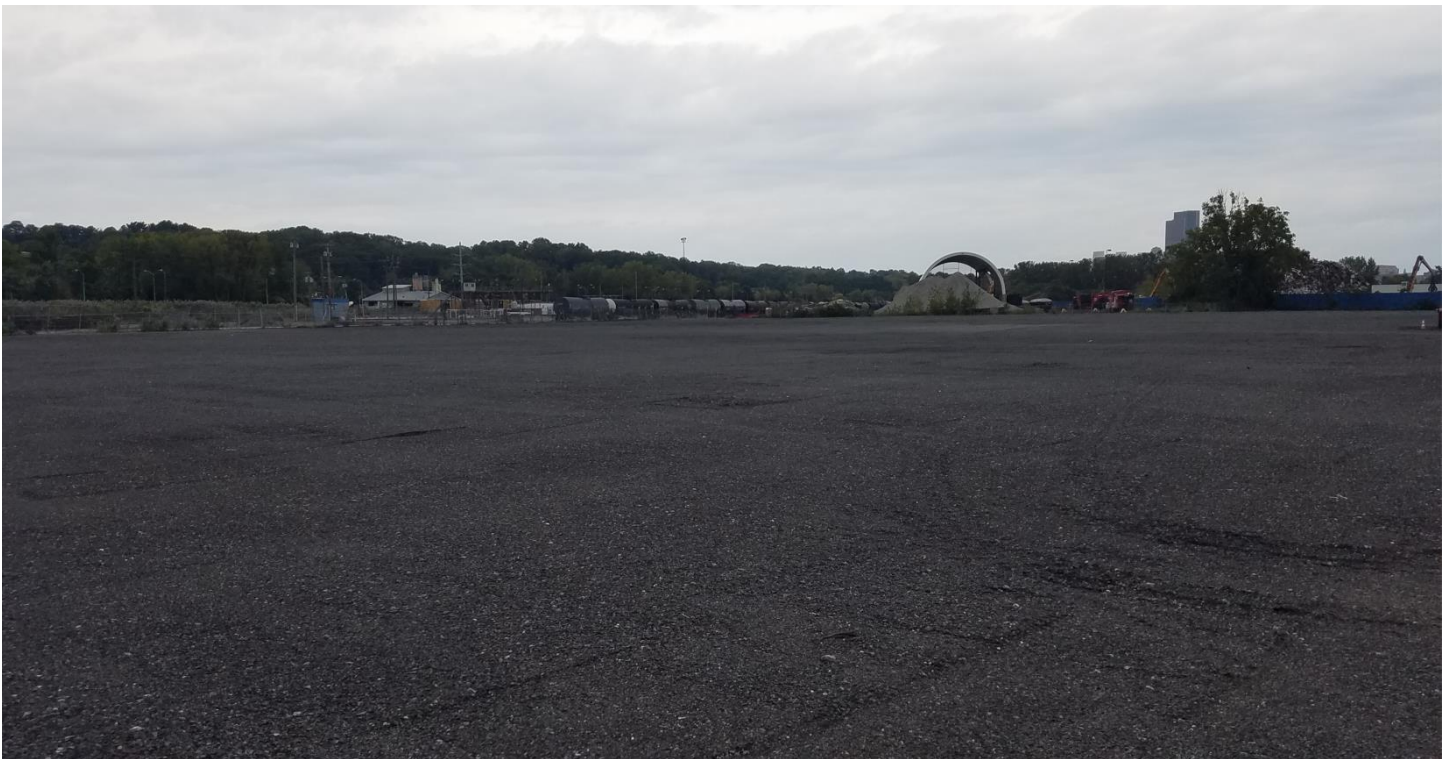
Photo #2 –Existing Site Looking NW (Crushed Millings Remediation Cap)

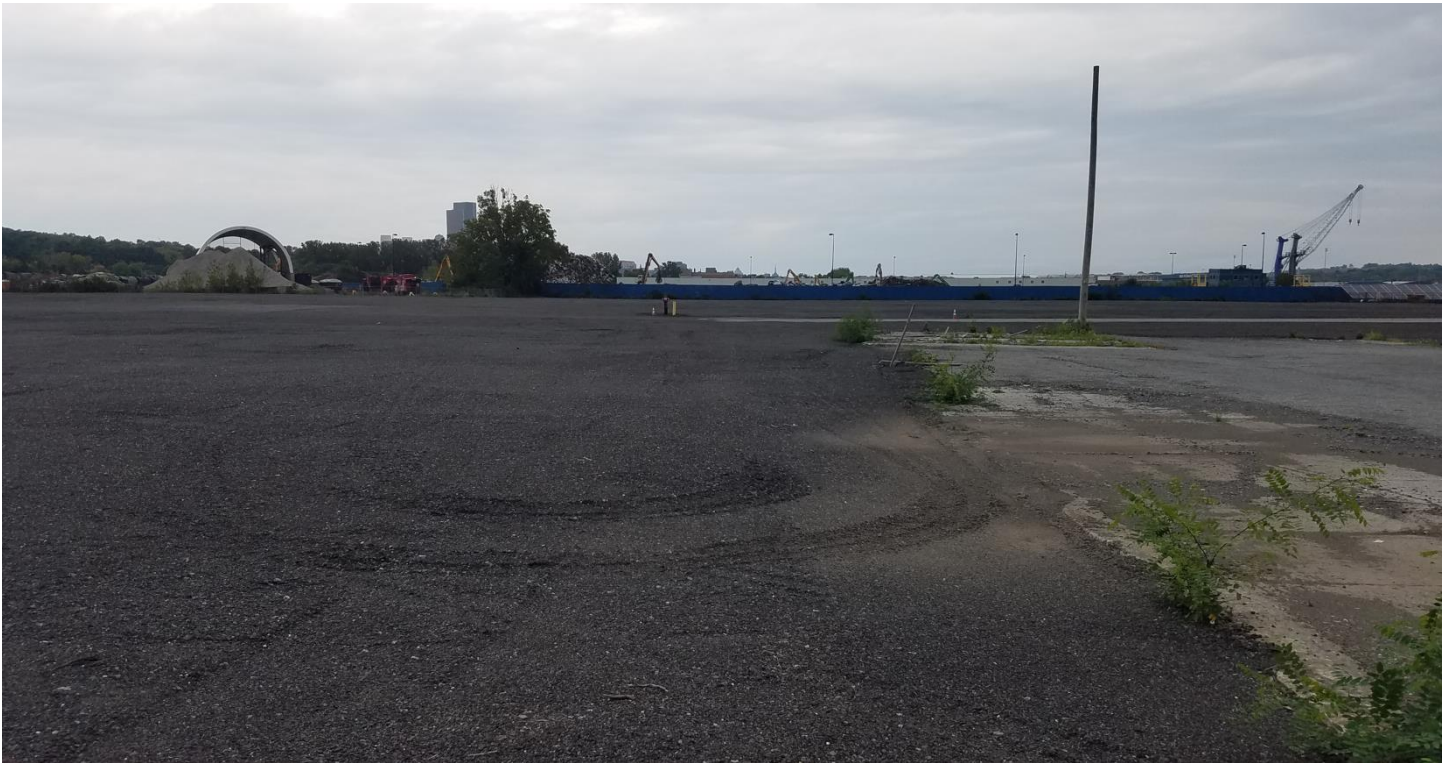
Photo #3 –Existing Site Looking North (Crushed Millings Remediation Cap & Existing Building Foundations)

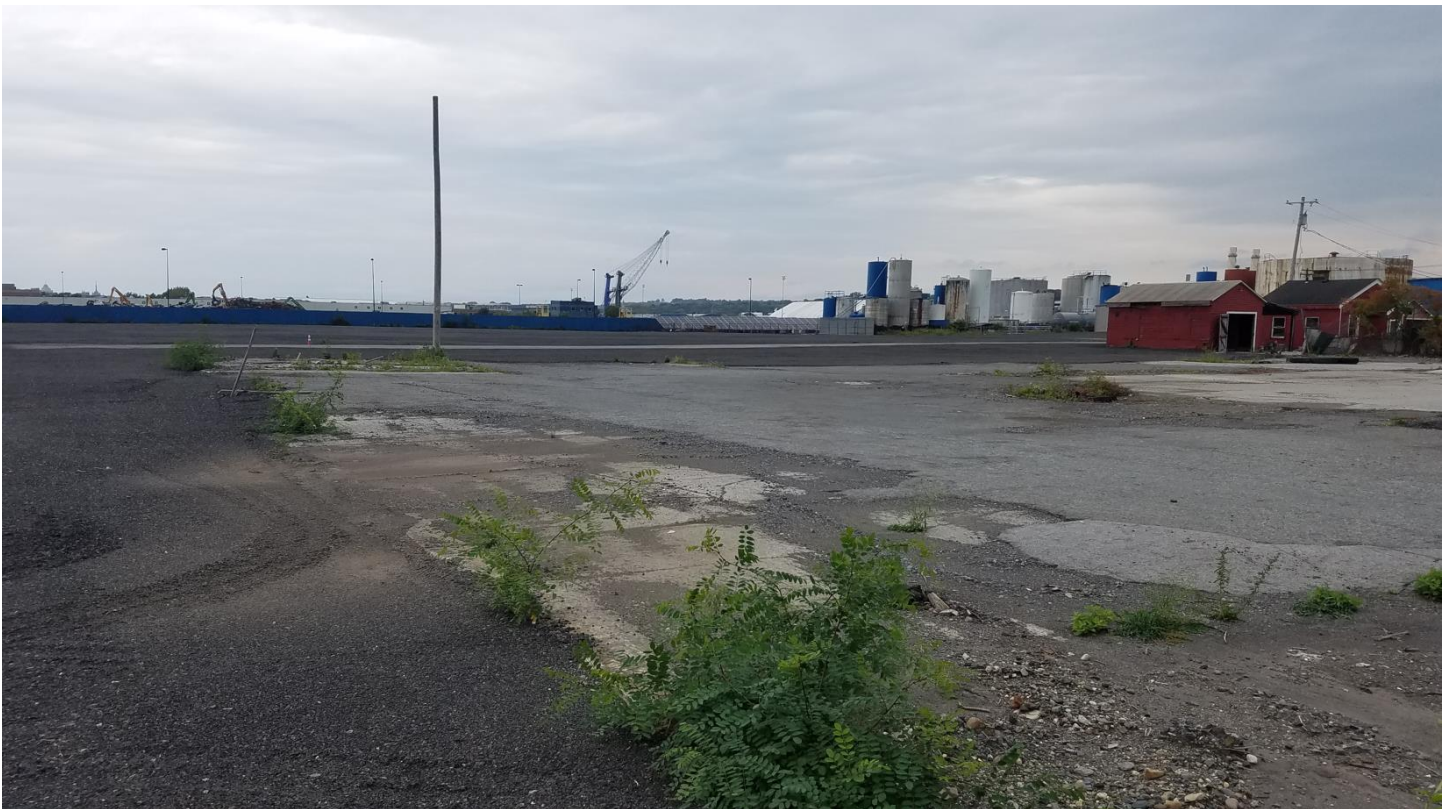
Photo #4 –Existing Site From Center Looking NE (Crushed Millings Remediation Cap & Existing Building Foundations)

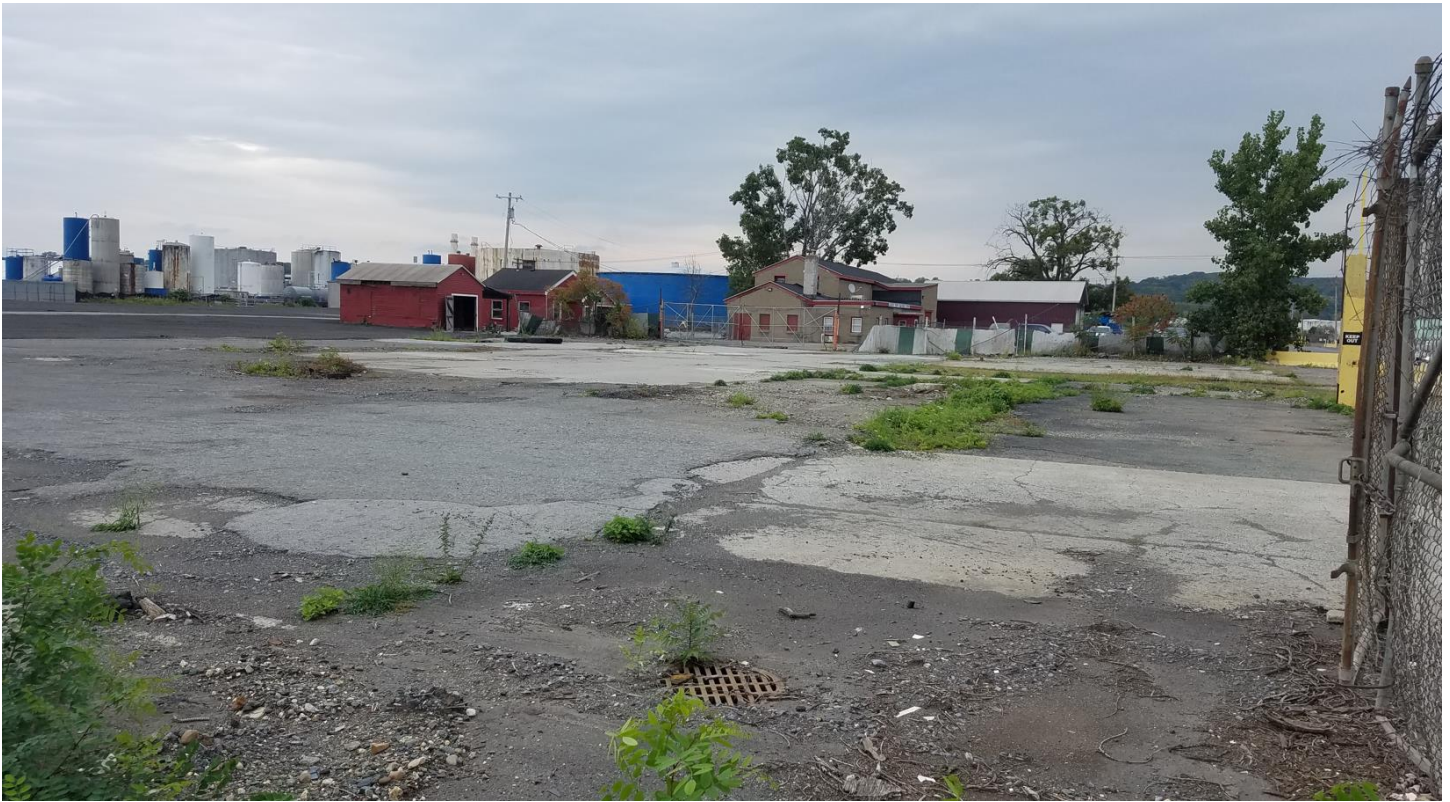
Photo #5 –Existing Site Along Raft St Looking East (Existing Building Foundations)

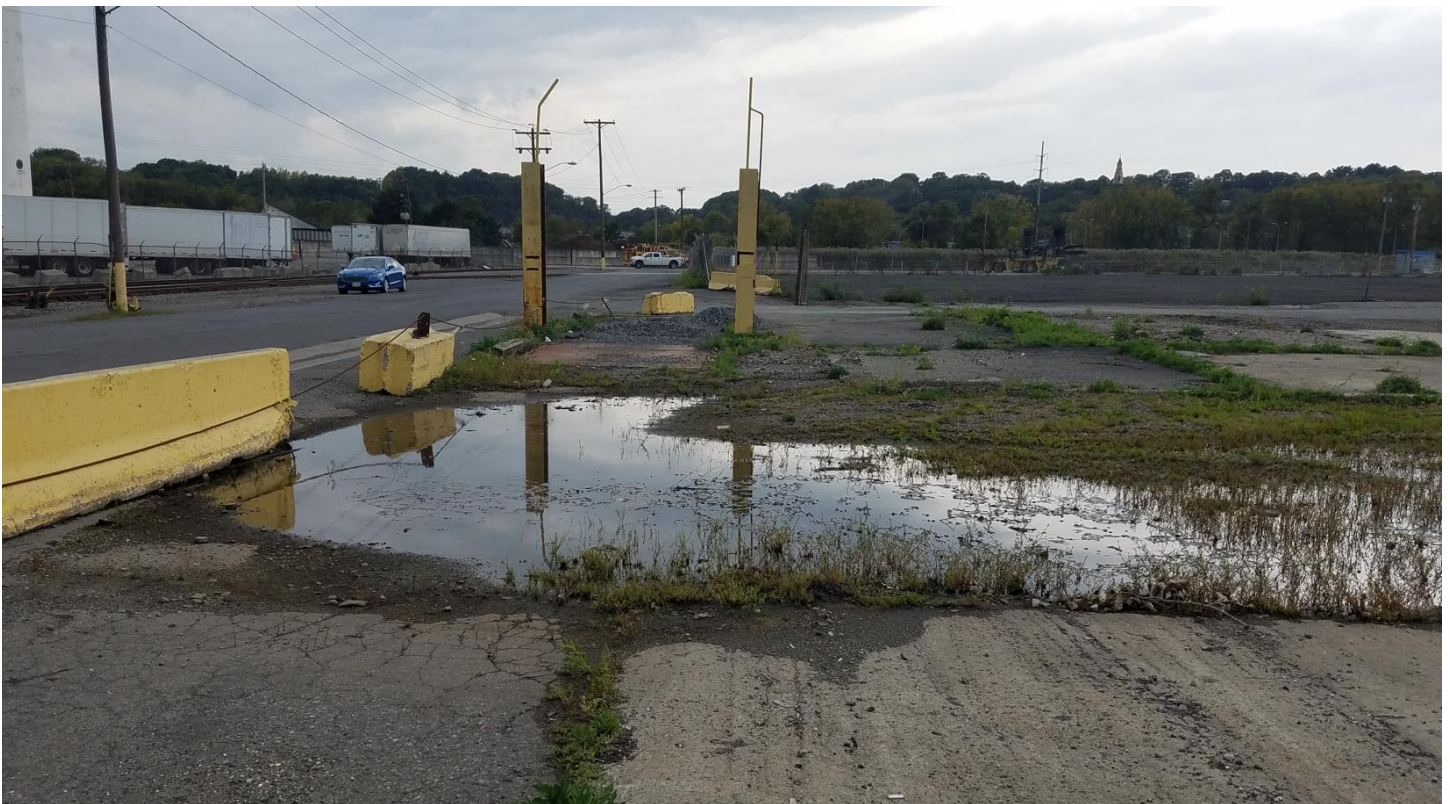
Photo #6 –Existing Site Along Raft St Looking West (Existing Building Foundations)

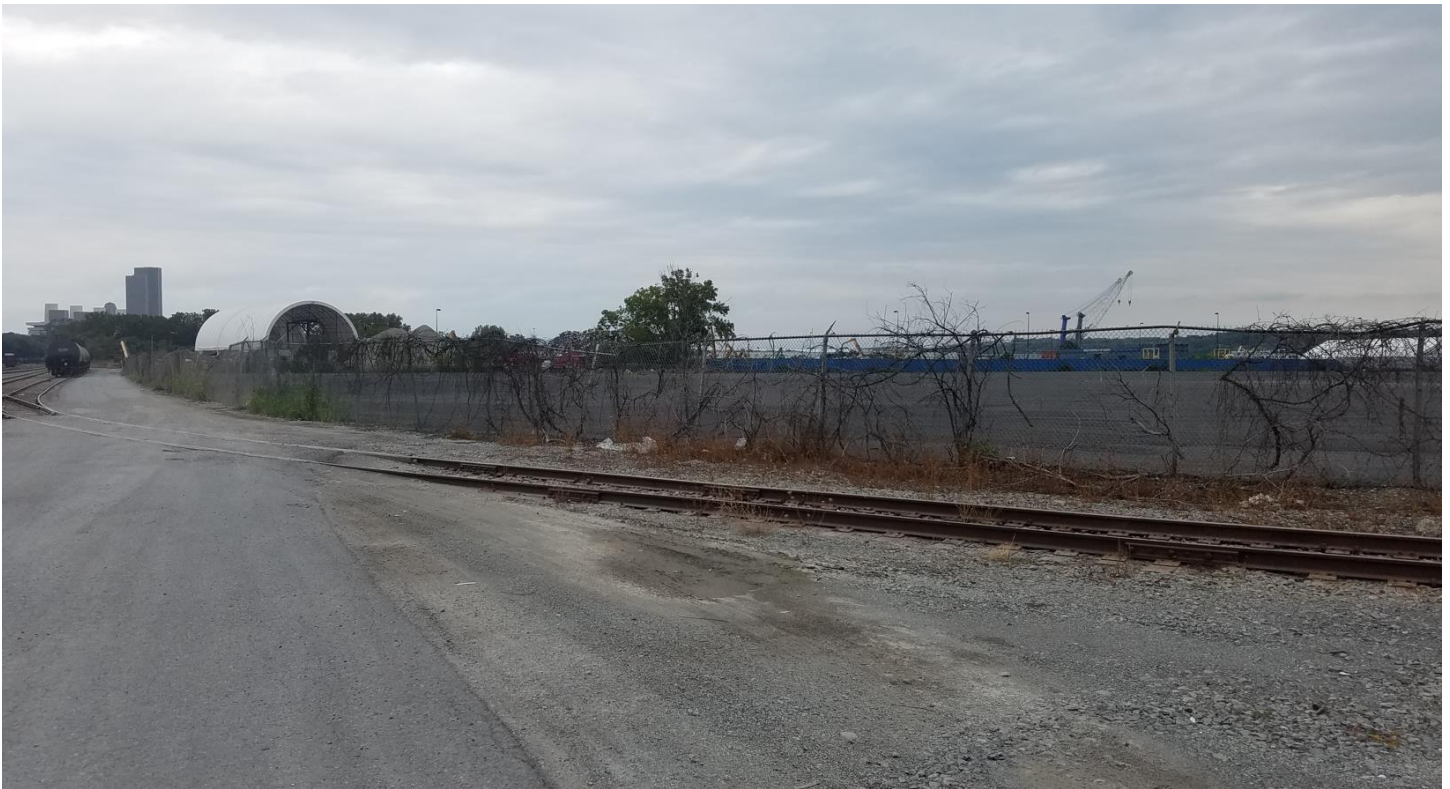
Photo #7 –Existing Perimeter Fence West Side

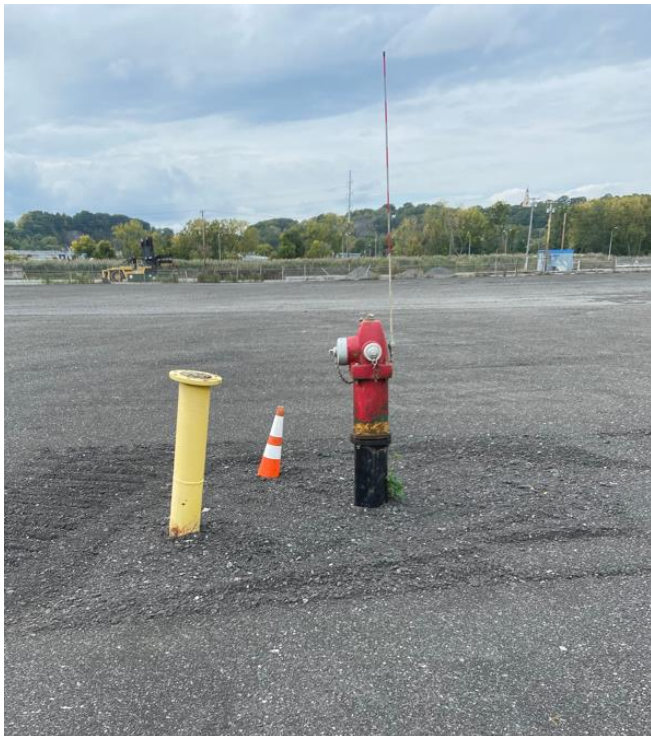
Photo #8 - Existing Hydrant/Water Line Center of Site

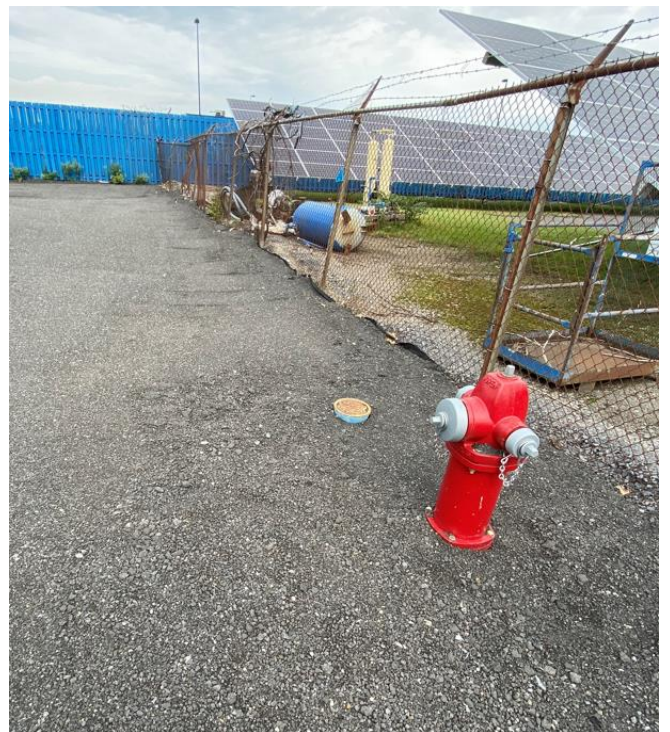
Photo #9 - Existing Hydrant/Water Line NW Corner
