Re: *Visual Structural Evaluation*
241 Orange St.
Albany, NY 12210
C.T. Male Associates Project No. 17.7639

As requested, C.T. Male Associates Engineering, Surveying, Architecture & Landscape Architecture, D.P.C. (C.T. Male Associates) conducted a visual structural evaluation of the above-referenced building on March 16, 2017. The purpose of this evaluation was to visually observe the condition of the building and to provide an opinion on its structural integrity. Based on our visual observations during this site visit, it is our opinion that this building is structurally unsound and should be condemned. As a result of being condemned, a pre-demolition asbestos survey cannot be completed, and as such, the building will need to be demolished per NYSDOL ICR-56 11.5 "Controlled Demolition with Asbestos in Place".

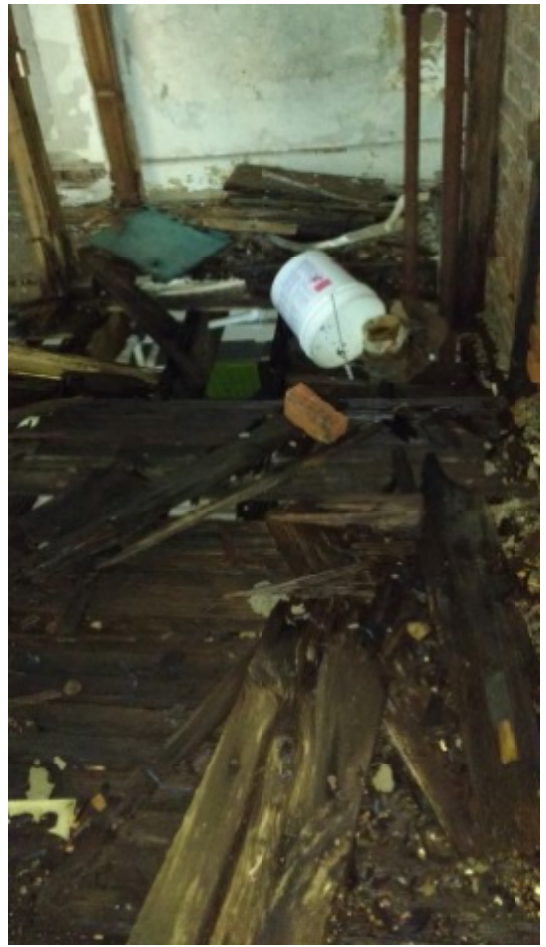
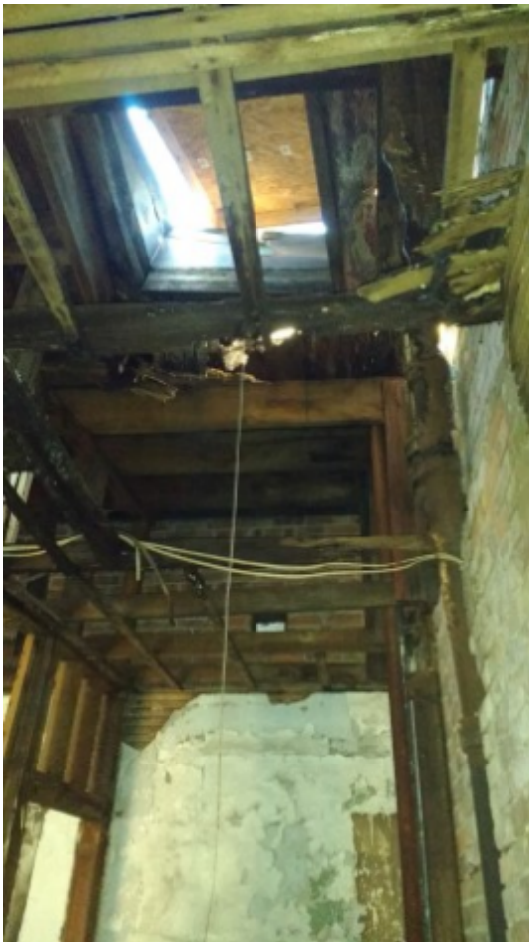
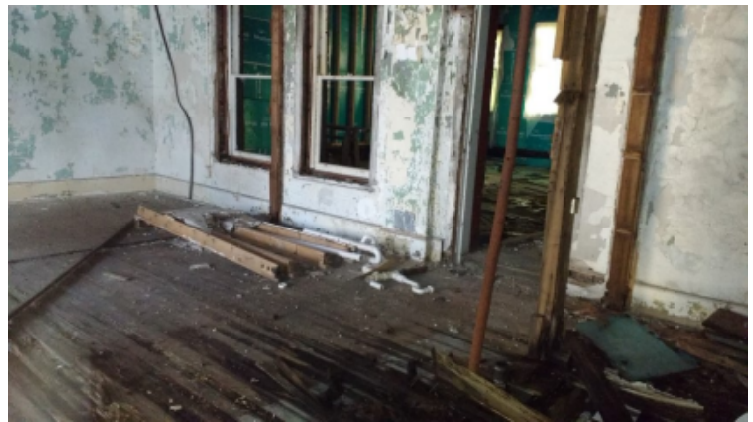
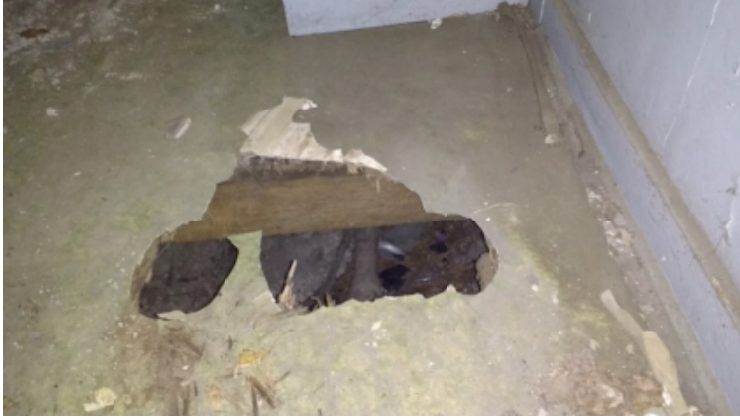
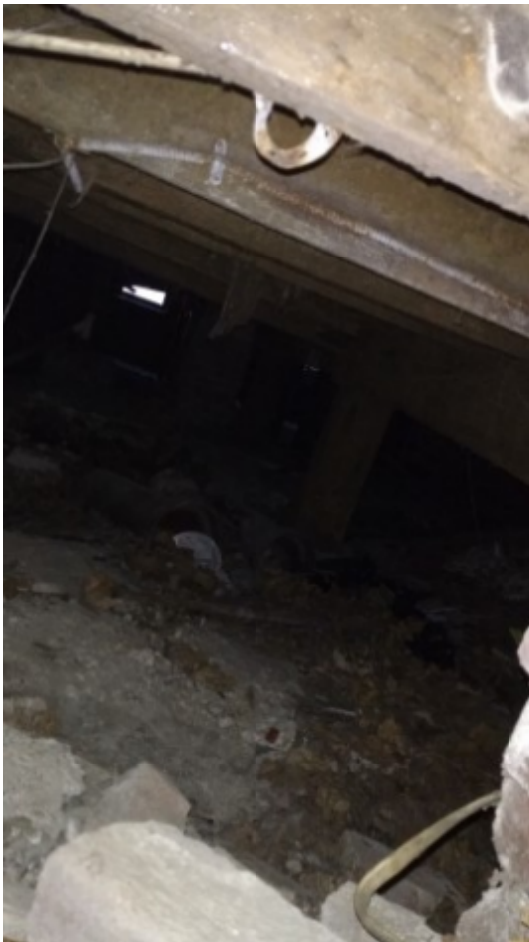
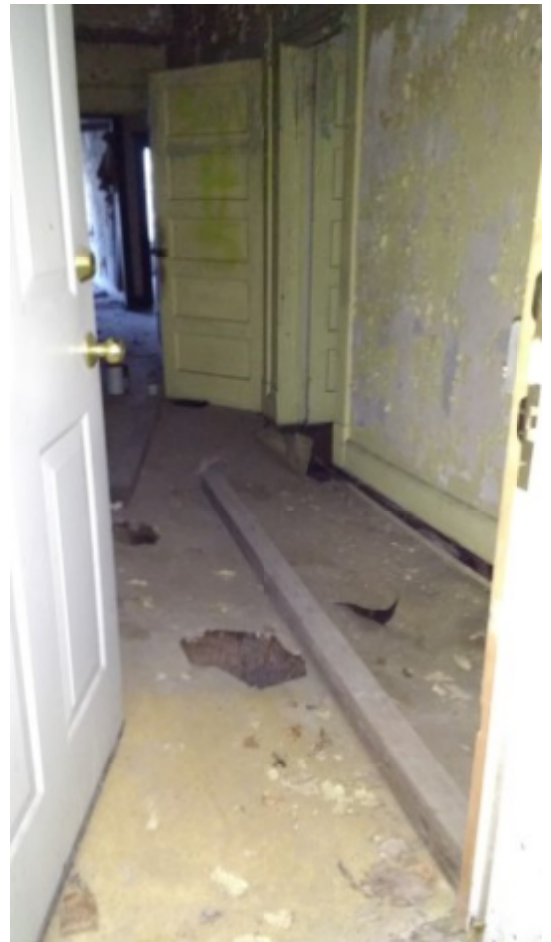
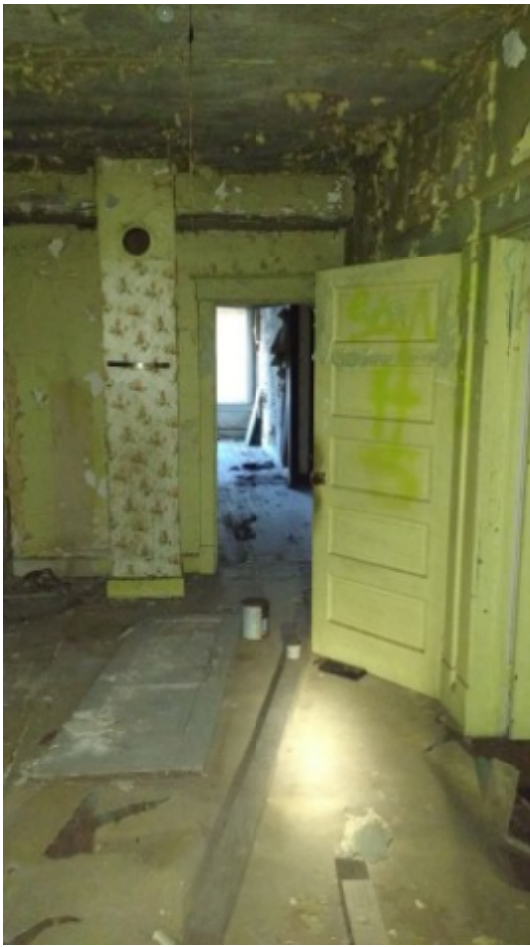
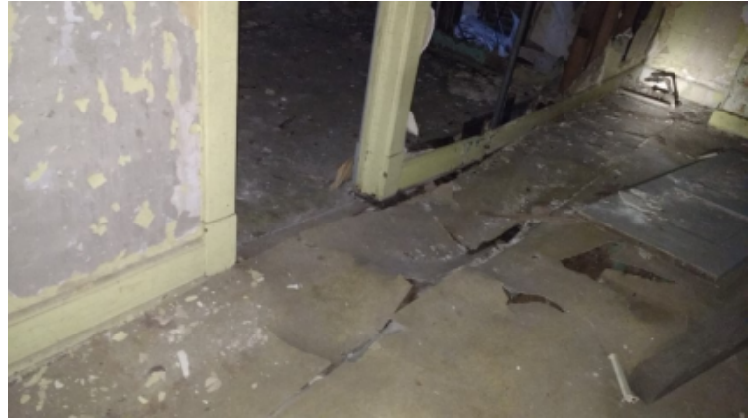
Photographs taken during our site visit are enclosed for your reference. The flooring and subfloor throughout the building are significantly deteriorated and there are numerous holes in the floor where it appears that a foot has gone through the floor between joists. Floor joists are also significantly deteriorated throughout and several areas of the floor are starting to drop.
