# C.T. MALE ASSOCIATES

RE: *Visual Structural Evaluation of Existing Building*  
*194 Partridge Street*  
*Albany, NY*  
*C.T. Male Project No. 17.7563*

*Visual Structural Evaluation of Existing Buildings  
194 Partridge Street - Albany, NY  
September 22, 2017  
Page 2*

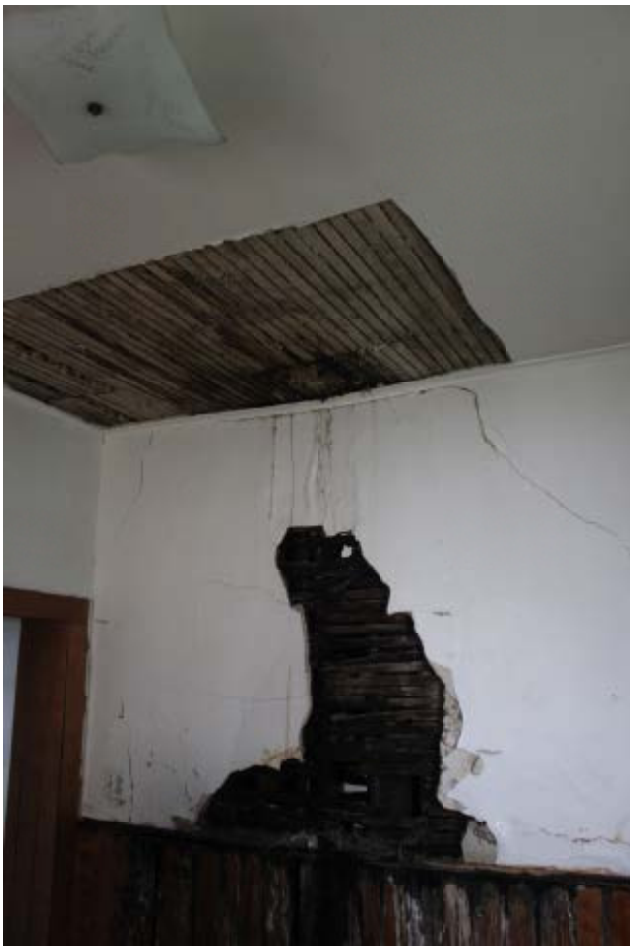
194 Partridge St 13.JPG

- Extensive damage to finishes is visible at the back kitchen/bathroom area. Wood behind finishes is wet and in some areas is starting to deteriorate and become soft. See photos 08-16. **Recommendation: Correct roof leaks. Remove all water damaged wall finishes. Repair or replace water damaged wall framing.**
- Floor sheathing felt soft at the back kitchen area. **Recommendation: All deteriorated sheathing should be replaced with new floor sheathing. Floor joists should be inspected as a part of this work and all deteriorated members should be repaired or replaced.**
