Re: *Visual Structural Evaluation*
436 Third Street
Albany, NY 12206
C.T. Male Associates Project No. 15.5188

As requested, C.T. Male Associates Engineering, Surveying, Architecture & Landscape Architecture, D.P.C. (C.T. Male Associates) conducted a visual structural evaluation of the above-referenced building on November 9, 2017. The purpose of this evaluation was to visually observe the condition of the building and to list all observed areas of structural concern.

Visual Structural Evaluation
436 Third St. - Albany, NY
November 15, 2017
Page 2

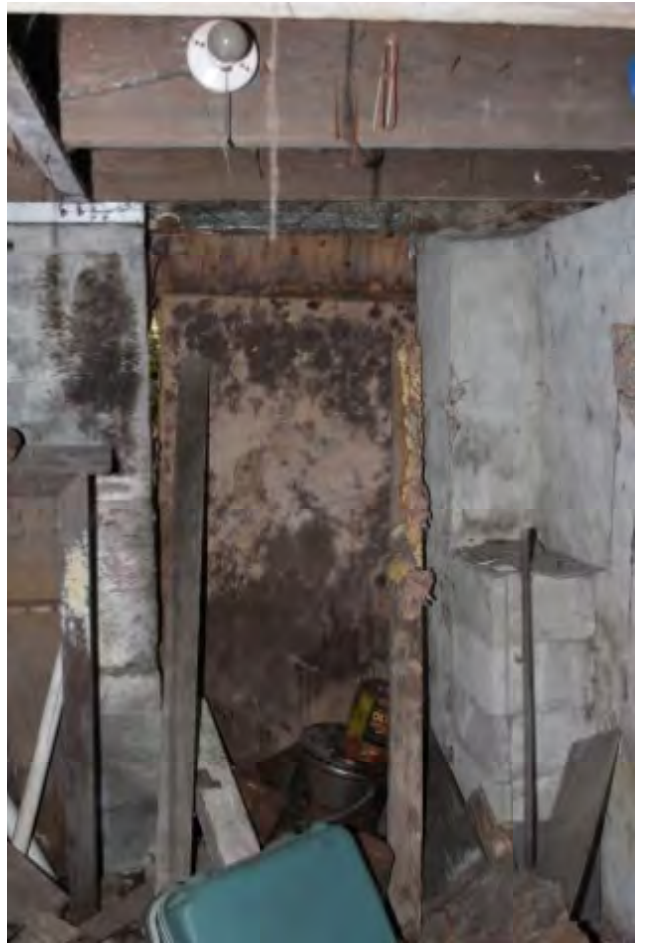
436 Third St 13.JPG

- Walls and floors at the original house generally appear in good structural condition. See photo 11.
- Flooring and framing at the back addition has water damage. See photo 13.
