C.T. MALE ASSOCIATES

July 18, 2019

Re: *Visual Structural Evaluation*
319 Sherman St.
Albany, NY 12206
C.T. Male Associates Project No. 15.5188

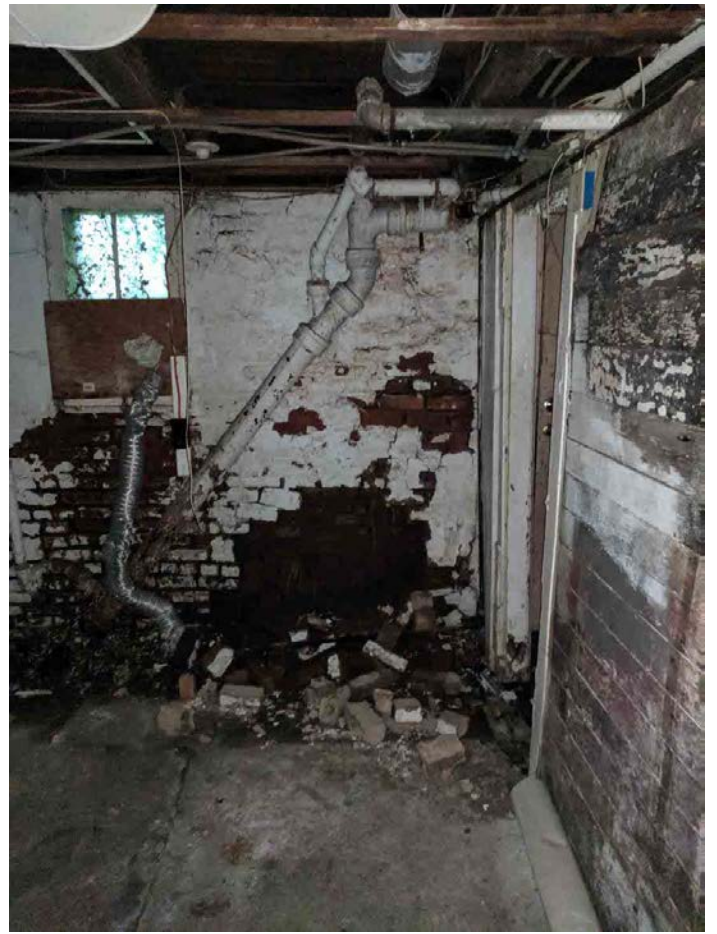
319 Sherman St 09

- Basement walls are typically brick. Masonry walls appear generally plumb, but are in need of repair in many locations. See photos 07-09.
- The front of the basement is finished. At finished spaces, the wood framed floor is significantly deteriorated. See photo 12.

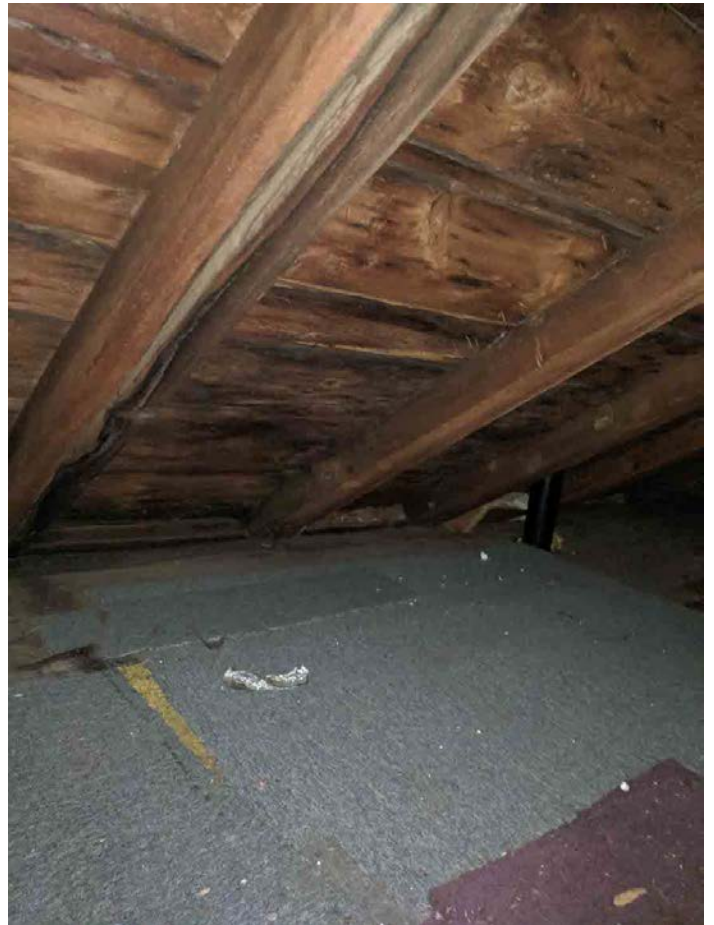
319 Sherman St 15

- The roof has a leak near the front of the building. Framing has some deterioration around the leak. See photo 06, 14-15 and photo 02 showing the trough at the front of the building.
- The middle and rear of the building appear intact and do not have obvious roof leaks.
